## Property Inspection Report

LOCATED AT:  
16508 Hailey Ct  
Tyler, TX 75703

INSPECTED ON:  
Wednesday, February 11, 2026

Inspector, Dominic Cacciapaglia 22932  
B2K Inspections

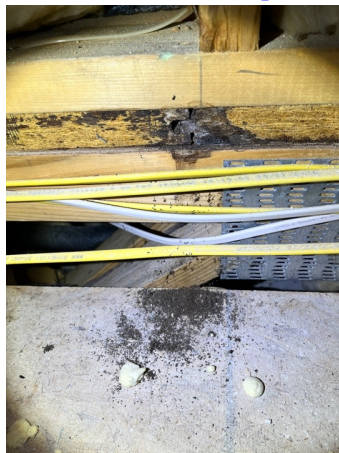
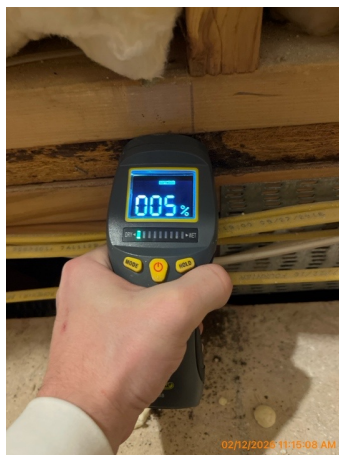
**18:** Inspector noted staining on framing members and subfloor in the left side attic above the main house (near the access door).

Appears to be from previous leakage at the toilet near this area.

Not wet at time of inspection. No evidence of active leakage

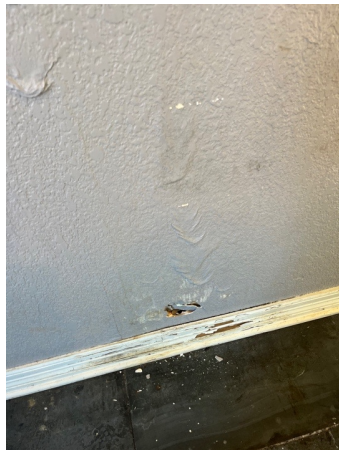
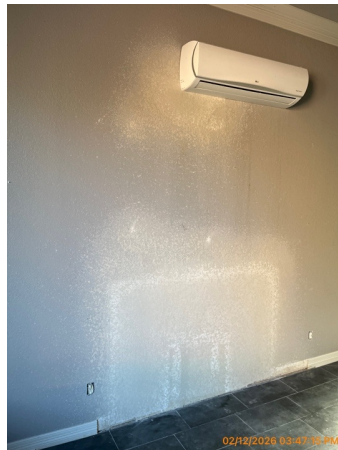
**21:** Wall in man cave showed signs of previous moisture damage on first day of inspection (subsequent to previous leakage of the mini split on this wall).

The wall was repaired during the second day of inspection (not subcontractors of B2K).

Repair work appears to be satisfactory.

No evidence of active leak at time of inspection.

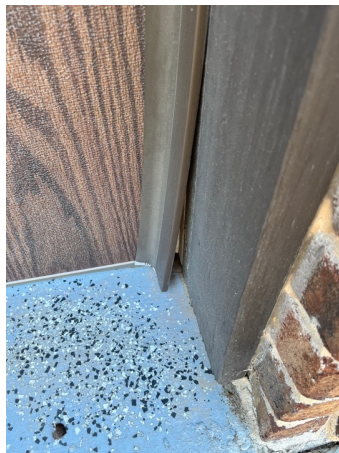
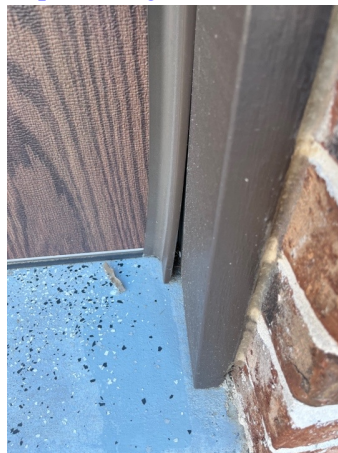
**23:** Lower ends of some weather strips coming loose near the overhead garage doors

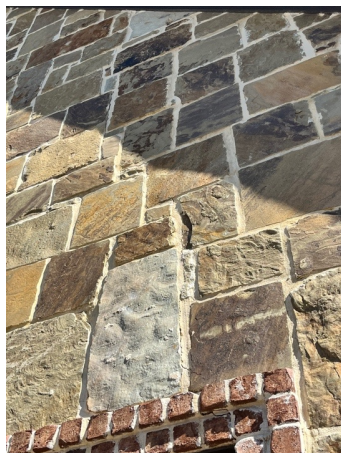
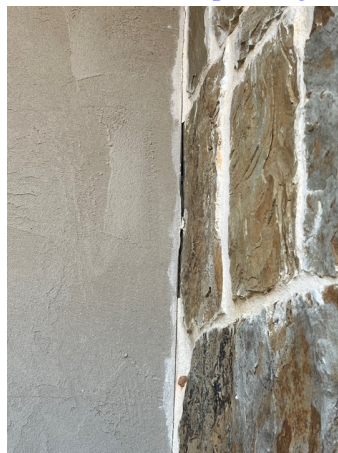
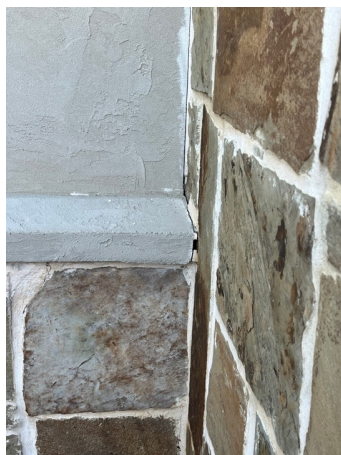
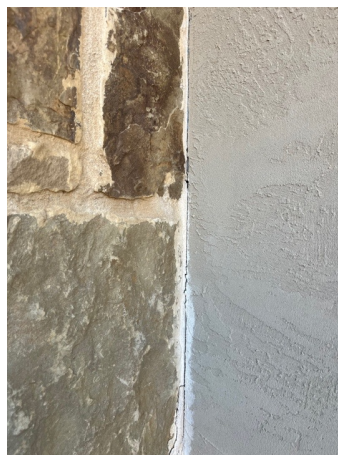
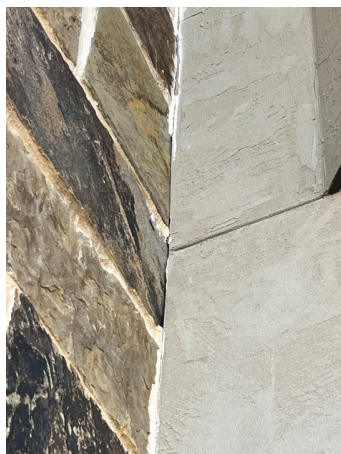
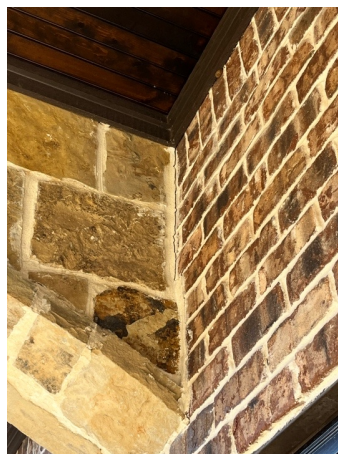
24: Minor cracks noted in areas. Grout could use repointing in these areas

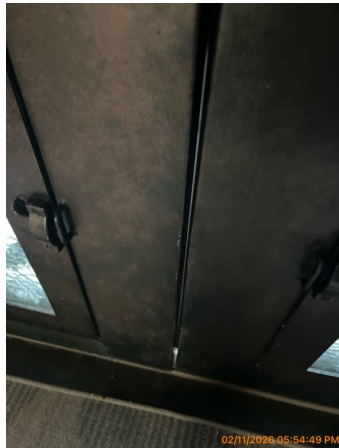
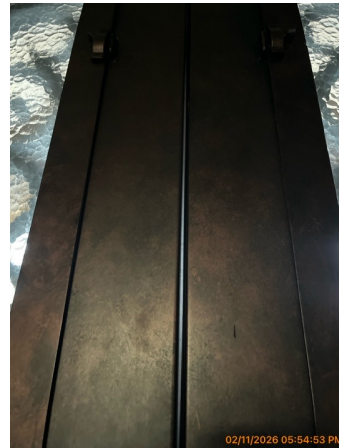
**28:** Front door doesn't seal tightly against weatherstripping when closed. Light seen through gap.

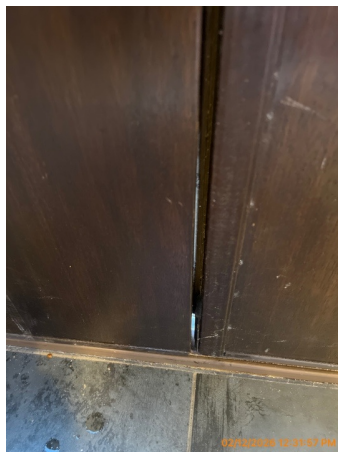
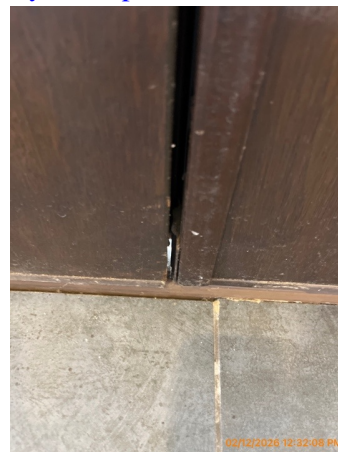
(Man cave, upstairs bedroom, detached garage etc).

We recommend all doors seal tightly to keep outside moisture/air out

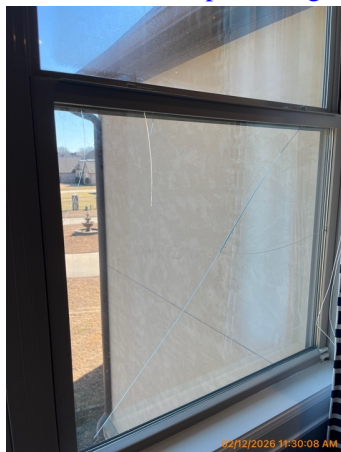
36: Window in upstairs right side bedroom has broken glazing

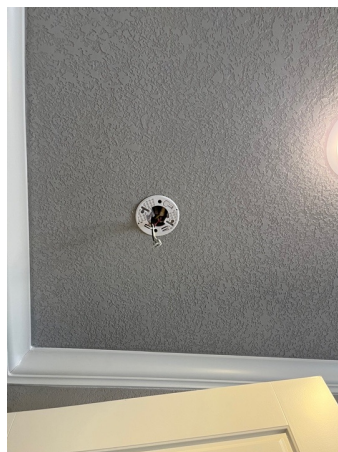
**94: Smoke detectors not present in all areas required. (Mounts present, but detectors missing in two upstairs bedrooms)**

One is required in each bedroom. One in each hallway adjacent to each sleeping area and at least one on each floor if more than one story. Alarm system connected detectors and heat detectors do not count toward the minimum.

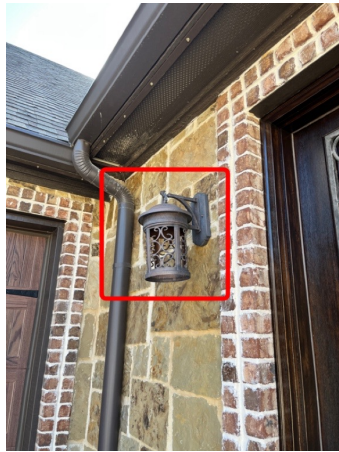
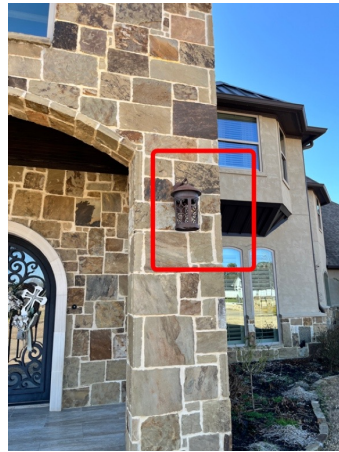
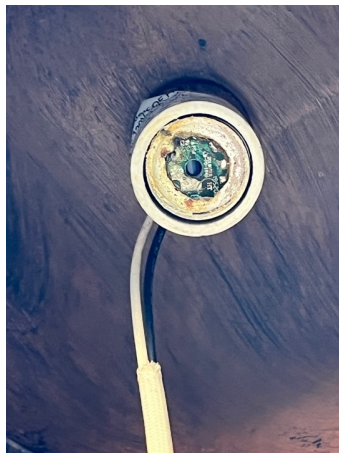
**100:** Some exterior lights were inoperative. Likely need new bulbs.

Fixture at front porch appears it has the base of a broken bulb stuck in the socket

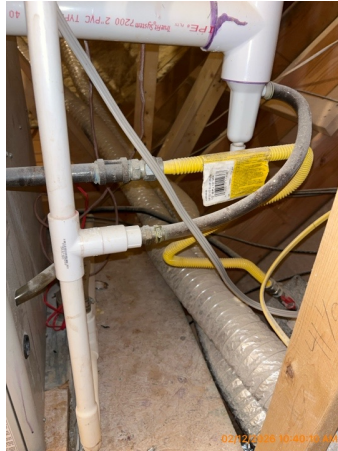
**124:** The fuel piping does not include a 'T' extension to collect condensation and debris, as is considered good practice. In the course of future upgrading or repair, a 'drip leg' should be added to the gas piping just ahead of the connector.

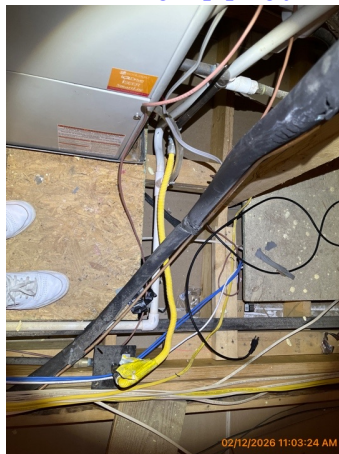
**142:** The fuel piping does not include a 'T' extension to collect condensation and debris, as is considered good practice. In the course of future upgrading or repair, a 'drip leg' should be added to the gas piping just ahead of the connector.

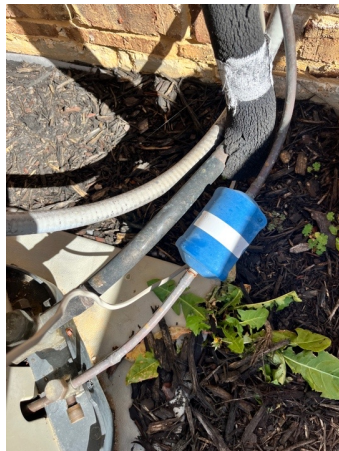
176: Insulation is deteriorated and missing from portions of the refrigerant lines in areas. We recommend that all missing insulation be replaced to increase energy efficiency.

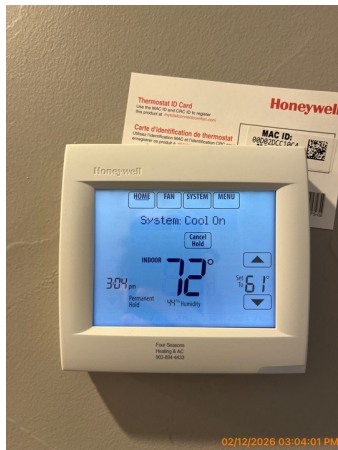
**196:** Failed to respond to user controls. Blower operated, but condensing unit did not turn on when thermostat was set to cool.

Recommend evaluation by specialist and repair as necessary.

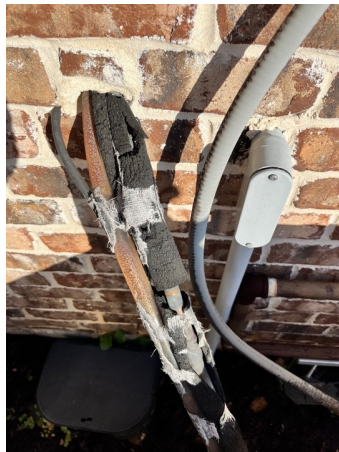
**203:** Insulation is deteriorated and missing from portions of the refrigerant lines in areas. We recommend that all missing insulation be replaced to increase energy efficiency.

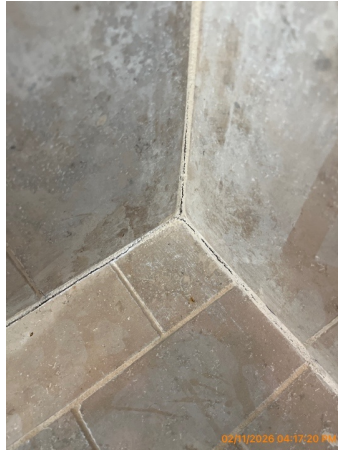
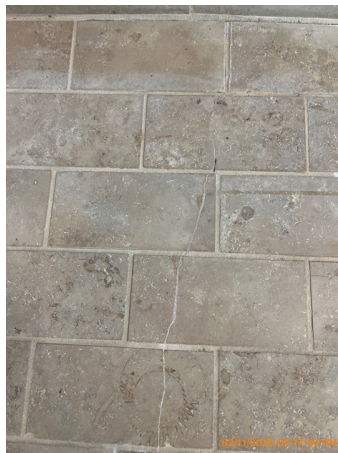
**234:** Minor cracks in grout and some cracked tiles noted in master shower

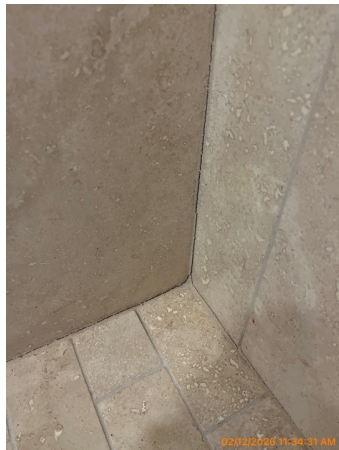
235: Minor cracks in grout of upstairs middle bedroom shower

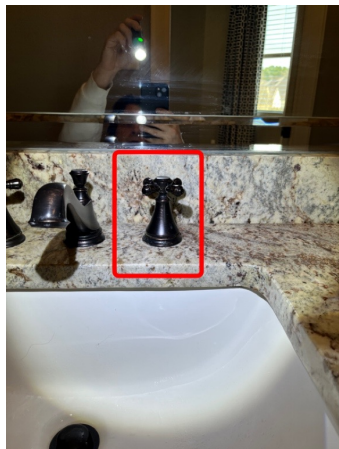
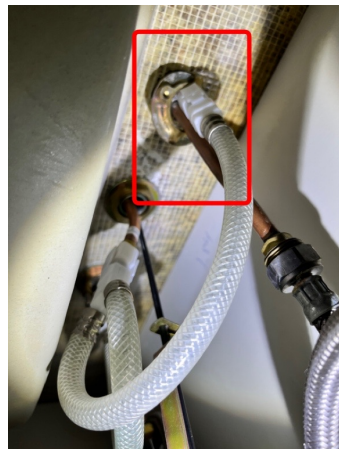
236: Cold water valve handle is loose where it should be secured to the countertop. (Upstairs right side bedroom en-suite bathroom)

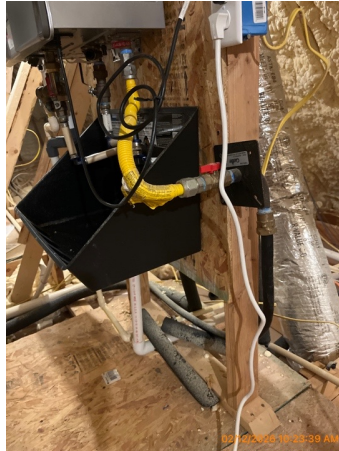
**247: GAS SHUT-OFF VALVE:** The gas piping does not include a sediment trap/drip leg installed downstream of the shutoff valve to collect condensation and debris. In the course of future upgrading or repair, a 'drip leg' should be added to the gas piping just ahead of the connector.

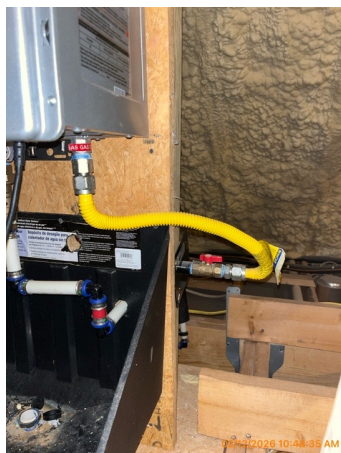
**264:** GAS SHUT-OFF VALVE: The gas piping does not include a sediment trap/drip leg installed downstream of the shutoff valve to collect condensation and debris. In the course of future upgrading or repair, a 'drip leg' should be added to the gas piping just ahead of the connector.

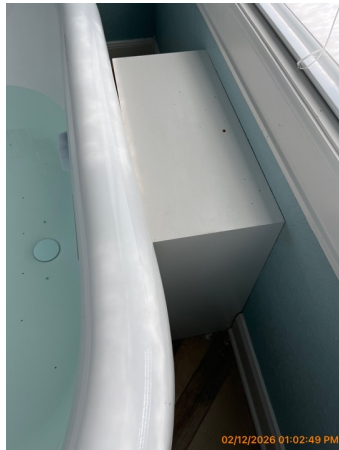
275: The hydrotherapy tub was not functional at the time of inspection. Recommend the tub be further evaluated and repaired, if necessary.  
(There may be a tripped GFCI receptacle in finished space behind tub)

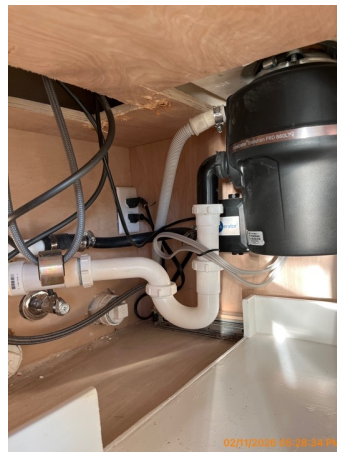
**281:** Dishwasher lacks air gap or backflow loop or the loop is not elevated high enough. This is considered a deficiency.

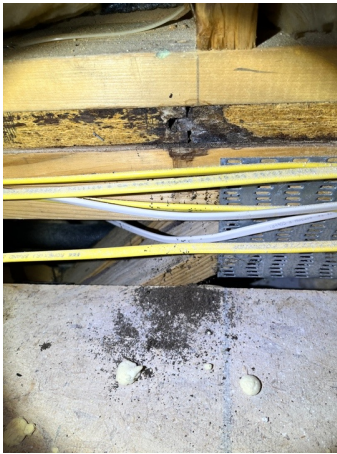
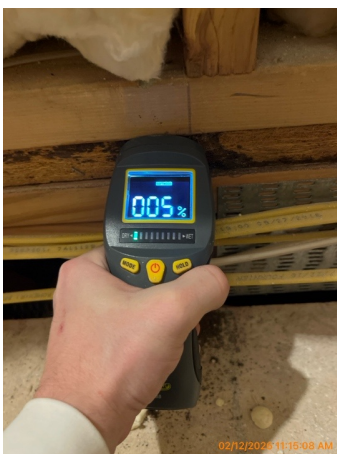
Not wet at time of inspection. No evidence of active leakage

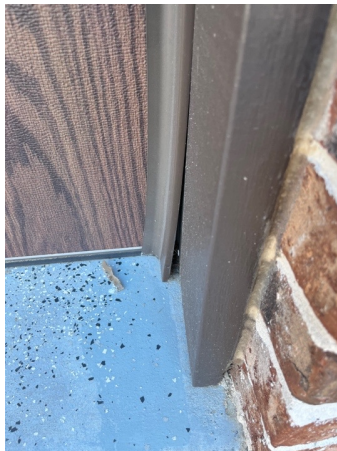
s-23: Lower ends of some weather strips coming loose near the overhead garage doors

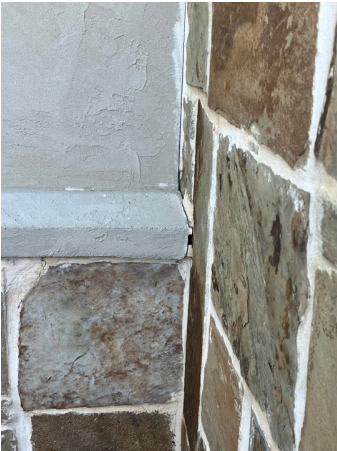
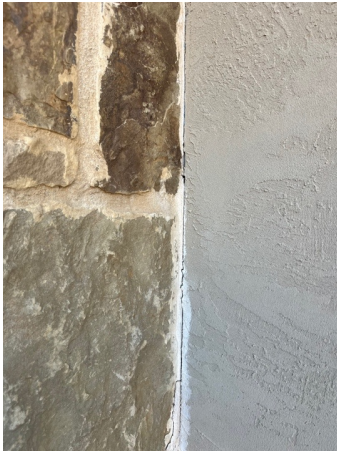
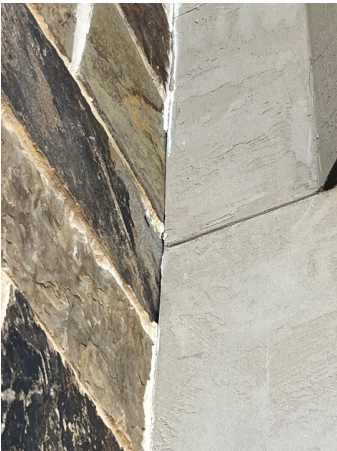
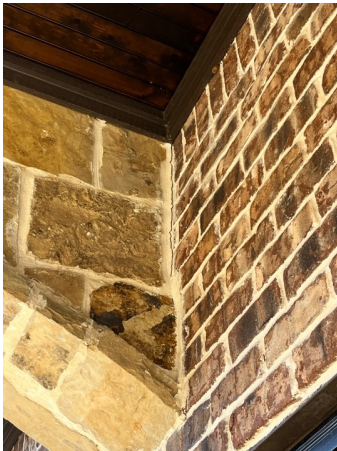
s-24: Minor cracks noted in areas. Grout could use repointing in these areas

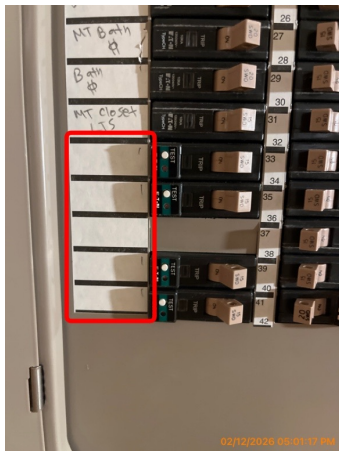
s-54: GENERAL: The service panel is not fully labeled.

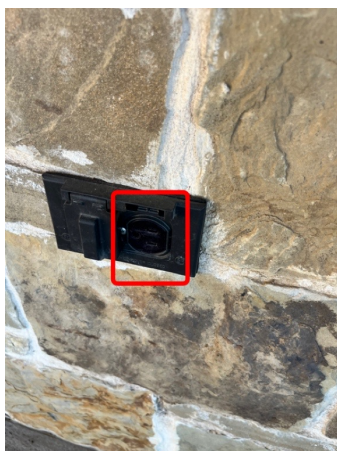
s-91: Three receptacles at the back patio area lack GFCI protection or failed to trip when tested. One lacks a cover.

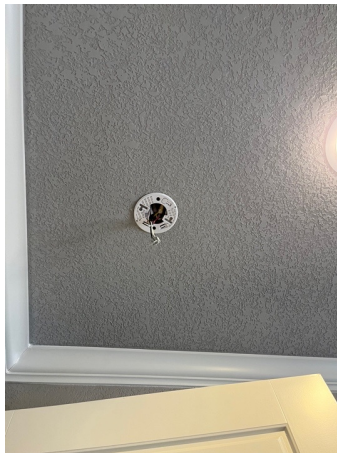
One is required in each bedroom. One in each hallway adjacent to each sleeping area and at least one on each floor if more than one story. Alarm system connected detectors and heat detectors do not count toward the minimum.

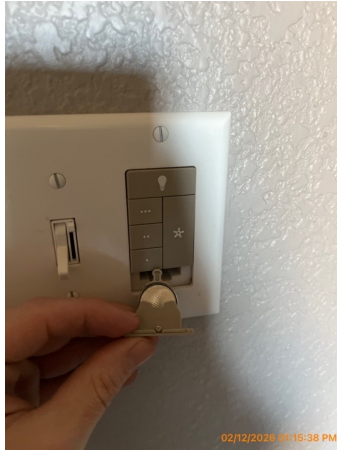
s-99: Ceiling fan/light in master bedroom were inoperative.  
Battery in control may be dead.

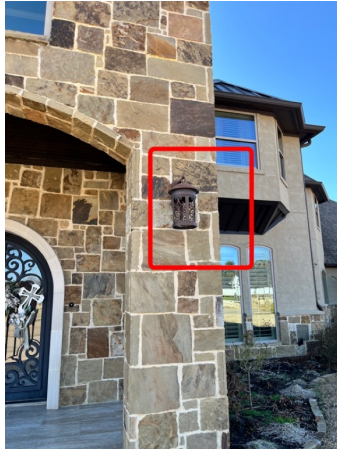
s-100: Some exterior lights were inoperative. Likely need new bulbs.  
Fixture at front porch appears it has the base of a broken bulb stuck in the socket

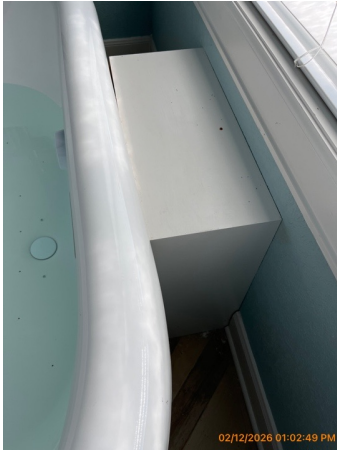
(There may be a tripped GFCI receptacle in finished space behind tub)

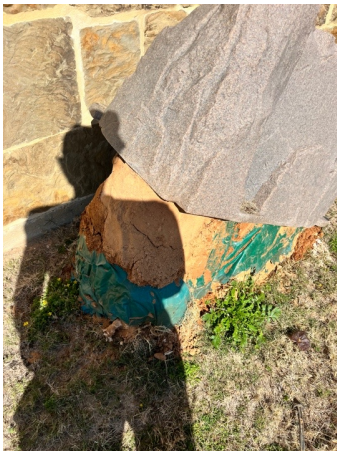
s-305: Cover for backflow preventer was completely filled with dirt (maybe from ants).  
Dirt should be cleared so valves are made accessible
