NPI MISSOURI INC

SEWER INSPECTION

1100 E Liberty St
Mexico, MO 65265

04/08/2025

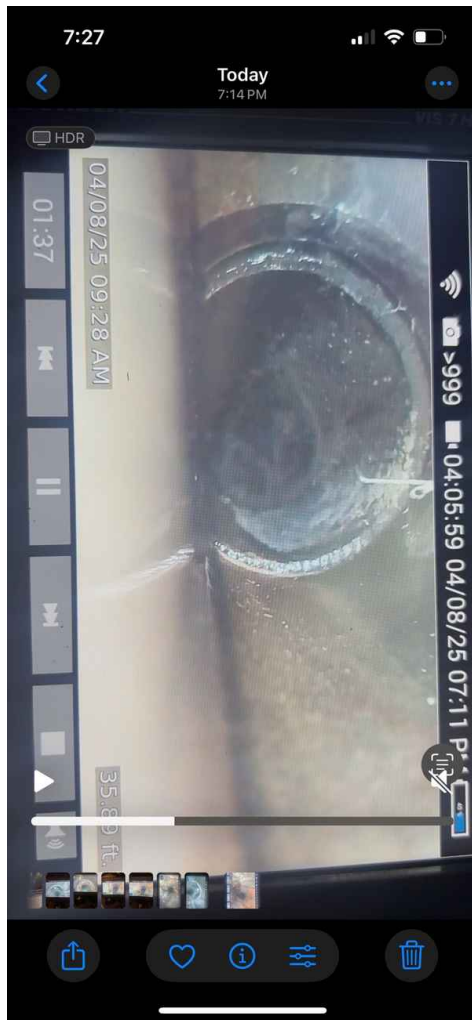
3.1.1 Drain System

BELLY

There is a low point in the drain line which will promote clogging. Standing water was observed in low point. We recommend further review and repair as needed.

Contact a qualified plumbing contractor.

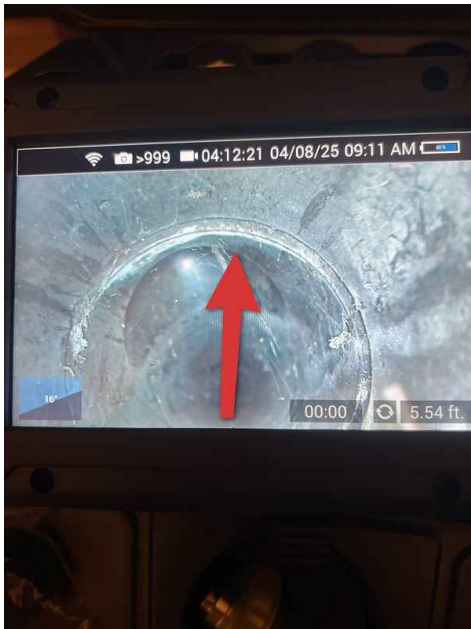
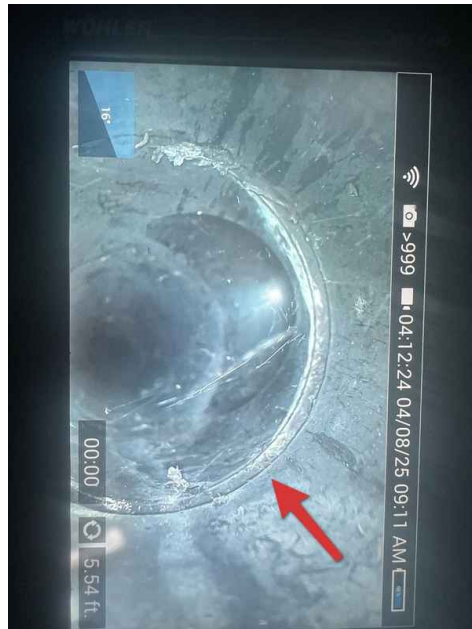
3.1.2 Drain System

OFFSET

There is a offset in the drain line where two pipes are not properly connected and there is a "lip" which can cause clogging. We recommend further review and repair as needed.

Contact a qualified professional.

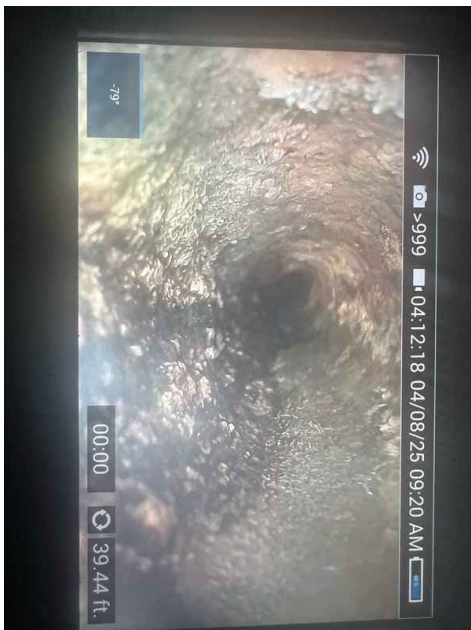
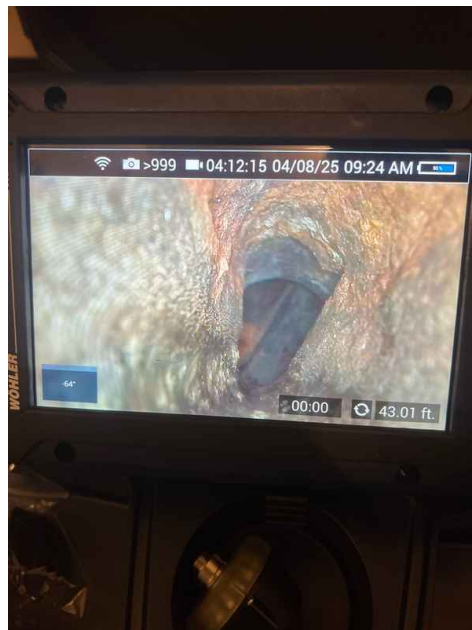
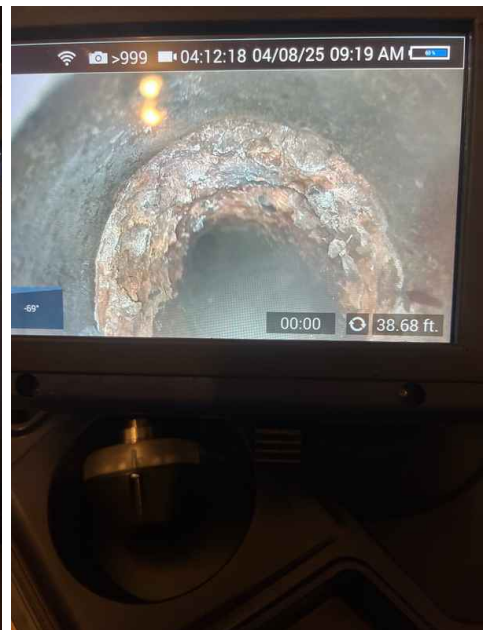
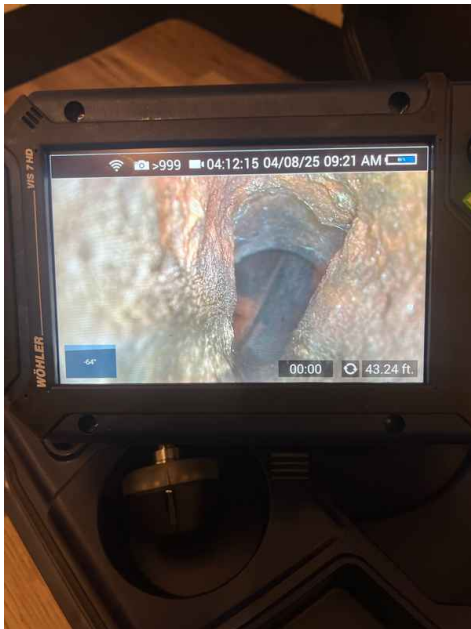
3.1.3 Drain System

SCALE BUILD UP

There is scale build up inside sewer line which will promote clogging. We recommend repair as needed.

Contact a qualified professional.

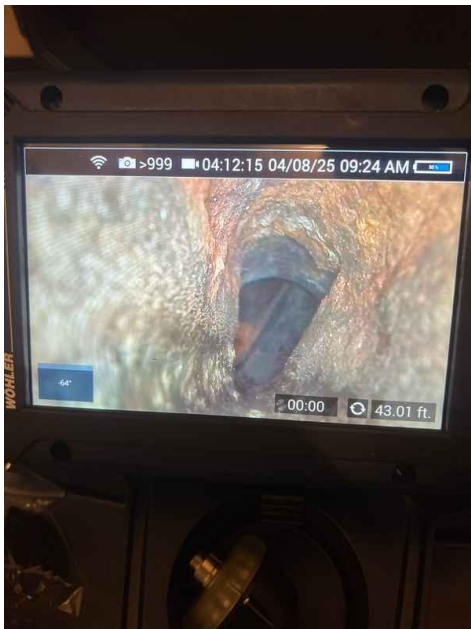
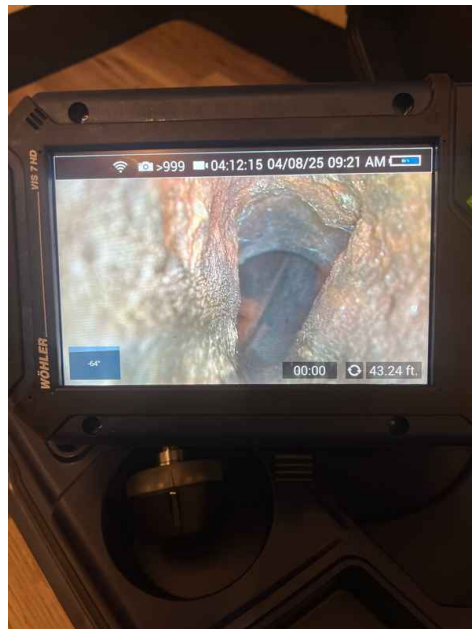
3.1.4 Drain System

SEWER LINE OCCLUSION > THAN 75%

As we examined the line we found the drain to have an occlusion of more than 75%. Corrective action is needed. When you have a sewer line problem, your sinks, toilets and even bathtub might drain slowly or not at all. We would highly recommend a professional plumbing drain company exam the problem and correct the issue as soon as possible.

Contact a qualified professional.
