# MERIT INSPECTION SERVICE INC.

## PROPERTY INSPECTION REPORT FORM

**Name of Client:** Kermit & Minnie Feuge **7/30/2024** **Date of Inspection**

**4402 Cherry Mountain Loop, Fredericksburg, TX**

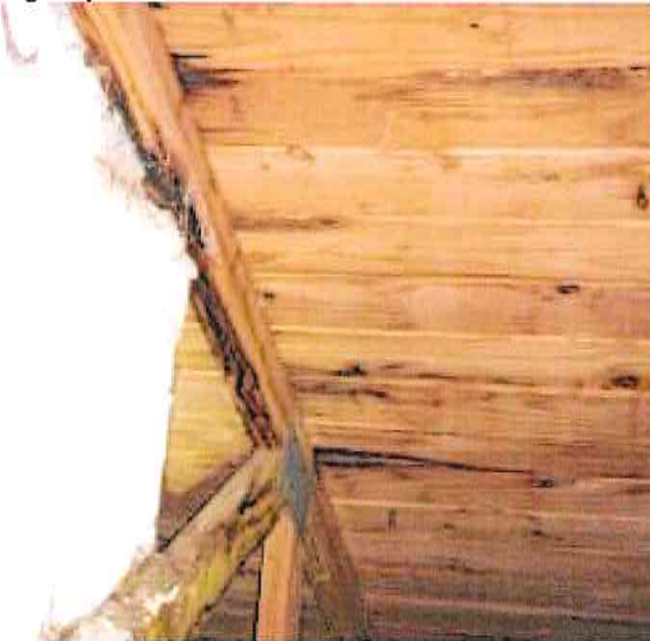
**Noted evidence of prior moisture migration into attic. See stains at roof decking. From prior roofing as per sellers statement.**

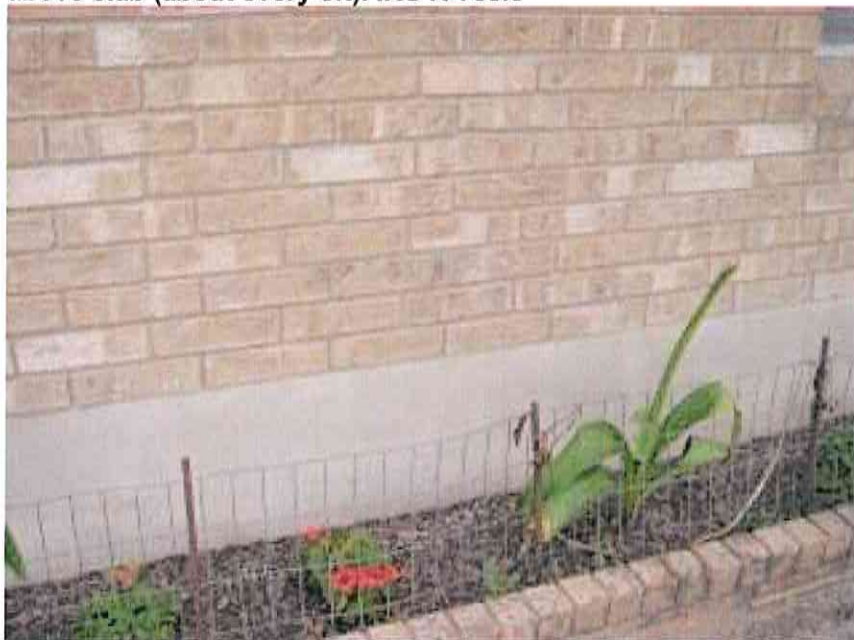
Builder/mason did not install "weep drains" in exterior masonry walls. These are needed to drain vent moisture/condensation in wall voids. Weep holes are drilled in lowest mortar joint at base of masonry wall just above slab (about every 3ft). IRC R-703.6

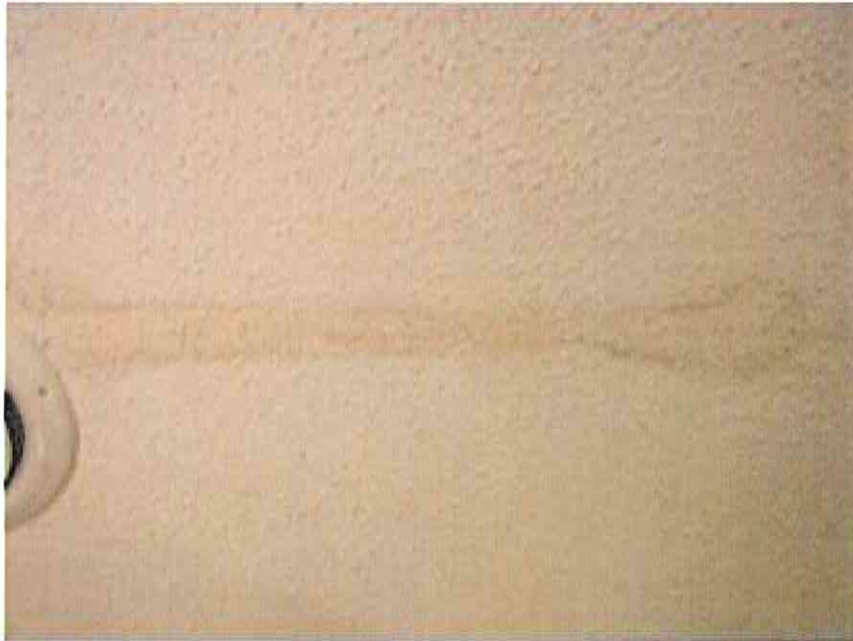
Noted moisture stains to interior. Sellers should disclose complete details of any and all prior moisture penetration into the home Determined to be from leaking prior to current roof (as per sellers statement also).

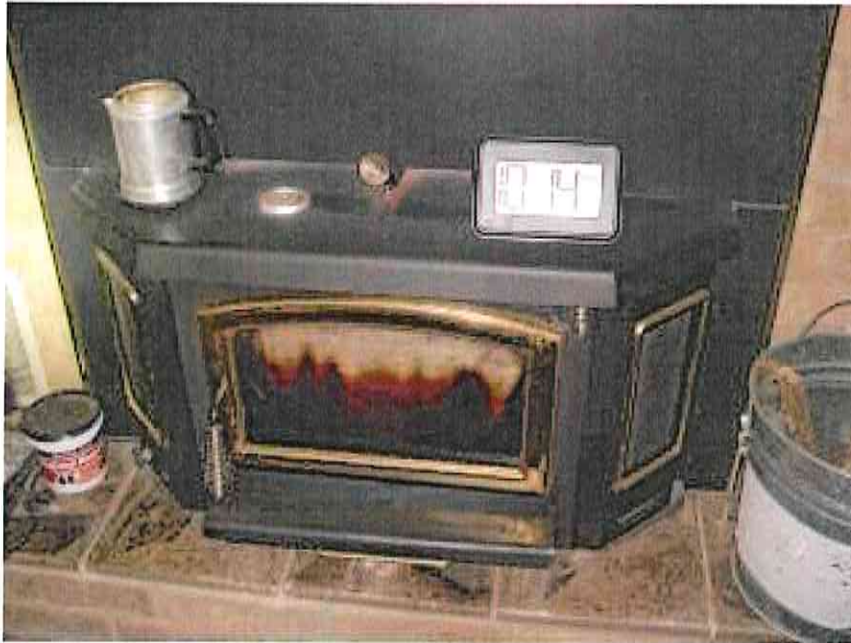
**Metal insert – no access to chimney for viewing.**

**Chimney above roof line appears absorbing/wicking moisture (either due to nature or condition of materials)  
Consider repairing any and all openings and clear masonry sealing chimney above roof line.**

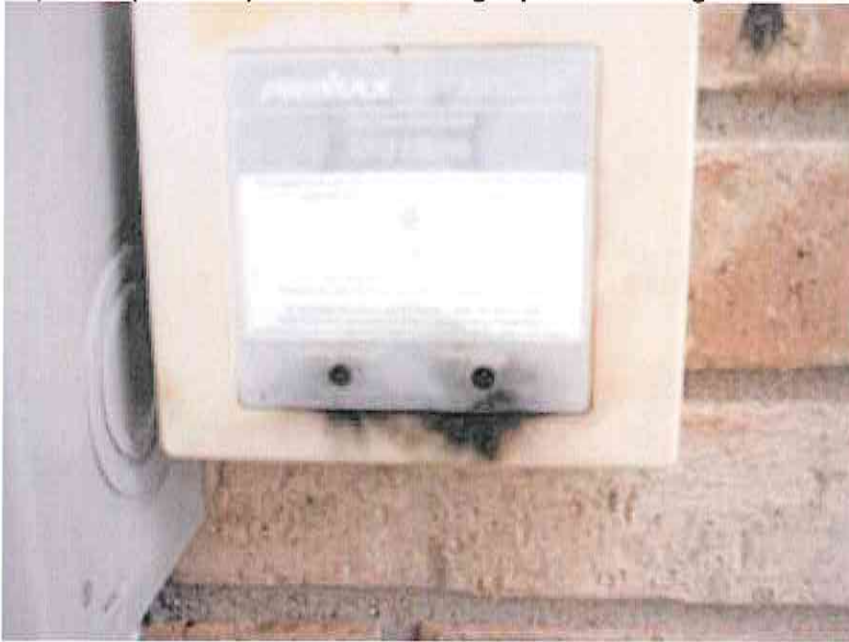
The lightening arrestor/surge protector device inter connected to service panel appears to have been depleted. (see soot). Consider having replaced – though not an electrical code requirement. Contact CTEC.

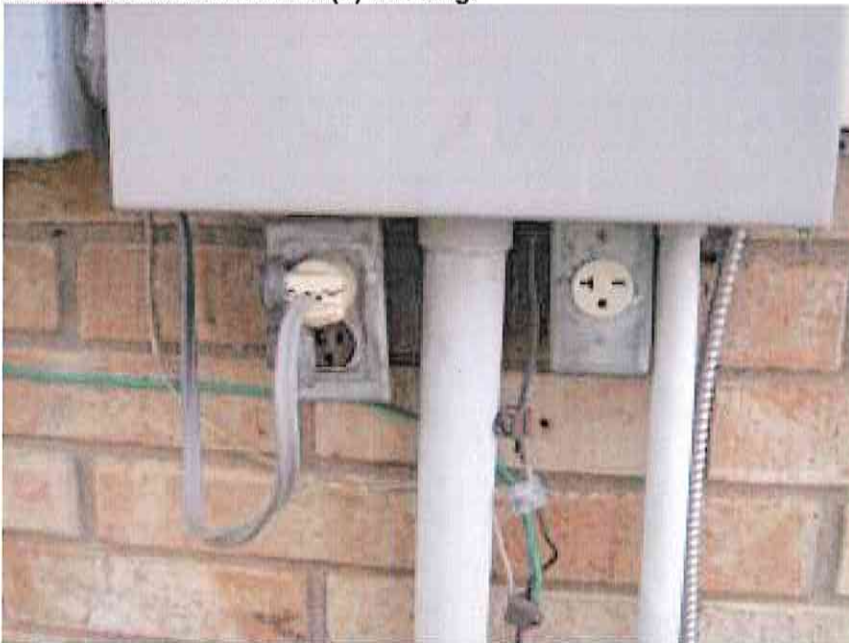
All exterior circuits should be GFCI protected with weatherproof covers/enclosures.

All exterior or exposed installed electrical circuits should be protected from direct exposure (conduit) See example photos.

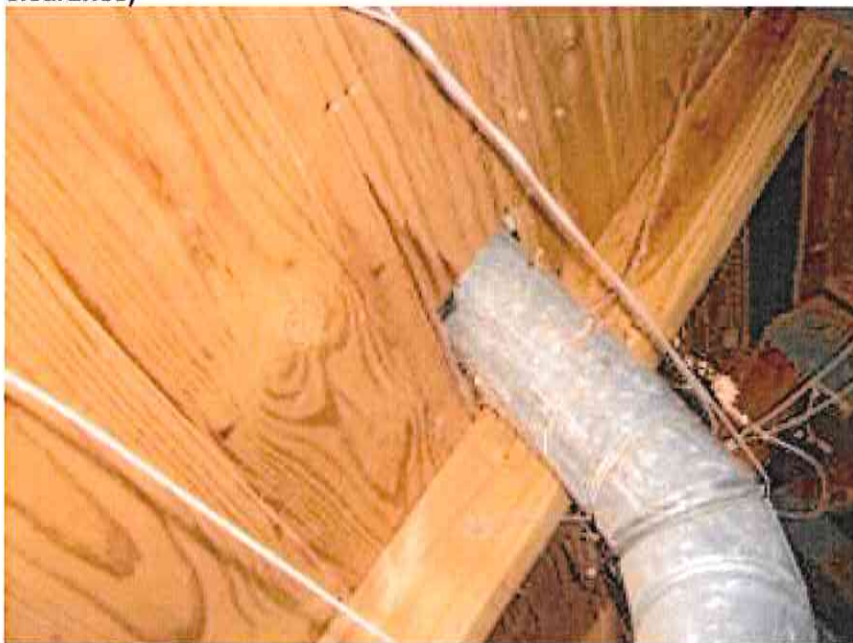
**Metal (type B) flue pipe observed near or in contact with combustible materials. (requires minimum 2" clearance)**

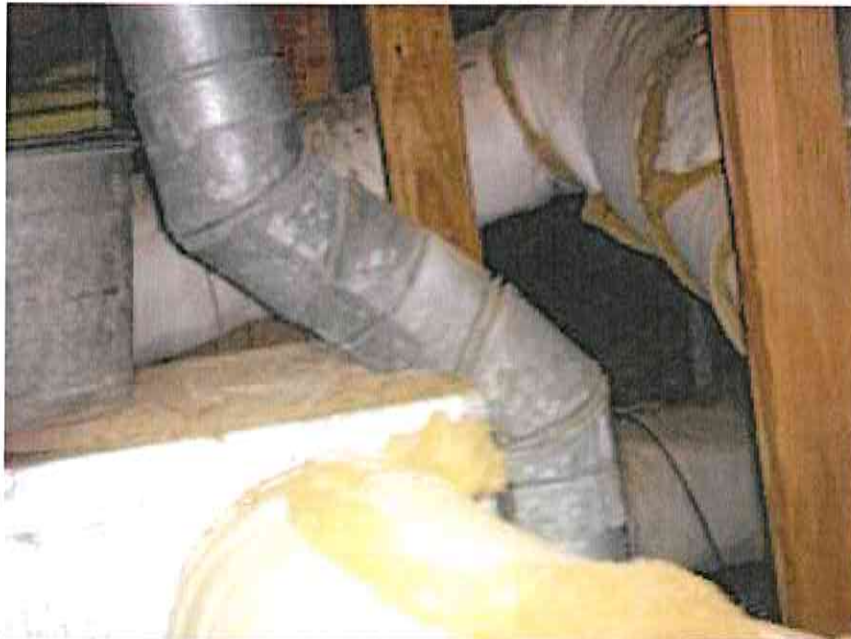
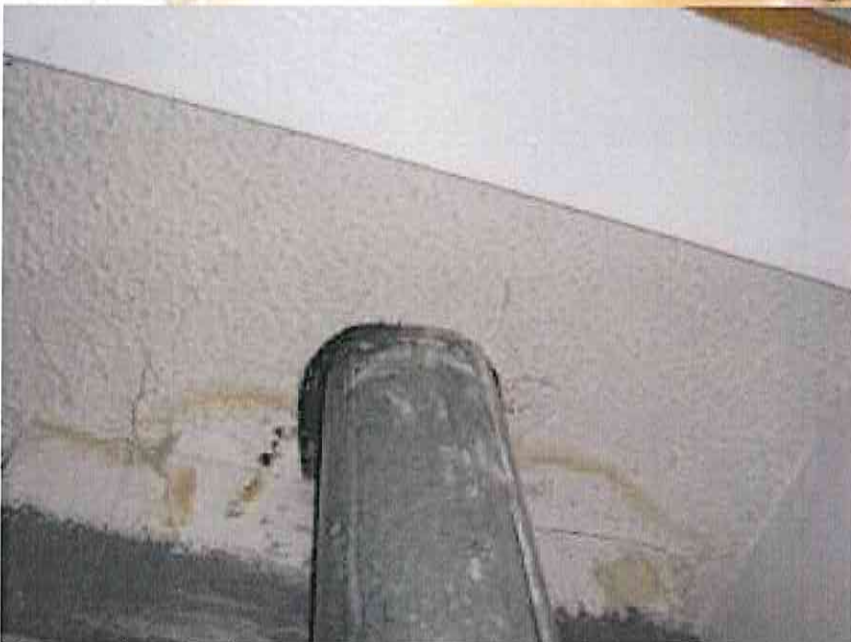
**Furnace does not have proper combustion air supply. Combustion air should come from outside of conditioned air.**

**Consult a licensed HVAC contractor.**

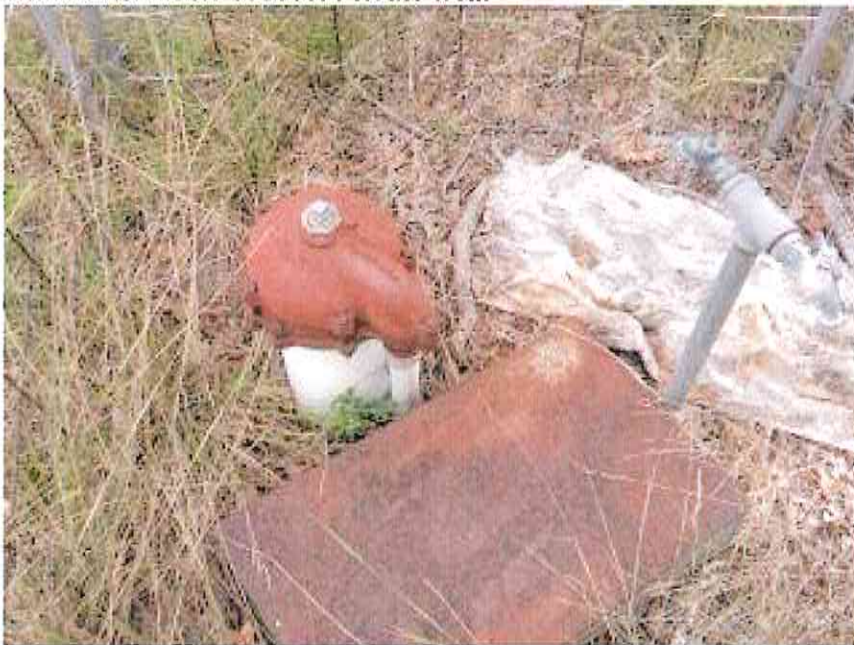
**All exposed water lines should be protected from freezing.**

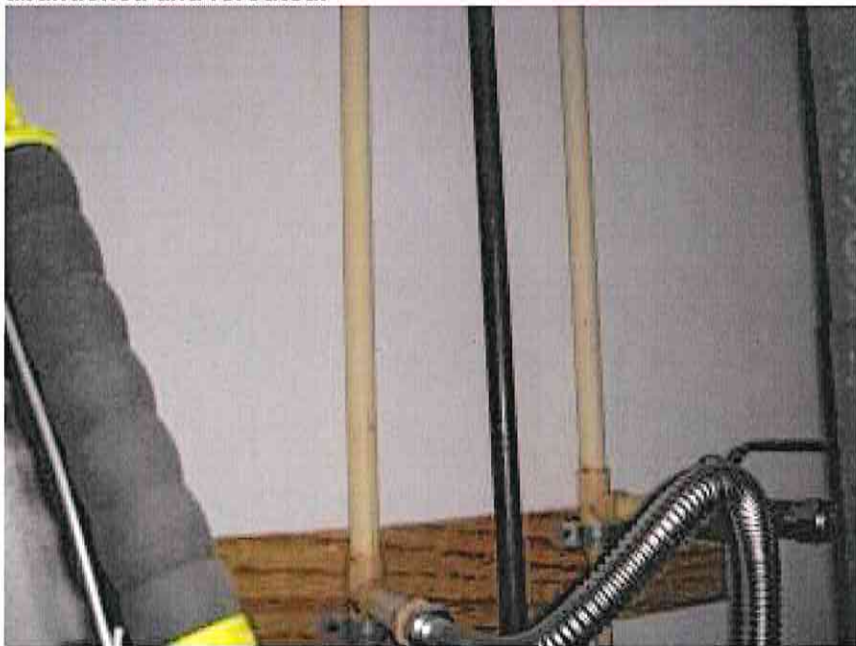
As is common with homes of this age and/or visibly observed during the inspection process this home appears to have had copper water service lines run through the concrete foundation. New PVC piping noted in storage, in attic and inside cabinets (+ sellers statements) indicate that copper water lines have been abandoned and rerouted.

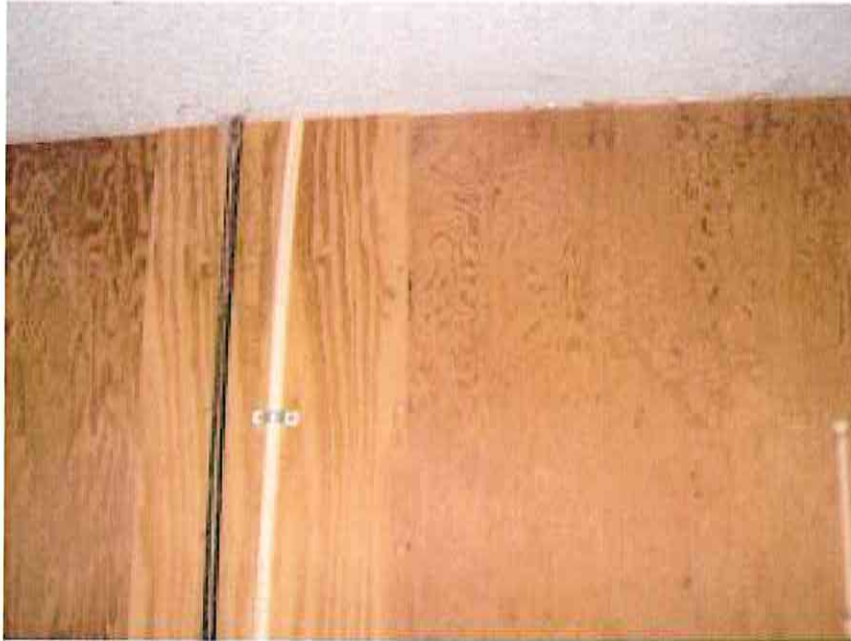
CPVC piping.

The use of PVC pressurize waterlines were observed. The IRC (international residential code) does not currently allow the use of PVC as pressurize waterlines inside of a structure. The theory being that PVC waterlines are not designed to withstand the stresses of thermal expansion. It is recommended that a plumber be consulted to evaluate conditions present and make repair/replacement recommendations and estimates. **Note:** This requirement may not have been in place when this home was constructed. The Texas Real Estate Commission has determined that we identify this condition as a "Deficiency".

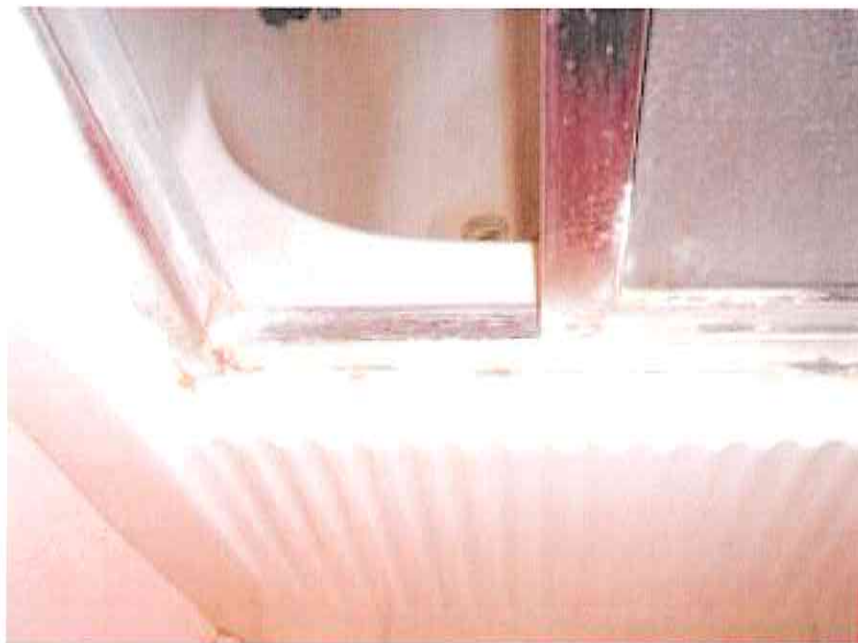
Also noted a surface crack to base of stand up shower in fiberglass.

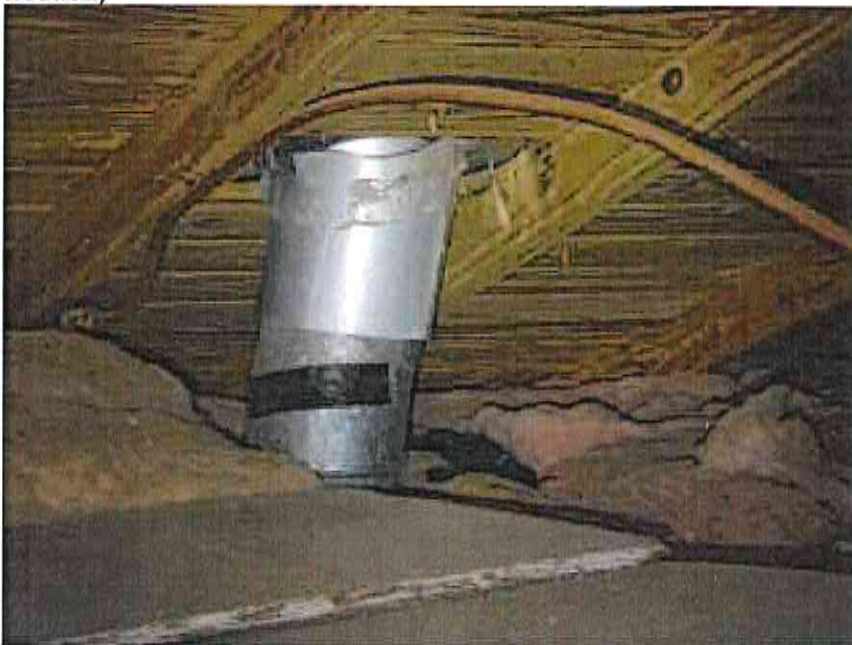
Vent hood pipe does not fully terminate outside of structure. See pulled away section in attic. (better tape needed)

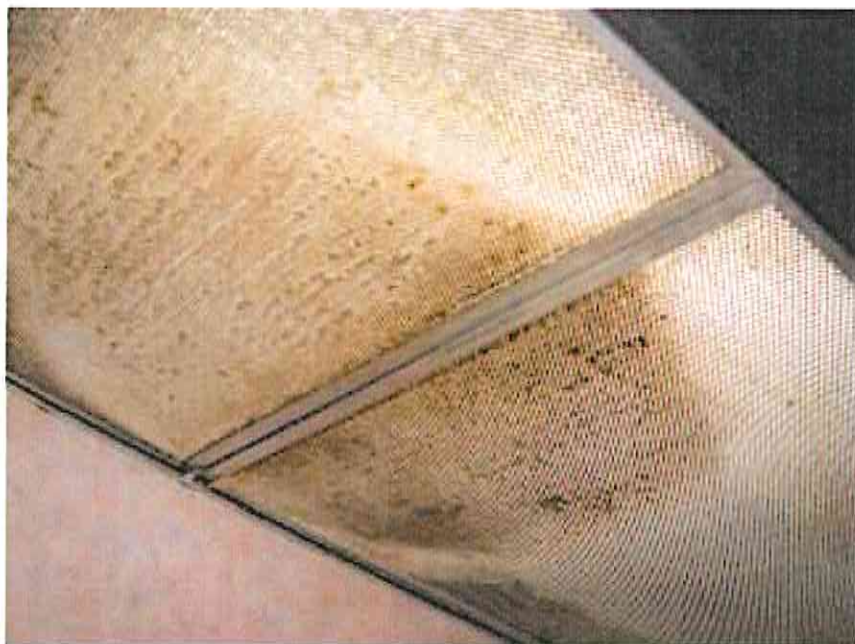
**Vent hood filter is dirty/greasy. (fire hazard)**

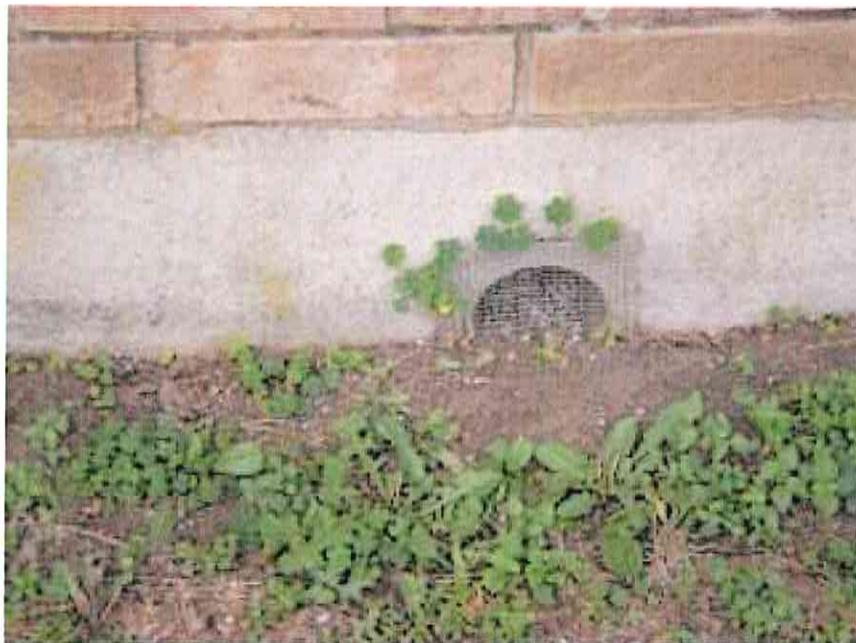
**Noted considerable lint in dryer vent. Consider having cleaned/serviced before connecting dryer.**
