YOUR INSPECTION REPORT

**2393 Highway Z
Hermann, MO 65041**

**Inspected Date: 6/18/2026
Report ID: 1143782**

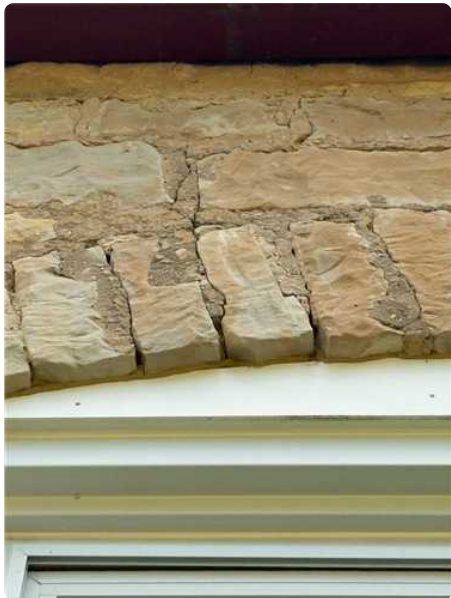
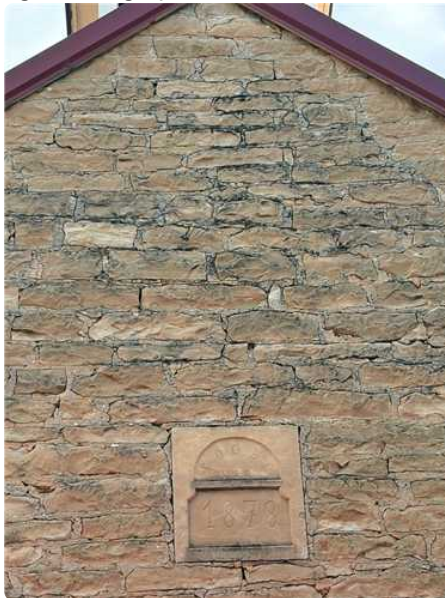
- The school house there is mortar missing/cracking apart. Recommend a mason tuck point where necessary.

1. The school house there is mortar missing/cracking apart. Recommend a mason tuck point where necessary.
-

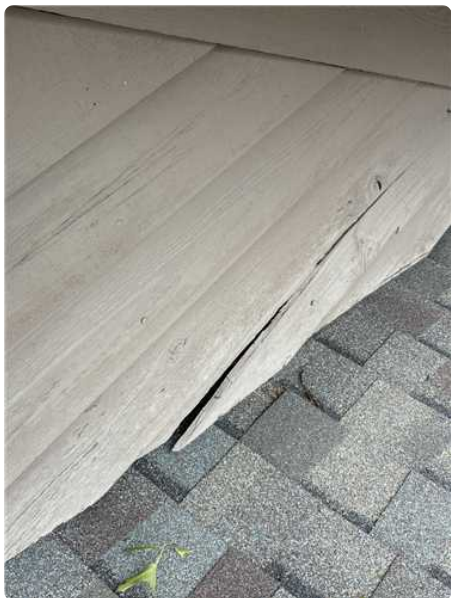
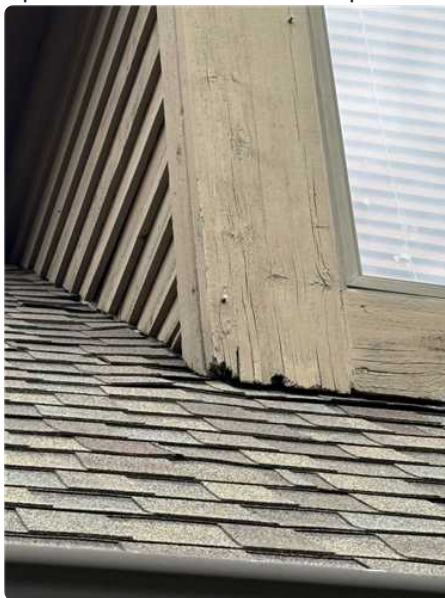
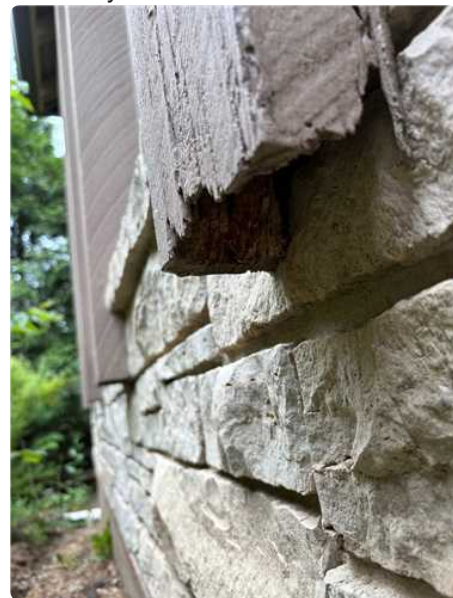
- The right side of the main house along the roof there are a few pieces of siding split apart/loose. The front of the dormers a few of the trim boards are cracking. A couple of the decorative vertical post along the windows are soft/rotted at the bottom. Recommend a professional evaluate and replace as necessary.

2. The right side of the main house along the roof there are a few pieces of siding split apart/loose. The front of the dormers a few of the trim boards are cracking. A couple of the decorative vertical post along the windows are soft/rotted at the bottom. Recommend a professional evaluate and replace as necessary.

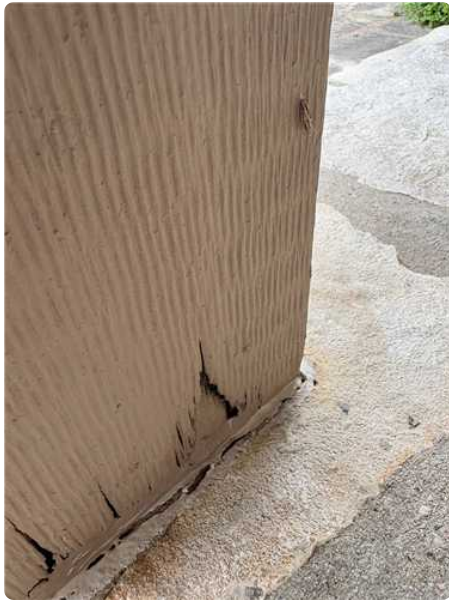
The left deck that has the downspout attached to it is soft/rotted at the bottom. The back porch left post is also soft/rotted at the bottom. Recommend a contractor evaluate and replace as necessary.

1. The left deck that has the downspout attached to it is soft/rotted at the bottom. The back porch left post is also soft/rotted at the bottom. Recommend a contractor evaluate and replace as necessary.

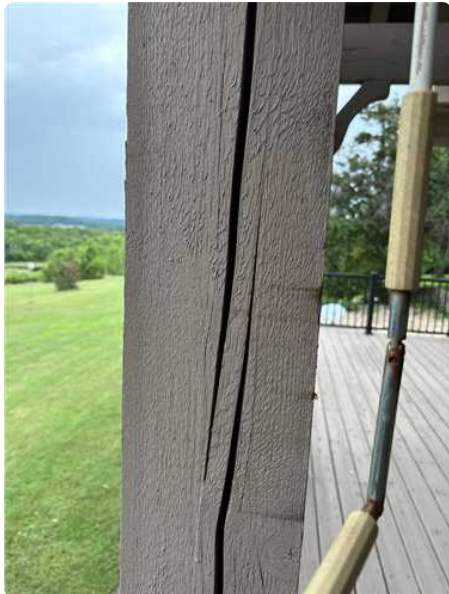
- The deck is not attached to the home by today's standards. Recommend a contractor evaluate and install proper fasteners.
- The left deck the support post for the roof a couple are cracked. Recommend a contractor to further evaluate. Follow their recommendations if action is necessary.

2. The deck is not attached to the home by today's standards. Recommend a contractor evaluate and install proper fasteners.
-

3. The left deck the support post for the roof a couple are cracked. Recommend a contractor to further evaluate. Follow their recommendations if action is necessary.
-

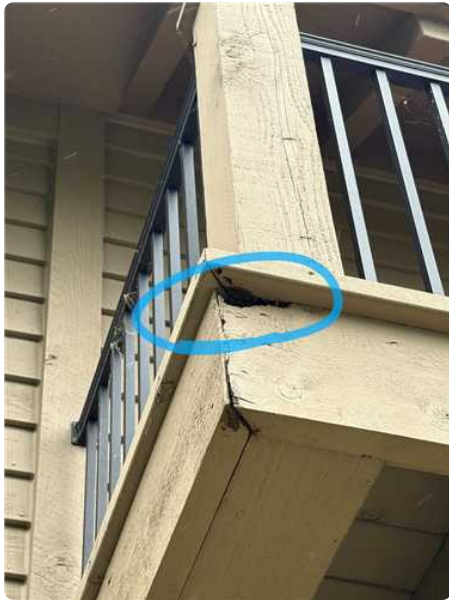
- The outer edge of the balcony the floor joist are missing floor joist hangers. Consider installing floor joist hangers.
- The balcony guardrail left post the top piece is rotted. The right end of the balcony the skirt board is soft/rotted. Recommend a contractor to evaluate and replace as necessary.

4. The balcony guardrail left post the top piece is rotted. The right end of the balcony the skirt board is soft/rotted. Recommend a contractor to evaluate and replace as necessary.

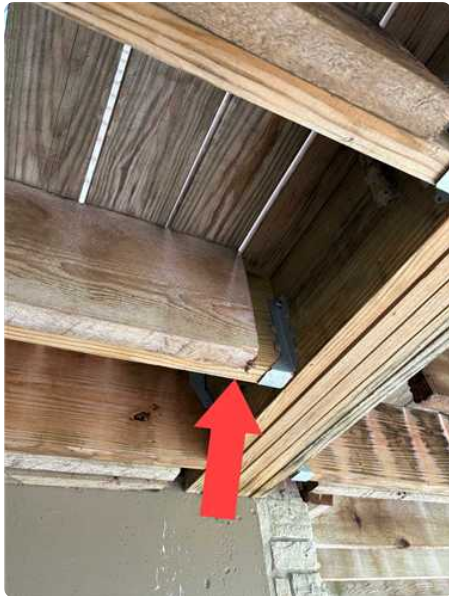
- Under the main deck left of the AC units there are a couple of floor joist that are too short and small pieces of joist are attached to the floor joist, not typical. Usually the piece attached to the floor joist is longer/runs length of the floor joist. Recommend a contractor evaluate and repair as necessary.

2. Under the main deck left of the AC units there are a couple of floor joist that are too short and small pieces of joist are attached to the floor joist, not typical. Usually the piece attached to the floor joist is longer/runs length of the floor joist. Recommend a contractor evaluate and repair as necessary.

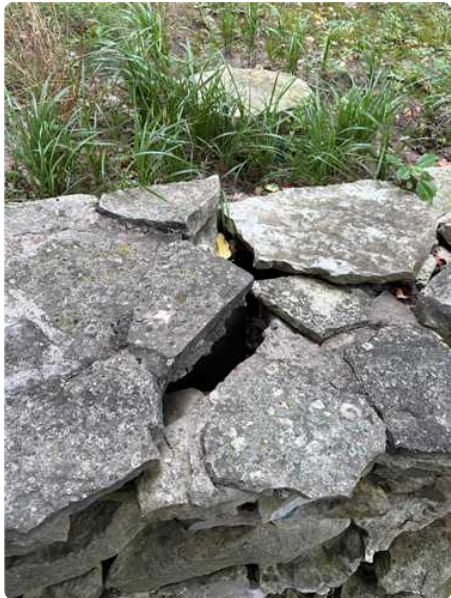
- The left side front retaining wall has settled and separated. Recommend a professional evaluate and repair.

1. The left side front retaining wall has settled and separated. Recommend a professional evaluate and repair.

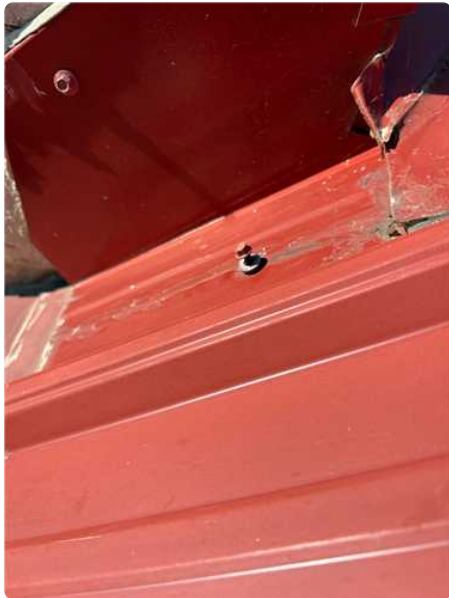
- The school house has a metal roof that is 8-10 years old. Roof was inspected from ladder in a few places roof was too steep to walk safely.
- The school house roof the back side of the chimney there is a screw sticking up. I also noticed there are several screws throughout the roof installed at an angle. Recommend a reputable roofer evaluate and repair/replace screws as necessary.

1. The school house roof the back side of the chimney there is a screw sticking up. I also noticed there are several screws throughout the roof installed at an angle. Recommend a reputable roofer evaluate and repair/replace screws as necessary.
-

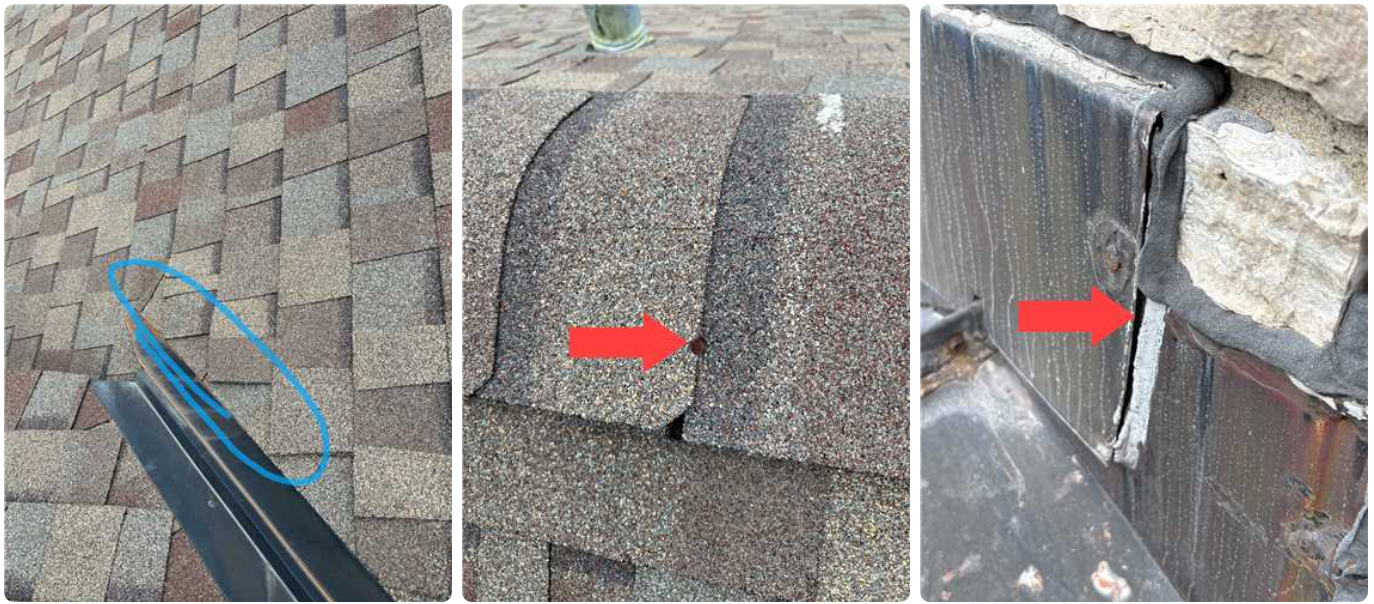
- The house roof the left dormer the valley metal is pushing the shingles up. The main ridge there are a couple of exposed nails. The sealant along the chimney flashing is starting to crack apart. Recommend a reputable roofer evaluate and repair/seal as necessary.

2. The house roof the left dormer the valley metal is pushing the shingles up. The main ridge there are a couple of exposed nails. The sealant along the chimney flashing is starting to crack apart. Recommend a reputable roofer evaluate and repair/seal as necessary.

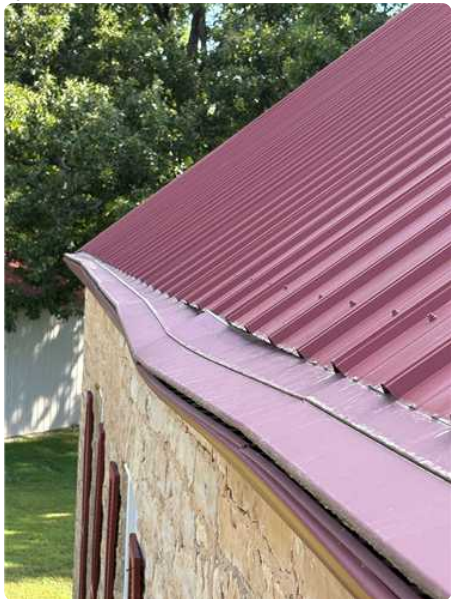
- Where needed, extend the downspouts farther away from the foundation either above or below ground. Be sure to use solid and not perforated piping for this purpose.
- The school house gutter/gutter guard on the left side of the building are pushed out in one spot. Recommend a professional evaluate and correct.

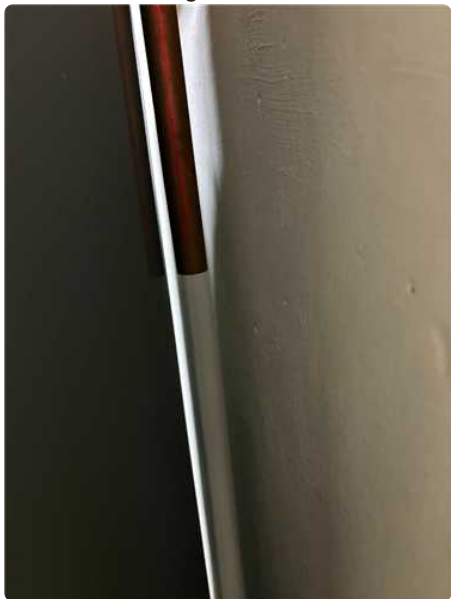
- 🔑 • Both water heaters in the house the TPR extensions are not the proper length. Recommend a plumber replace with extension that goes within 3-6 inches of the floor.

2. Both water heaters in the house the TPR extensions are not the proper length. Recommend a plumber replace with extension that goes within 3-6 inches of the floor.

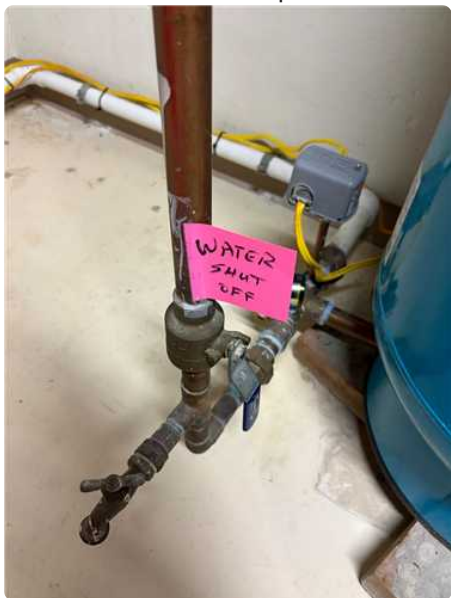
- The on site private water well on this property was not evaluated. Have the water quality tested by others. A well service company can provide additional information about the pump's condition, which is recommended.
- Water softener operation is outside the scope of this inspection. Consult with a service company for service and maintenance instructions.
- The water softener discharge pipe is connected to the main stack, not typical usually ran to the floor drain. Recommend a licensed plumber evaluate and correct if necessary.

2. The water softener discharge pipe is connected to the main stack, not typical usually ran to the floor drain. Recommend a licensed plumber evaluate and correct if necessary.
-

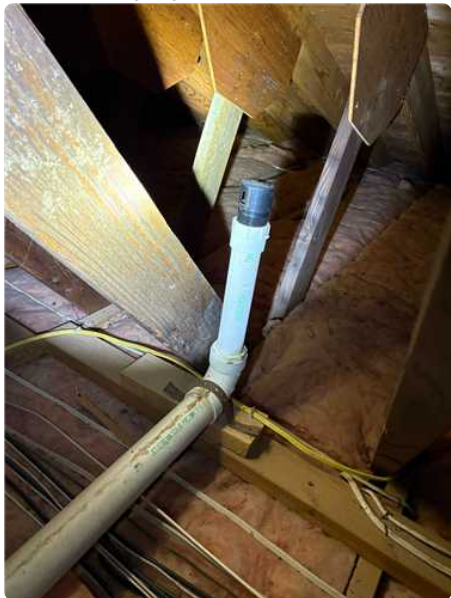
- The apartment plumbing is not vented through the roof. It is vented with an air admittance valve (AAV) a mechanical valve, not proper. Recommend a licensed plumber vent through the roof.

2. The apartment plumbing is not vented through the roof. It is vented with an air admittance valve (AAV) a mechanical valve, not proper. Recommend a licensed plumber vent through the roof.

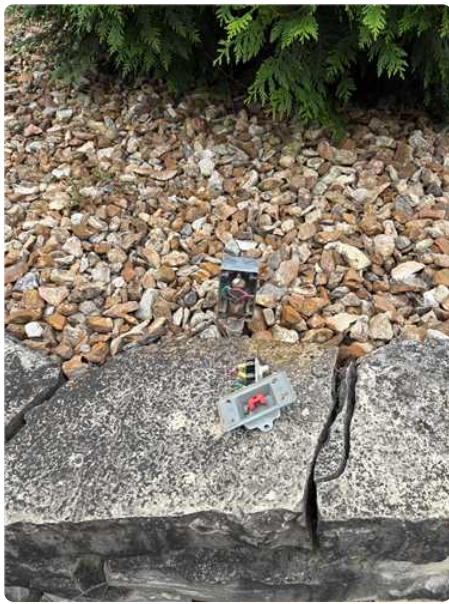
The left patio overlooking the lake there is a light switch taken apart. Recommend an electrician to evaluate and repair.

1. The left patio overlooking the lake there is a light switch taken apart. Recommend an electrician to evaluate and repair.

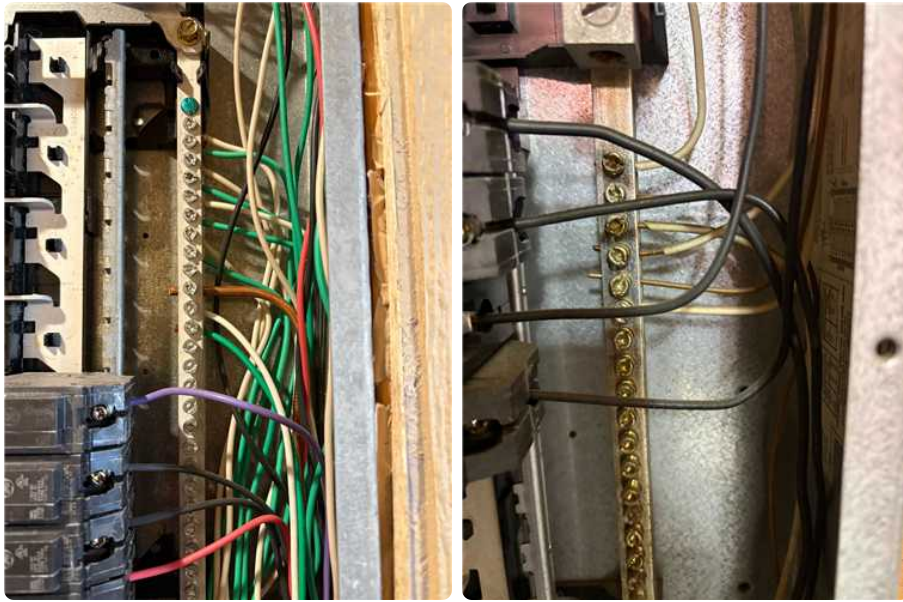
- The sub panel in the machine shed and panel in the stable which is also a sub panel. The grounds and neutrals are on the same terminal bars, not proper. Recommend a licensed electrician separate the grounds and neutrals on separate terminal bars.

1. The sub panel in the machine shed and panel in the stable which is also a sub panel. The grounds and neutrals are on the same terminal bars, not proper. Recommend a licensed electrician separate the grounds and neutrals on separate terminal bars.
-

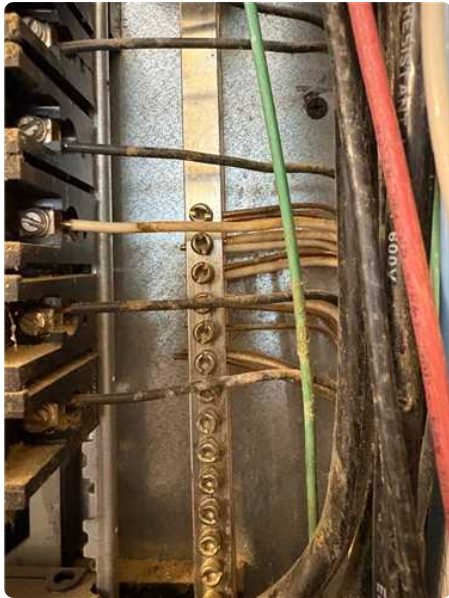
- In the main panel of the machine shed the ground and neutral wires are under the same screw. This was common when the building was built and acceptable but, today most standards require the ground and neutral to not be under the same screw during initial installations. Consider having an electrician correct this to meet the current standards.

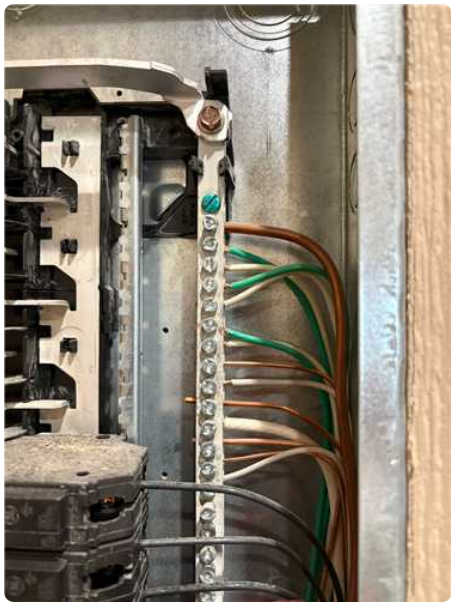
- The school house electric panel is a sub panel due main disconnect is on the pole below the meter. The grounds and neutrals are on the same terminal bars, not proper. Recommend a licensed electrician separate the grounds and neutrals on separate terminal bars. The school house has a 200 amp service.

2. The school house electric panel is a sub panel due to main disconnect is on the pole below the meter. The grounds and neutrals are on the same terminal bars, not proper. Recommend a licensed electrician separate the grounds and neutrals on separate terminal bars. The school house has a 200 amp service.

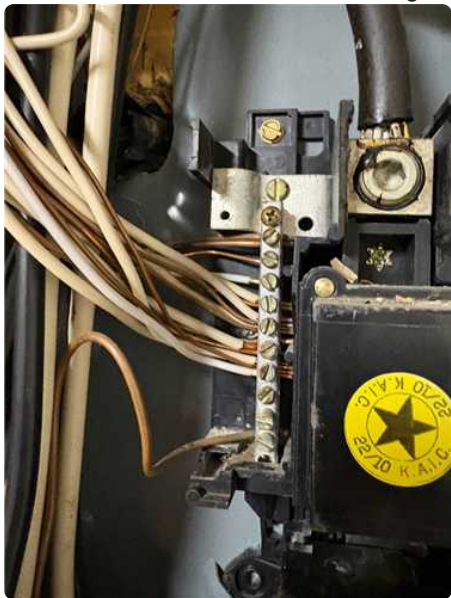
- The garage electrical panel door was not removed due to unable to reach the top screws in the door.
- In the left main panel the ground and neutral wires are under the same screw. This was common when the home was built and acceptable but, today most standards require the ground and neutral to not be under the same screw during initial installations. Consider having an electrician correct this to meet the current standards.

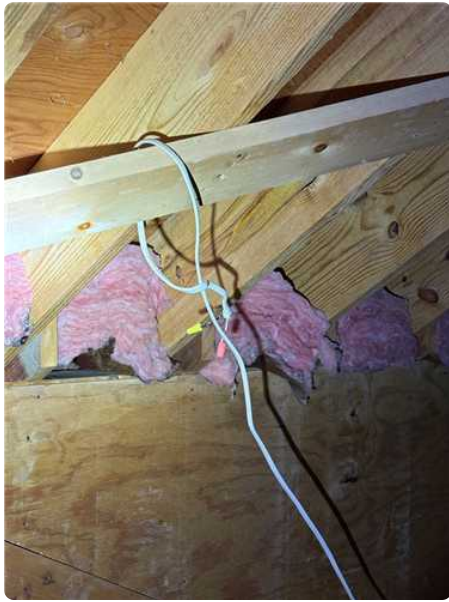
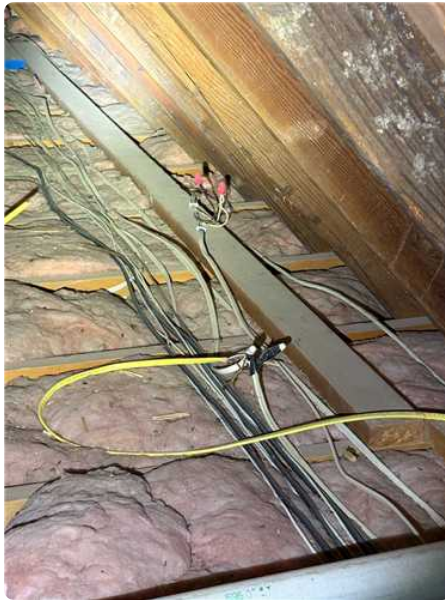
- The visible portions of this branch wiring looked acceptably installed with any noticed/visible exceptions noted in this report. Visual review is not always definitive.
- The main house attic in the front of the attic there is a loose wire not in a junction box. In the basement back center room there is also a loose wire not in a junction box. In the attic above the apartment there are open junctions. Recommend a licensed electrician evaluate and install in junction boxes.

1. The main house attic in the front of the attic there is a loose wire not in a junction box. In the basement back center room there is also a loose wire not in a junction box. In the attic above the apartment there are open junctions. Recommend a licensed electrician evaluate and install in junction boxes.

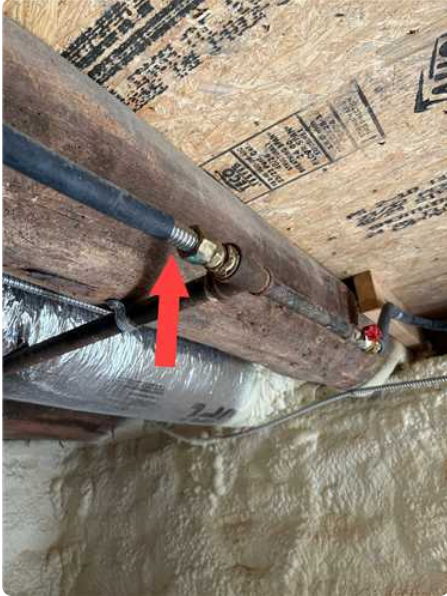
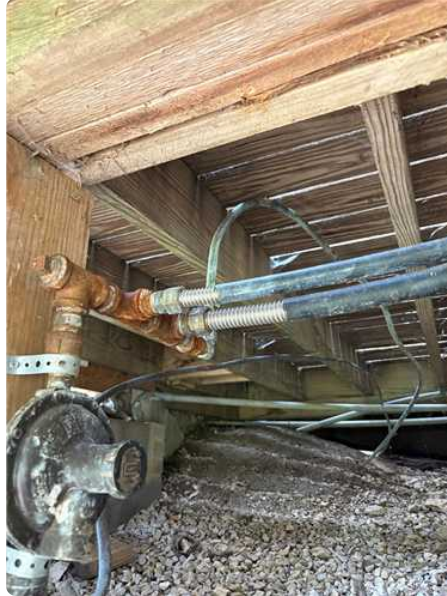
- 🔑 • The school house has CSST flexible gas line. The protective sheathing is cut back from the connections. Under the house deck the CSST gas line the sheathing is also cut back. The gas lines may need to be bonded. Recommend a HVAC tech evaluate and bond if necessary.

1. The school house has CSST flexible gas line. The protective sheathing is cut back from the connections. Under the house deck the CSST gas line the sheathing is also cut back. The gas lines may need to be bonded. Recommend a HVAC tech evaluate and bond if necessary.

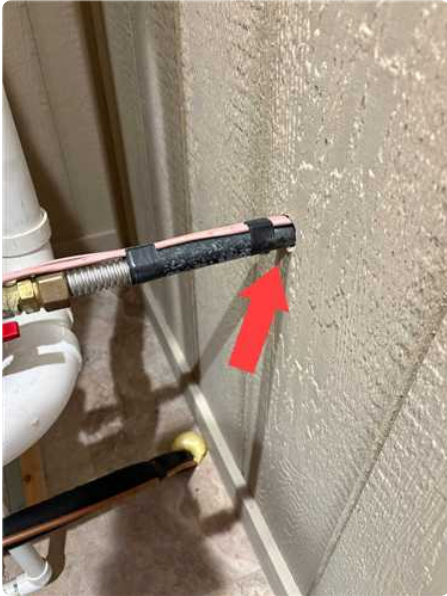
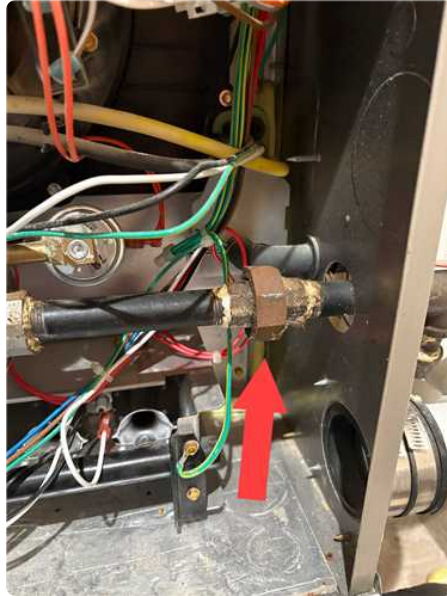
- 🔑 • The CSST gas line runs through the wall, only solid piping such as black iron is supposed to run through the wall. Recommend a HVAC tech install a PVC pipe for the CSST to run through the wall. In the furnace cabinet there is a gas union, the union is supposed to be outside of the unit. Recommend a HVAC tech correct.

1. The CSST gas line runs through the wall, only solid piping such as black iron is supposed to run through the wall. Recommend a HVAC tech install a PVC pipe for the CSST to run through the wall. In the furnace cabinet there is a gas union, the union is supposed to be outside of the unit. Recommend a HVAC tech correct.
-

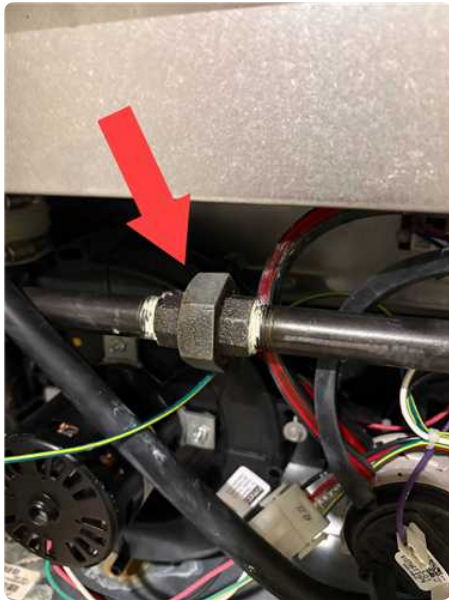
- The school house furnace is a Carrier LP operated furnace about 8 years old.
- The LP tanks were not inspected.
- The baseboard heaters in atrium room were working at time of inspection.
- 🔑 • The LP furnace in the house the gas line union is in the furnace cabinet, not supposed to be in the cabinet. Recommend a HVAC tec correct.

2. The LP furnace in the house the gas line union is in the furnace cabinet, not supposed to be in the cabinet. Recommend a HVAC tec correct.
-

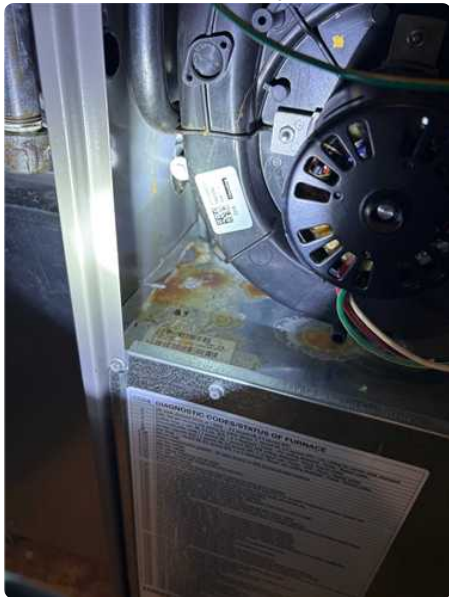
- The LP furnace in the house there is evidence of previous leaking in the furnace cabinet. Recommend a HVAC tech further evaluate and repair if necessary.

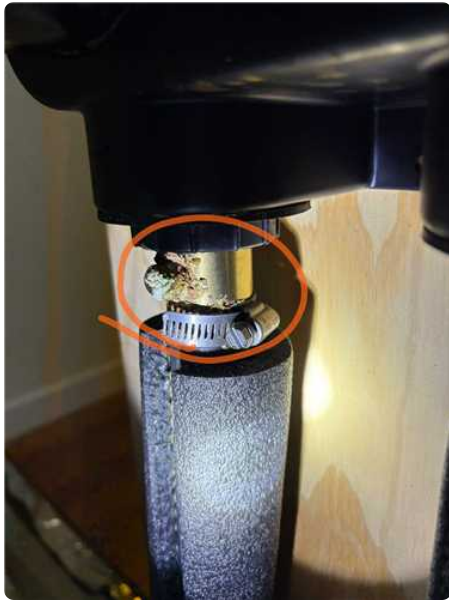
- Recommend a HVAC tech that specializes in geo thermal units evaluate the unit and preform any maintenance or repairs if necessary.
- The geothermal water line where it connects to the geo flo has corrosion on it. Recommend a HVAC tech evaluate and repair as necessary.

4. The geothermal water line where it connects to the geo flo has corrosion on it. Recommend a HVAC tech evaluate and repair as necessary.

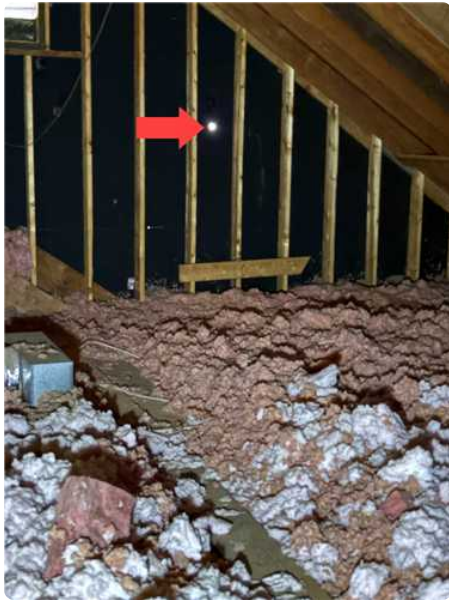
- The left end of the house attic there is a hole on the wall that daylight is showing through. Recommend evaluating and repair as necessary.

1. The left end of the house attic there is a hole on the wall that daylight is showing through. Recommend evaluating and repair as necessary.

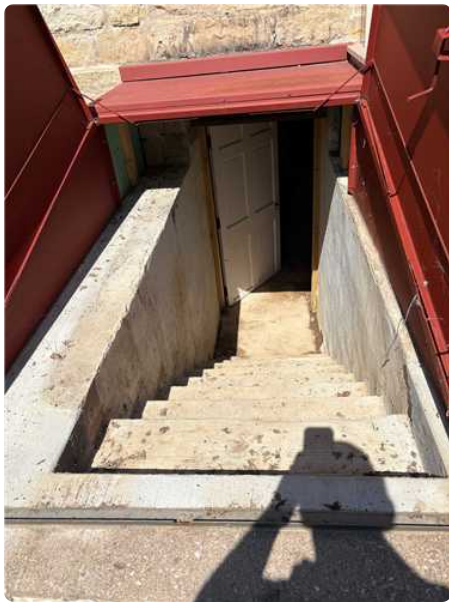
The school house basement stairs are missing a handrail. Recommend installing a handrail.

1. The school house basement stairs are missing a handrail. Recommend installing a handrail.

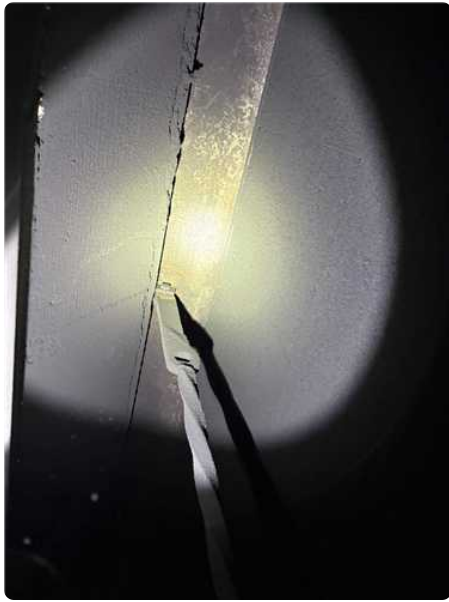
The house fireplace the damper is missing a clamp to keep the damper cracked open since the fireplace is LP. Recommend a professional install a damper clamp.

1. The house fireplace the damper is missing a clamp to keep the damper cracked open since the fireplace is LP. Recommend a professional install a damper clamp.

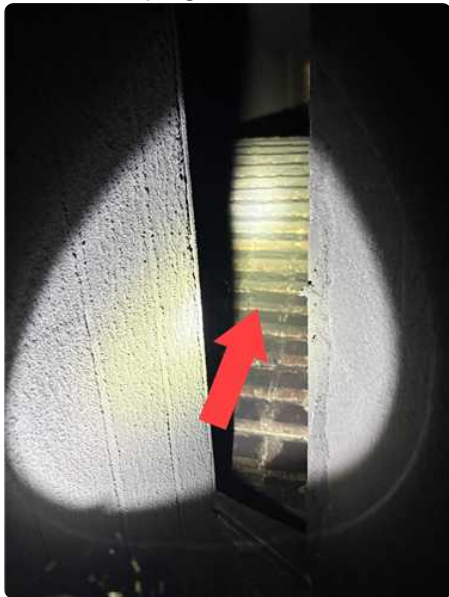
- The house fireplace the smoke chamber is not parged. If switching back to wood burning the smoke chamber would need to be parged with mortar.

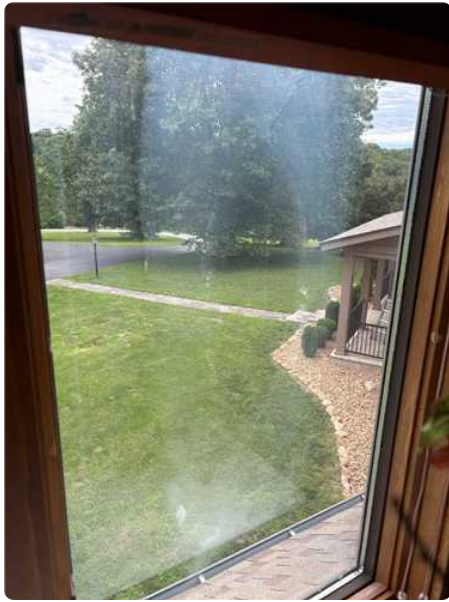
The great room left back upper window it appears the thermal seal is broken. The garage windows at the top of the stairs and the apartment front left window the thermal seals are broken. Recommend a window professional evaluate and repair/replace as necessary.

1. The great room left back upper window it appears the thermal seal is broken. The garage windows at the top of the stairs and the apartment front left window the thermal seals are broken. Recommend a window professional evaluate and repair/replace as necessary.

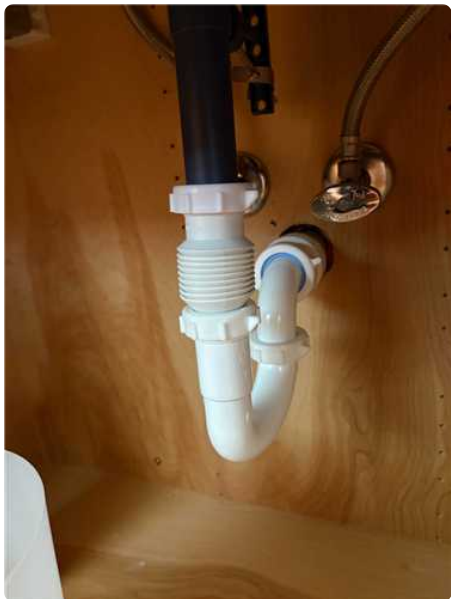
- Overflow drains were not tested for leaks as many are fully enclosed.
- Plumbing fixtures, faucets, and drains were in typical repair and operated with adequate water flow and drainage, with any exceptions noted in this report.
- The school house bathroom sink gurgles when it drains, possibly due to not properly vented. Recommend a licensed plumber further evaluate.
- The flexible style of drain piping used under the ___ school house and left basement ___ sink normally performs adequately. This type of pipe tends to collect alga and bacteria above the water trap, and replacement is recommended in the interest of home health.

1. The school house bathroom sink gurgles when it drains, possibly due to not properly vented. Recommend a licensed plumber further evaluate.
2. The flexible style of drain piping used under the ___ school house and left basement ___ sink normally performs adequately. This type of pipe tends to collect alga and bacteria above the water trap, and replacement is recommended in the interest of home health.

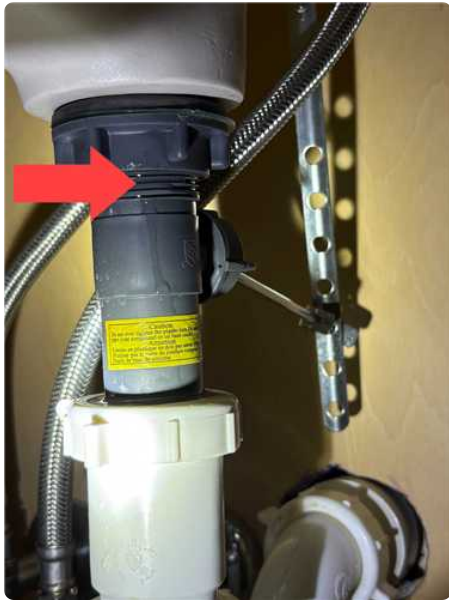
- The apartment bathroom sink is leaking where the drain connects to the basin. Recommend a plumber repair.

1. The apartment bathroom sink is leaking where the drain connects to the basin. Recommend a plumber repair.

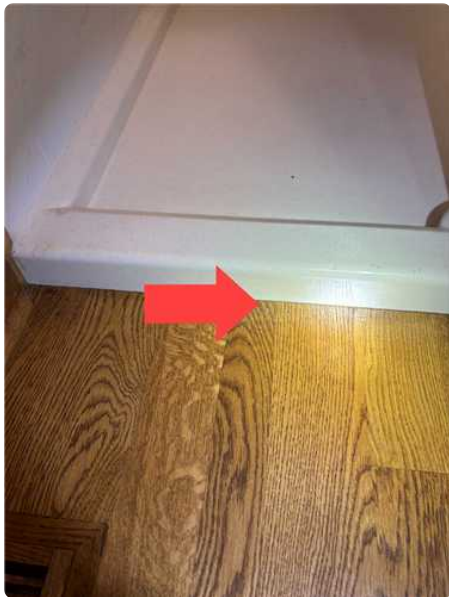
- Routine grout/caulk maintenance at tile and tub installations is important for preventing moisture problems at walls or sub-floor. When necessary, rake out poor grout/caulk and re-grout/caulk. Interior corners and the joint between the tile and the base can best be protected with silicone caulking.
- The school house shower is not sealed where the shower meets the flooring. Recommend sealing with appropriate sealant.

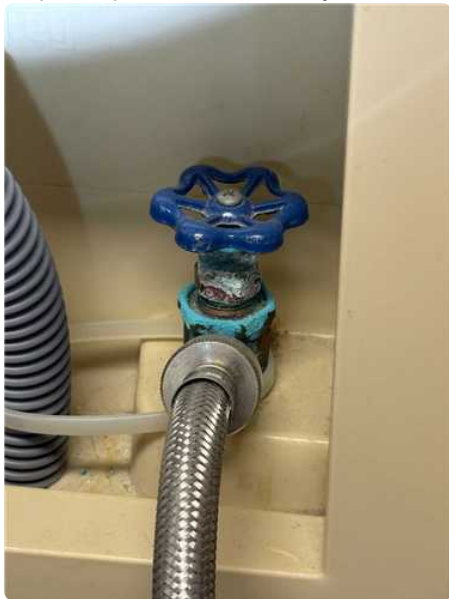
The house laundry room the washer connection is corroded. Recommend a licensed plumber evaluate and repair/replace as necessary.

1. The house laundry room the washer connection is corroded. Recommend a licensed plumber evaluate and repair/replace as necessary.
