RESIDENTIAL REPORT

10550 Hwy A
Higbee, MO 65257

04/17/2025

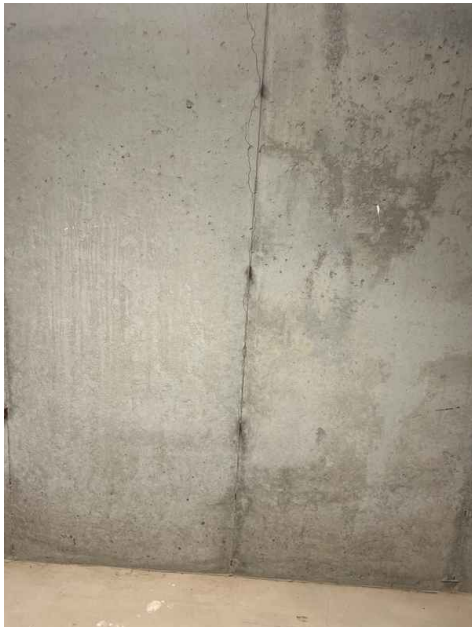
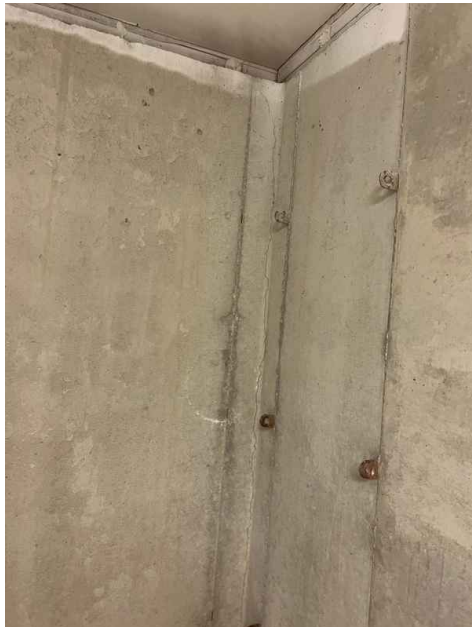
2.1.2 Foundation, Basement & Crawlspaces

TYPICAL CRACKING

Typical cracking is present in the foundation walls.

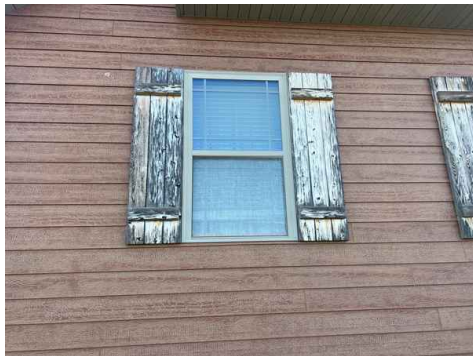
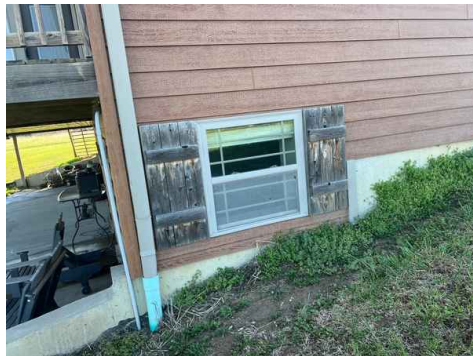
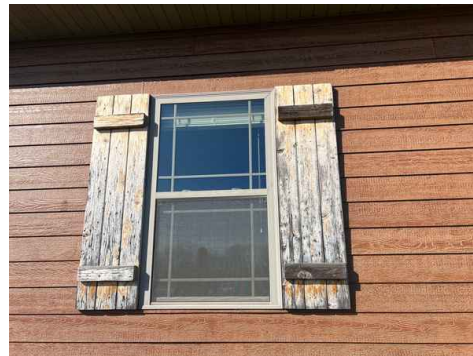
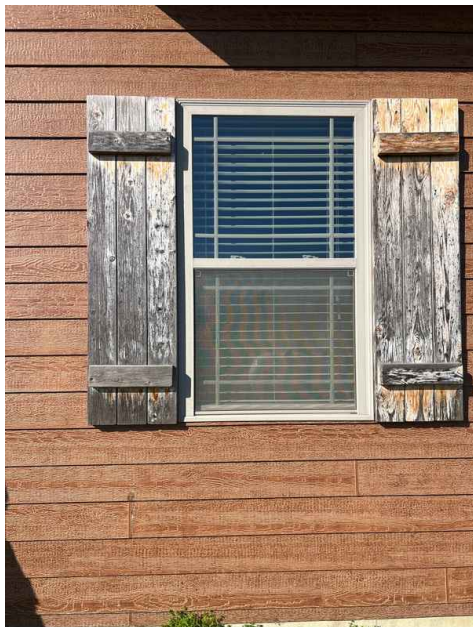
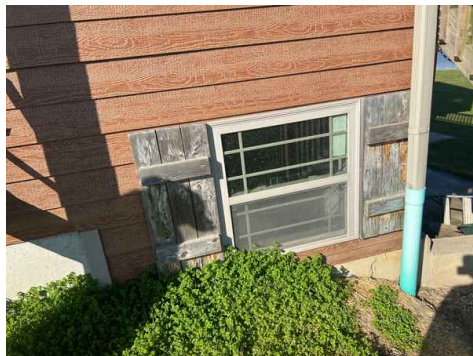
3.1.1 Siding, Flashing & Trim

PAINT NEEDED

Wood trim components were worn and in need of maintenance. Recommend maintenance to prevent further deterioration.

Contact a handyman or DIY project

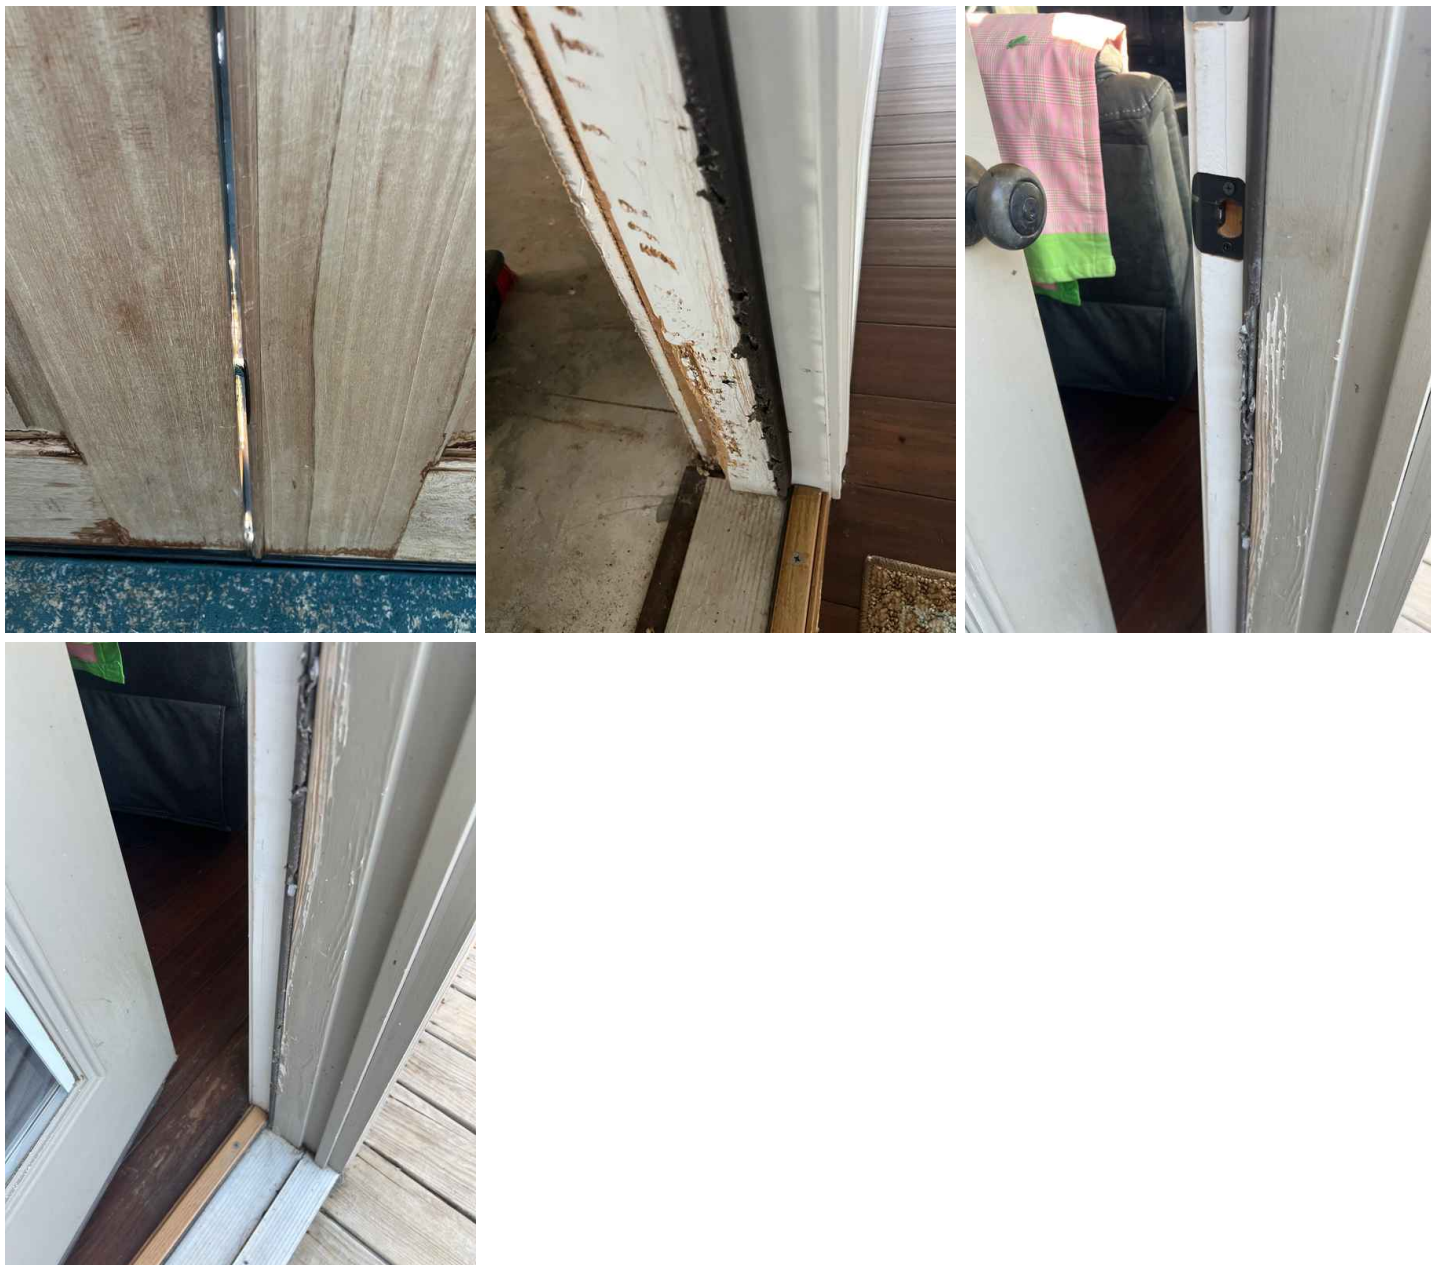
3.4.1 Exterior Doors

WEATHERSTRIPPING DAMAGED OR NOT PRESENT

Weather stripping is damaged or missing. This can result in significant energy loss and moisture intrusion. Recommend installation of standard weatherstripping.

Contact a handyman or DIY project

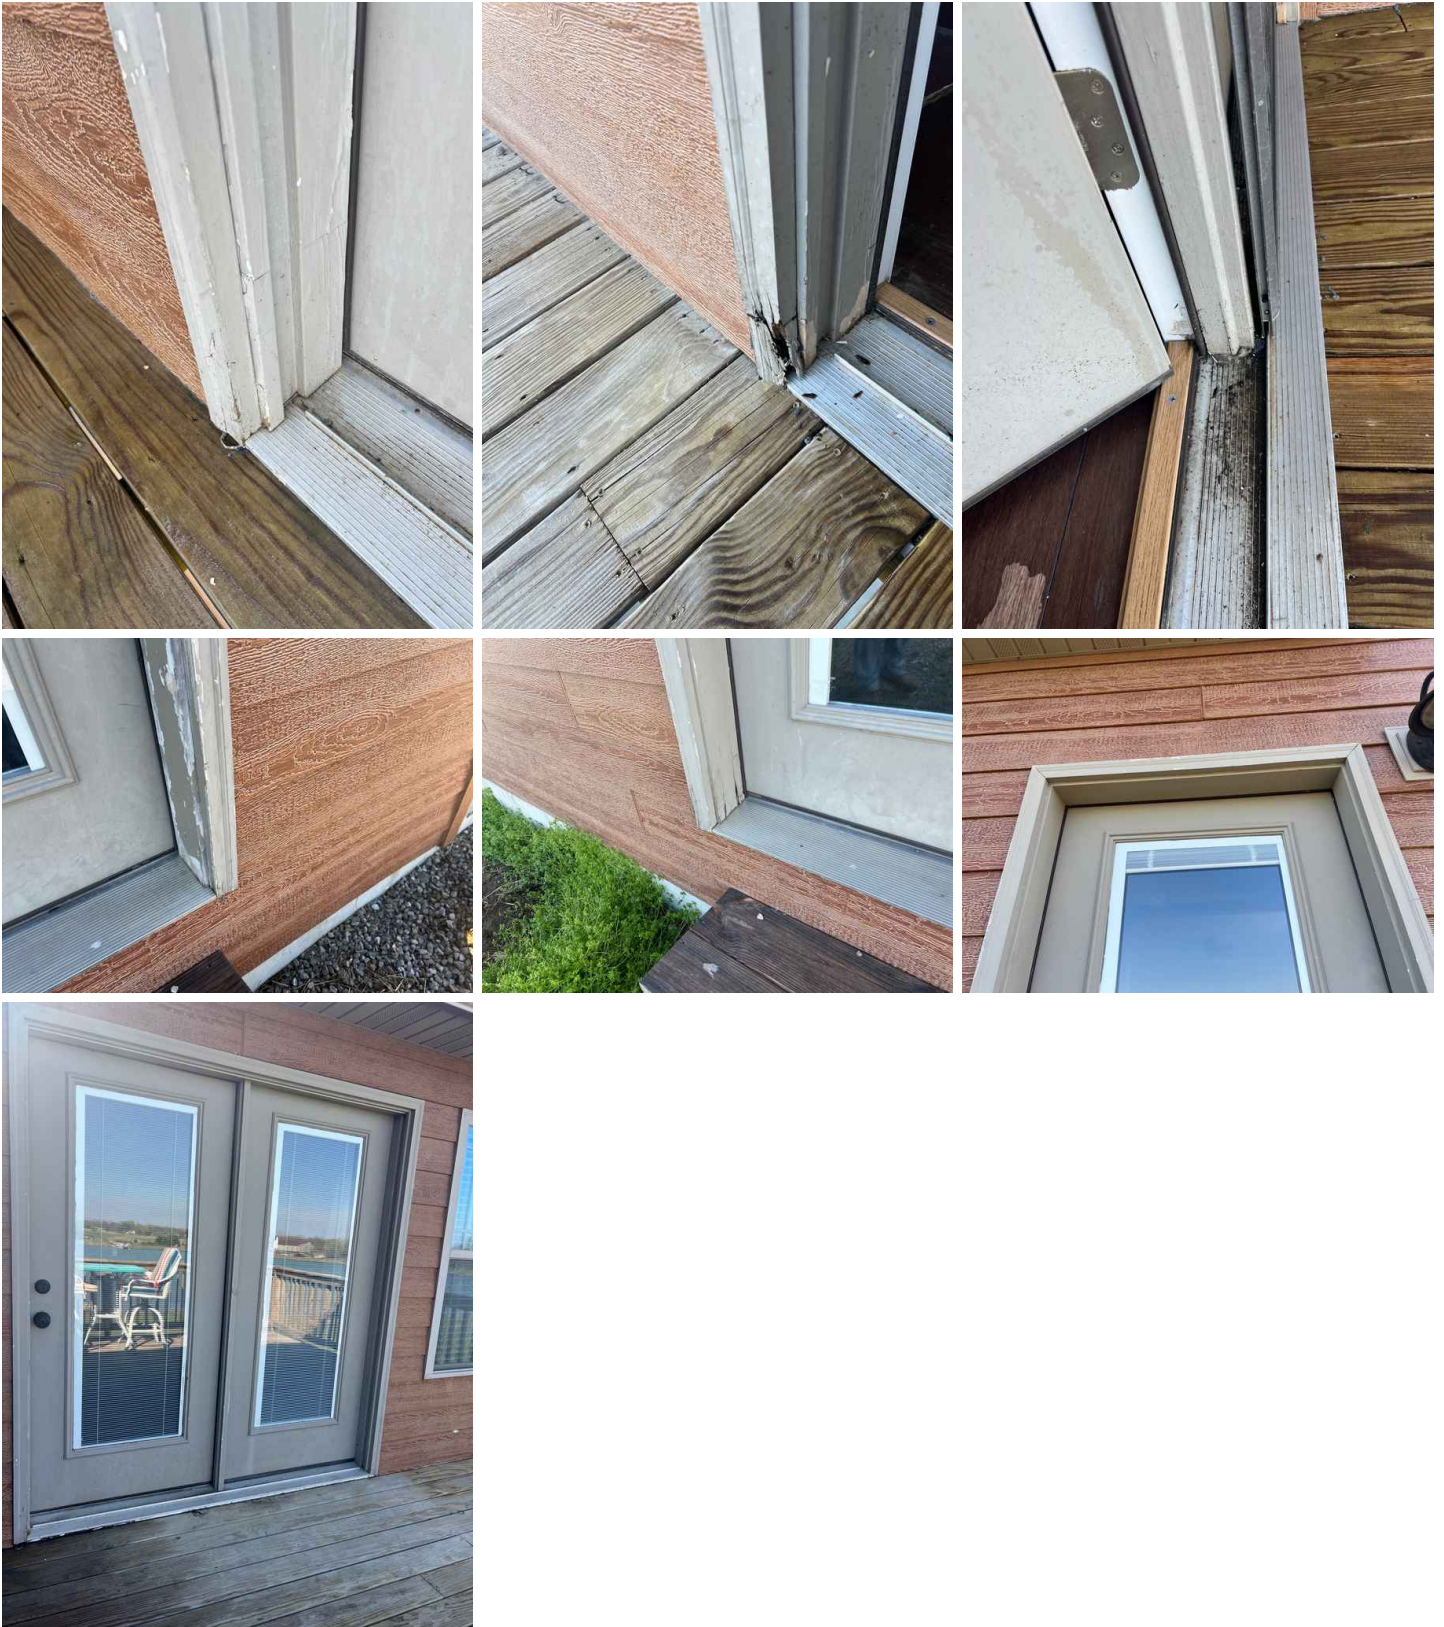
3.4.2 Exterior Doors

GENERAL DETERIORATION

Weather damage and deterioration are present in the frame(s). Recommend maintenance or replacement to prevent further deterioration.

Contact a qualified general contractor.

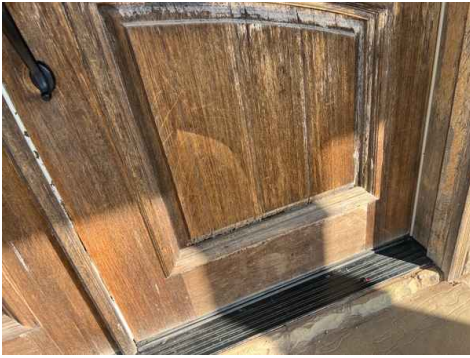
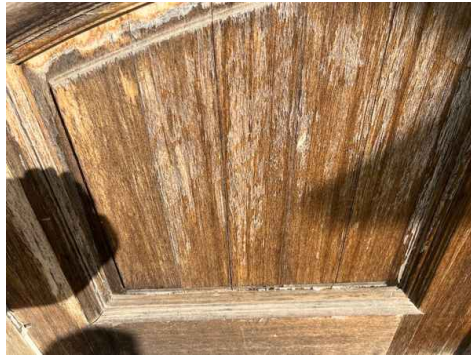
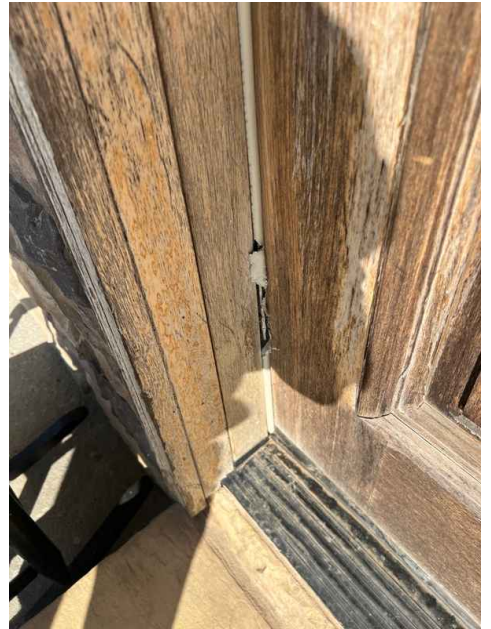
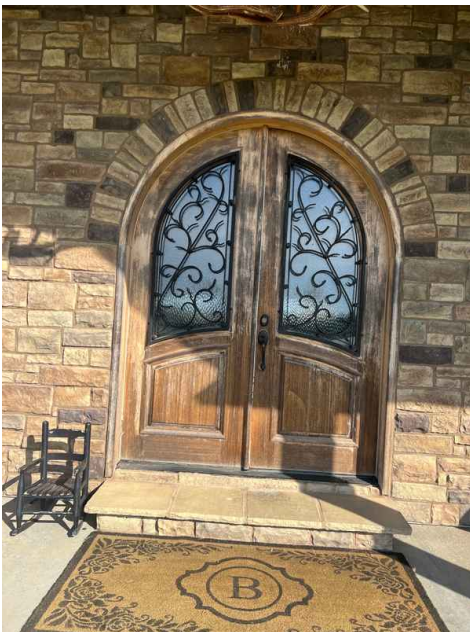
3.4.3 Exterior Doors

DAMAGED SURFACE

Surface damage is present to the main entry door. Recommend maintenance to prevent future deterioration.

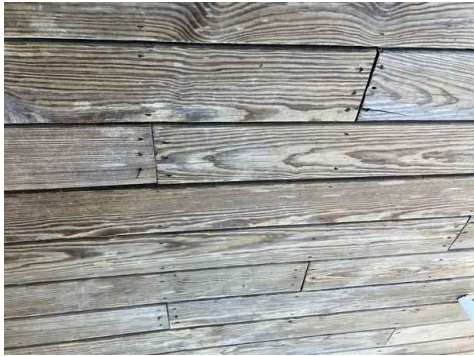
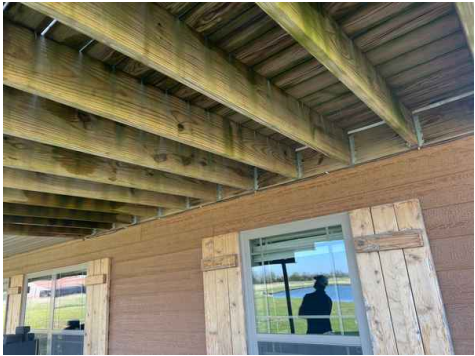
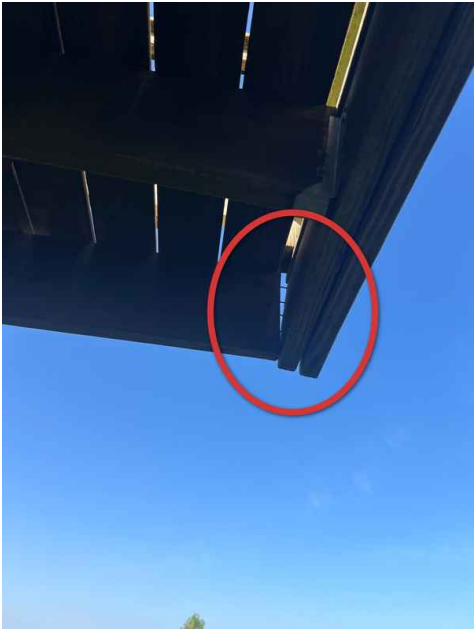
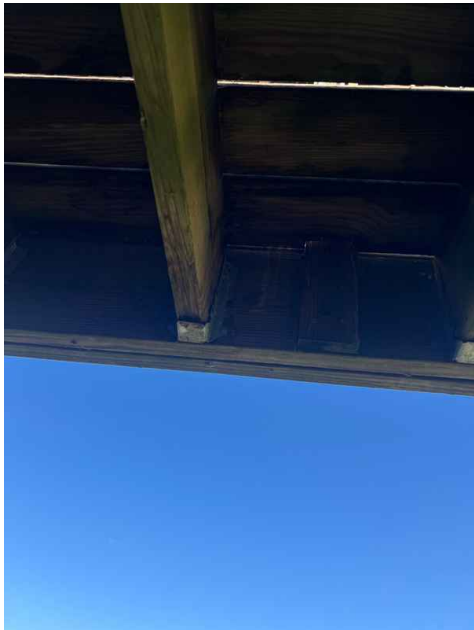
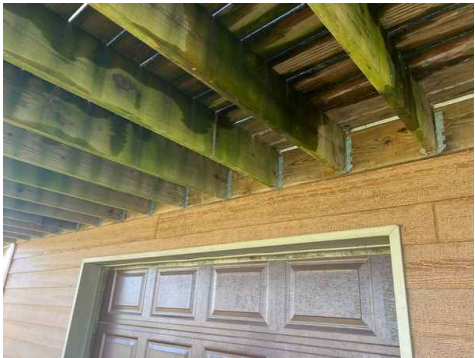
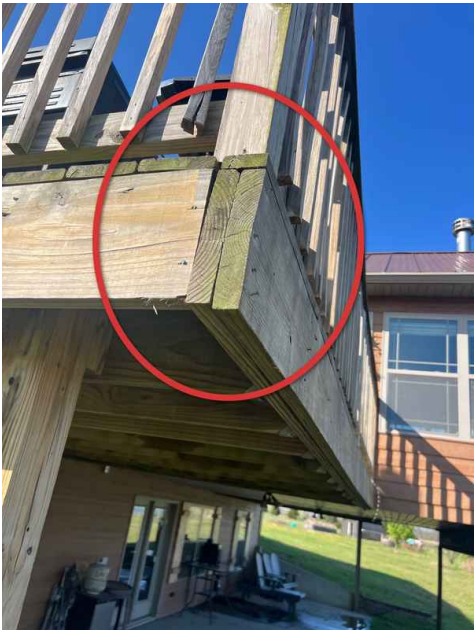
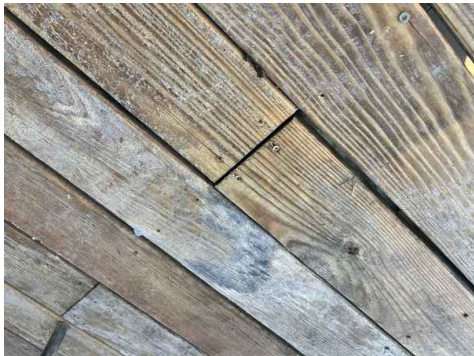
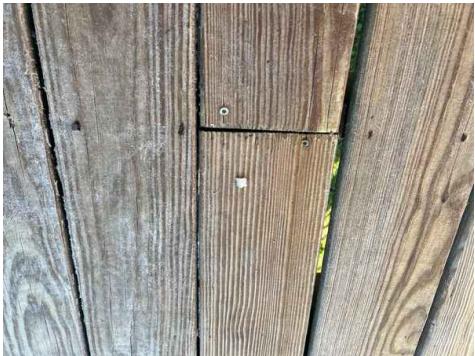
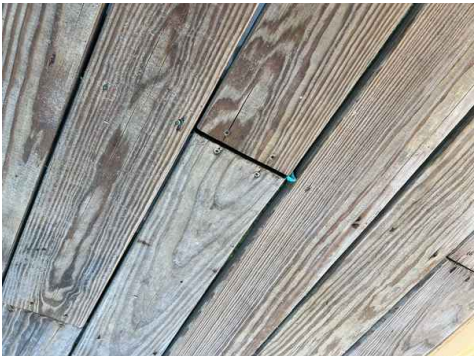
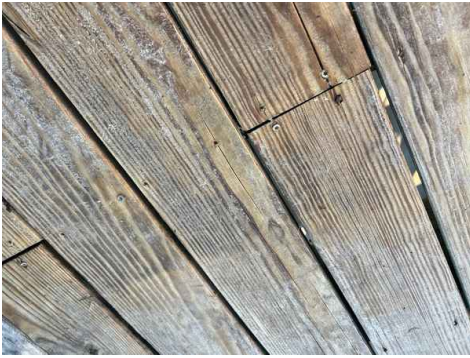
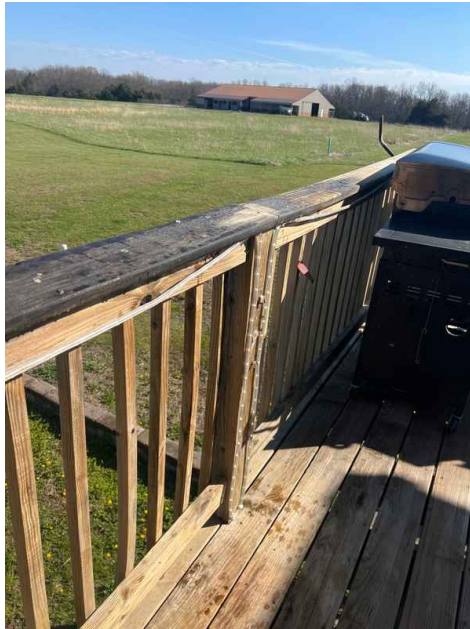
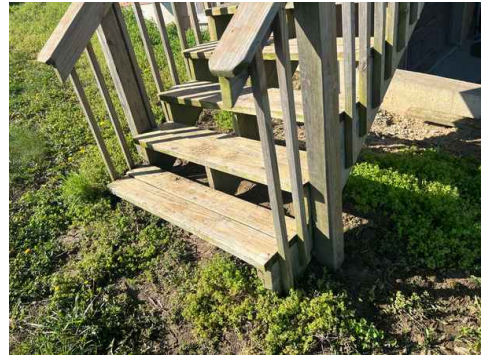
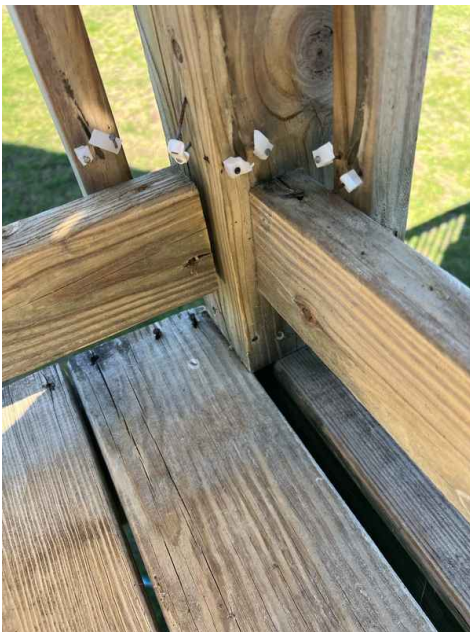
3.5.1 Decks, Balconies, Porches & Steps

IMPROPER DECK CONSTRUCTION PRACTICES

Deck ledgers are not bolted to the house, framing is not bolted to the support posts, rail assembly is not properly secured to the framing, poor wood to earth clearance is present at the stairs, and several fasteners are protruding from the deteriorated floor boards ends. Recommend further evaluation and repairs or replacement for safety purposes.

Contact a qualified professional.

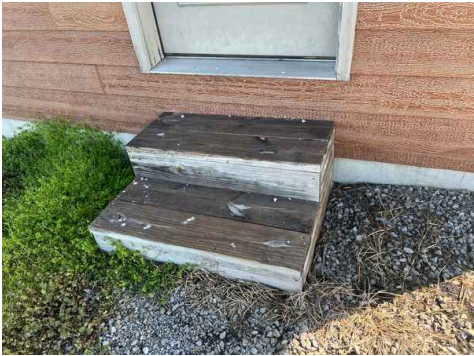
3.5.3 Decks, Balconies, Porches & Steps

STAIRS - DETERIORATED

Recommend replacement of the deteriorated wooden stair assembly for safety purposes.

Contact a qualified professional.

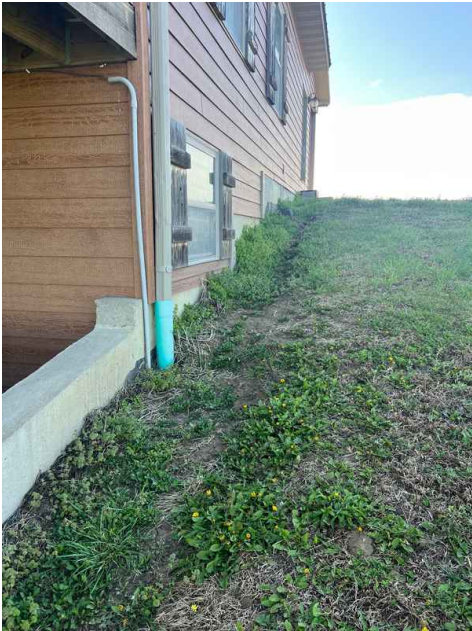
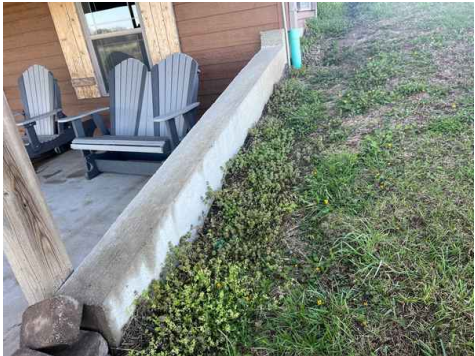
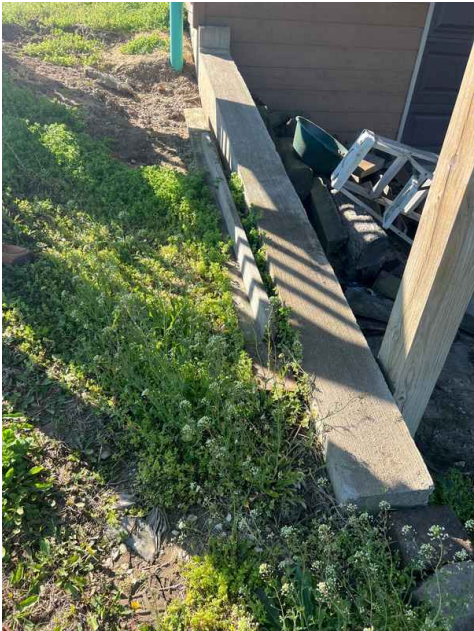
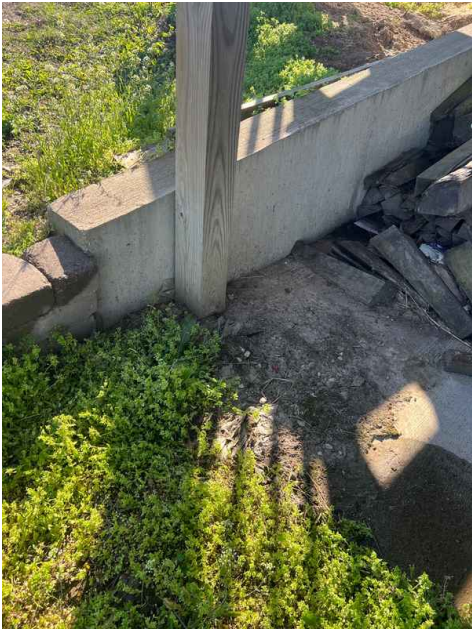
3.6.1 Vegetation, Grading, Drainage & Retaining Walls

EROSION

Erosion is present due to water channeling along the low areas next to the foundation of the home. Conditions can lead to water intrusion. Recommend maintenance/repairs.

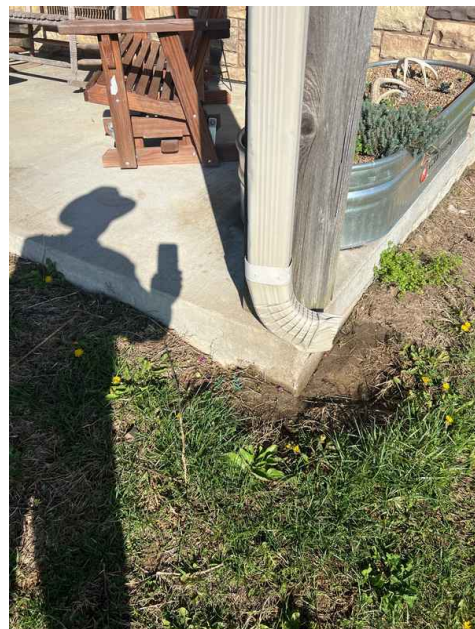
4.2.1 Roof Drainage Systems

DOWNSPOUTS DRAIN NEAR HOUSE

One or more downspouts drain too close to the foundation. This can result in excessive moisture in the soil at the foundation, which can lead to foundation/structural movement. Recommend adding downspout extensions to drain at least 6 feet from the foundation.

Contact a handyman or DIY project

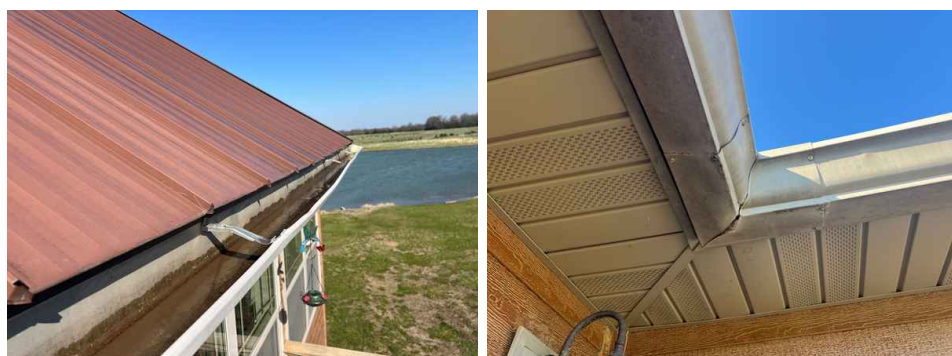
4.2.2 Roof Drainage Systems

LOOSE HANGERS

Rear gutters are filled with water, pulling away from the house, and leaking at the seams due damaged brackets. Recommend maintenance or replacement.

Contact a qualified roofing professional.

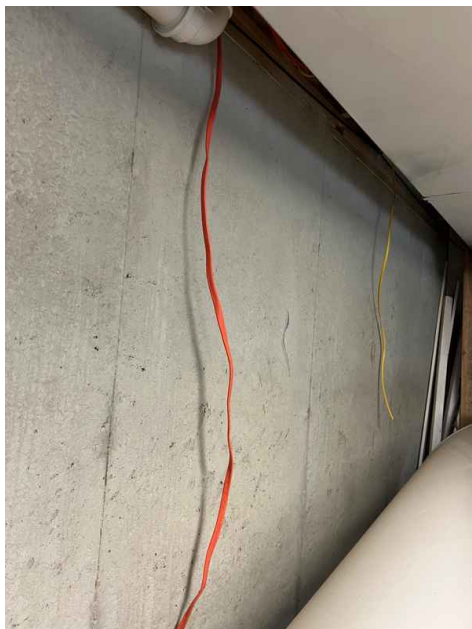
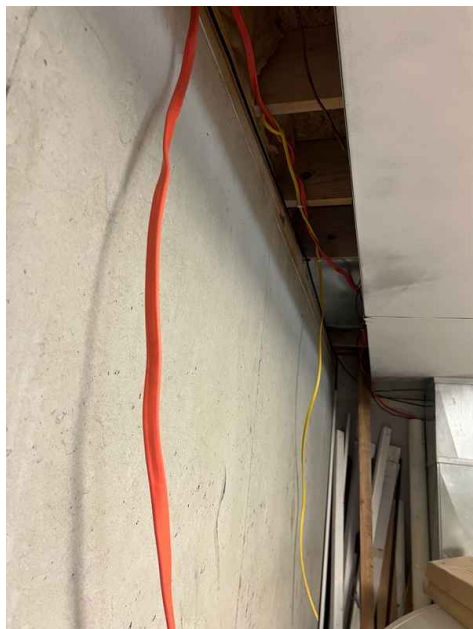
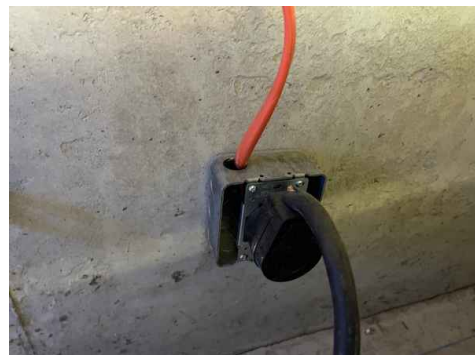
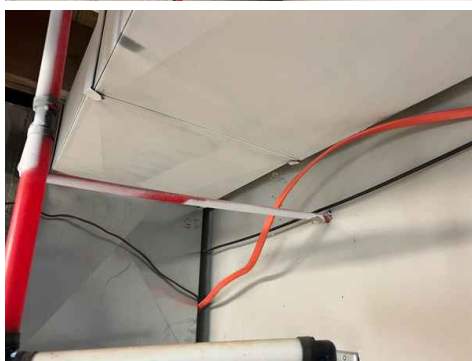
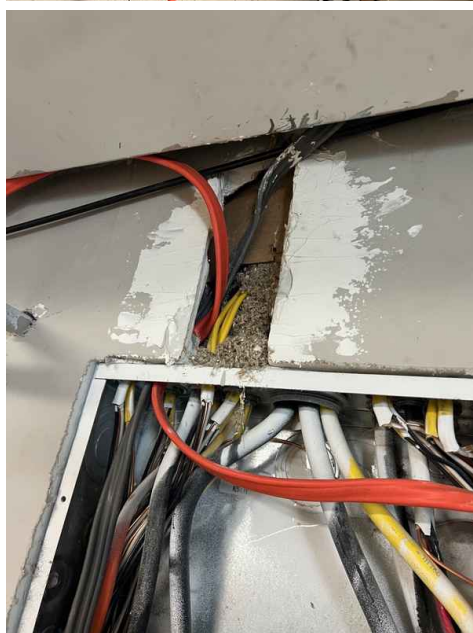
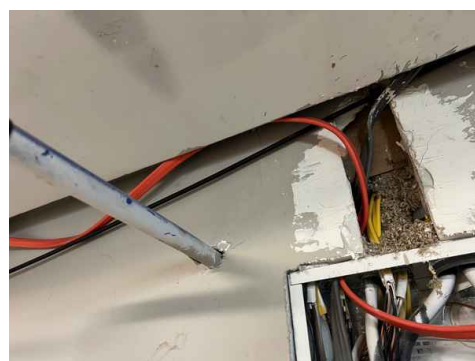
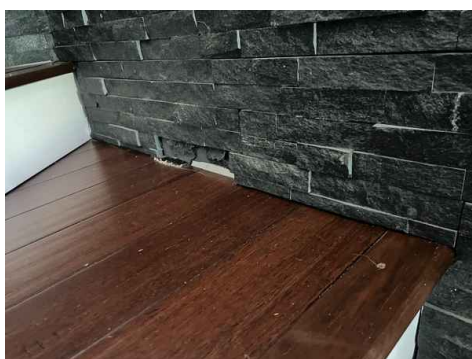
5.3.1 Branch Circuit Conductors, Overcurrent Devices and Compatibility of Their Amperage & Voltage

IMPROPER WIRING

Recommend maintenance to the improperly run and unsecured wiring.

Contact a qualified electrical contractor.

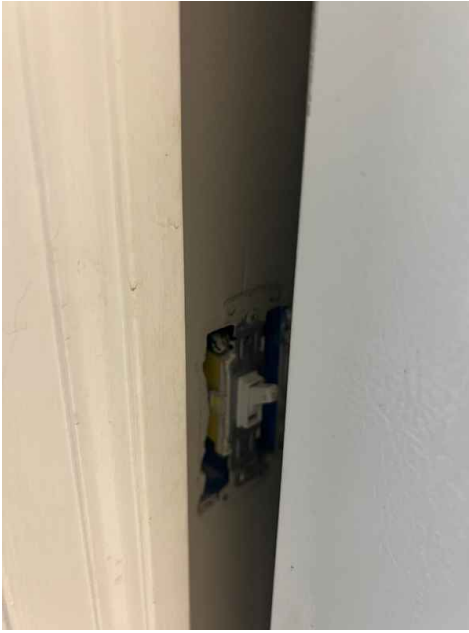
5.4.1 Connected Devices and Fixtures

COVER PLATES MISSING

Receptacles(s)/Switch(s) are missing a cover plate(s). Open wiring is a shock risk. Recommend installation of cover plates for safety purposes.

Contact a handyman or DIY project

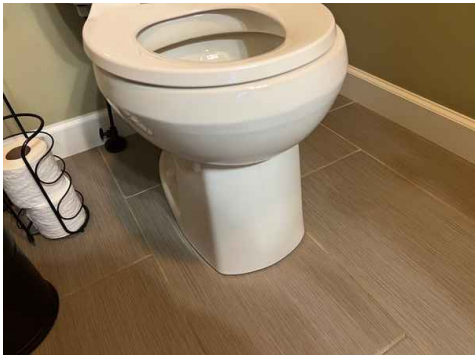
6.1.1 Fixtures / Faucets

TOILET LOOSE

Toilet(s) are loose on the floor. Recommend maintenance to prevent possible water damage.

Contact a handyman or DIY project

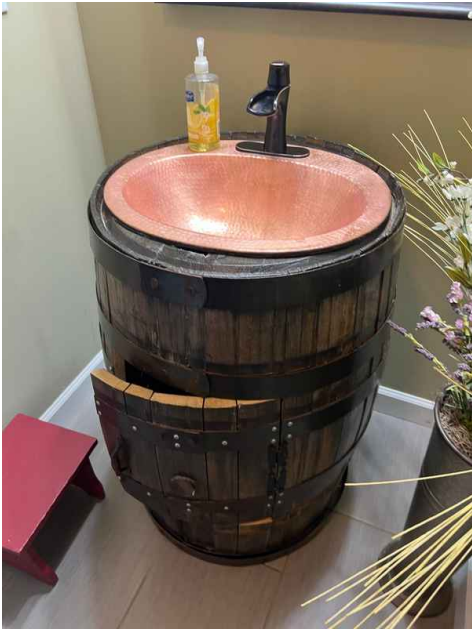
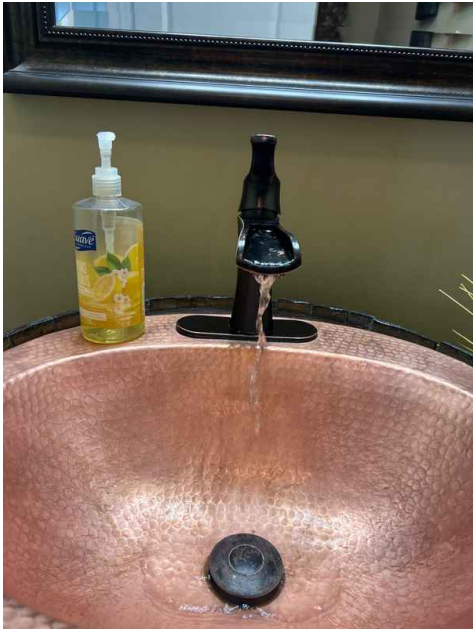
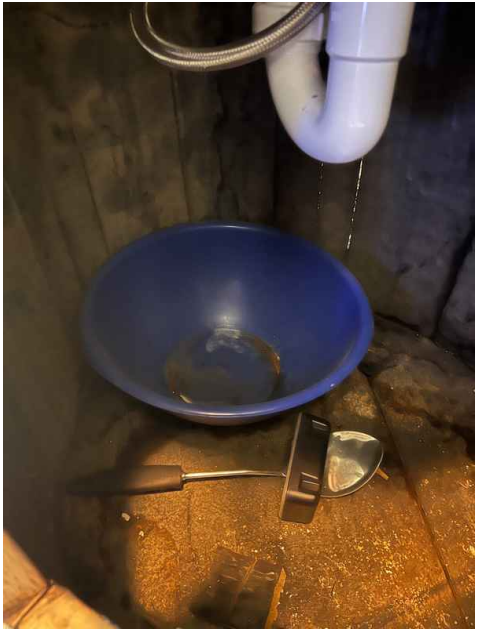
6.1.2 Fixtures / Faucets

LOOSE PEDESTAL

Pedestal and sink are damaged and not secured.

Contact a qualified professional.

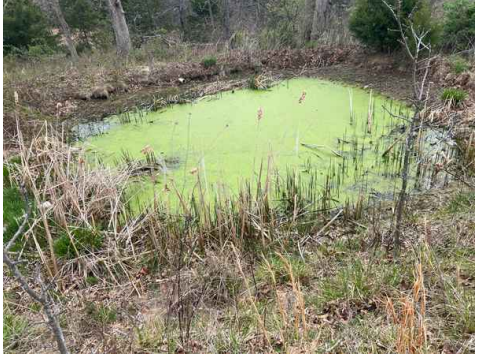
6.7.1 Septic System

SEPTIC SYSTEM DEFICIENCIES

System does not meet minimum state requirements. See separate septic report for details.

Contact a qualified professional.

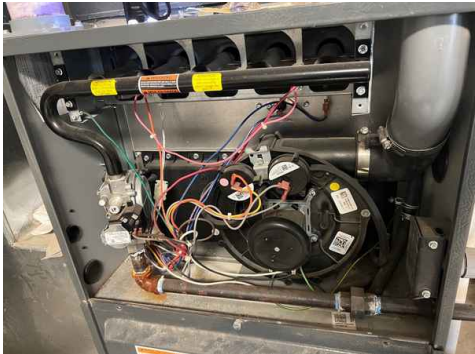
7.1.1 Heating Equipment

NEEDS SERVICING/CLEANING

HVAC systems should be cleaned and serviced by a qualified professional.

Contact a qualified HVAC professional.

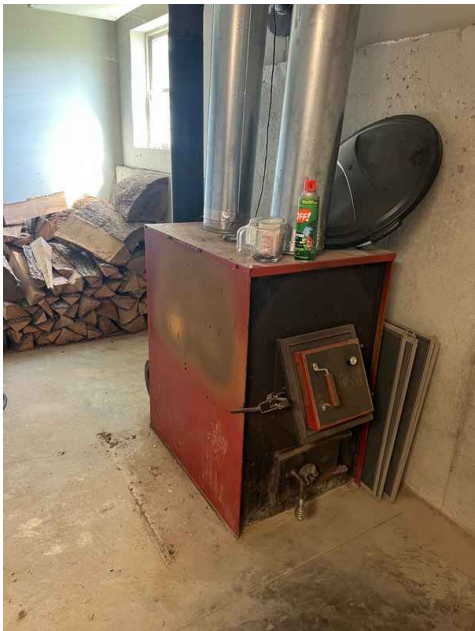
7.1.2 Heating Equipment

NOT INSPECTED

Auxiliary wood burning furnace was not inspected. Recommend further evaluation and cleaning by a qualified professional before using.

Contact a qualified professional.

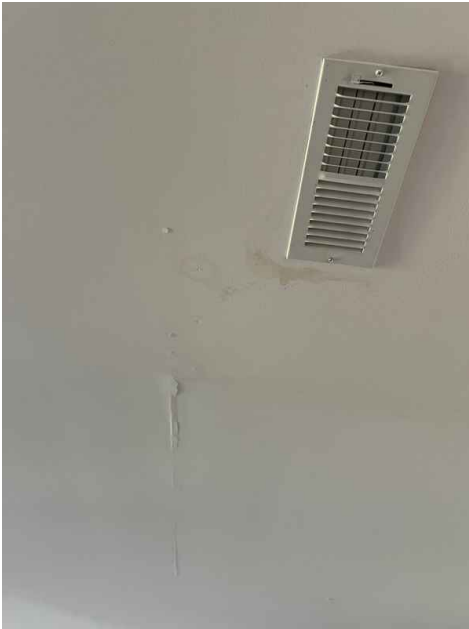
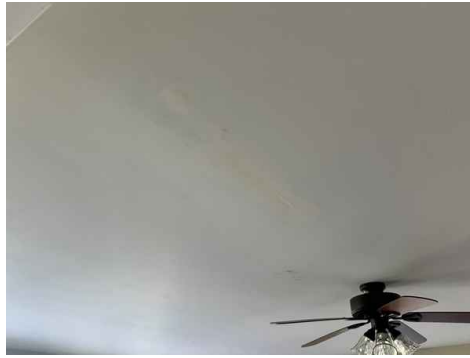
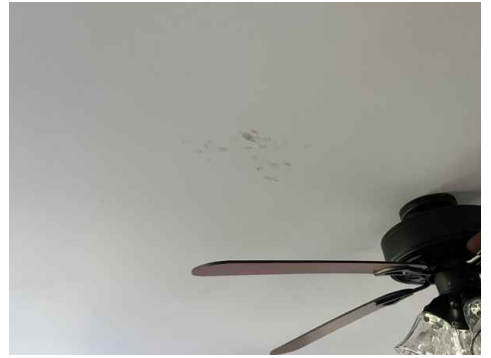
9.2.1 Ceilings

WATER STAINING/DAMAGE

Damaged, water stained, and previously repaired drywall are present on the basement ceiling. Suspect conditions are due to the damaged and repaired shower enclosure.

Recommendation
Recommend monitoring.

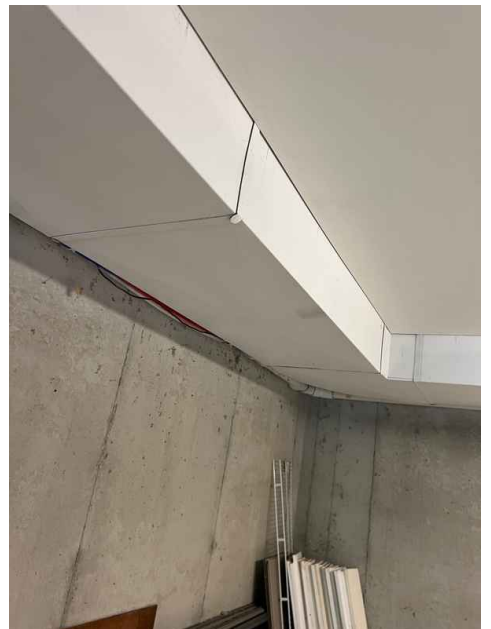
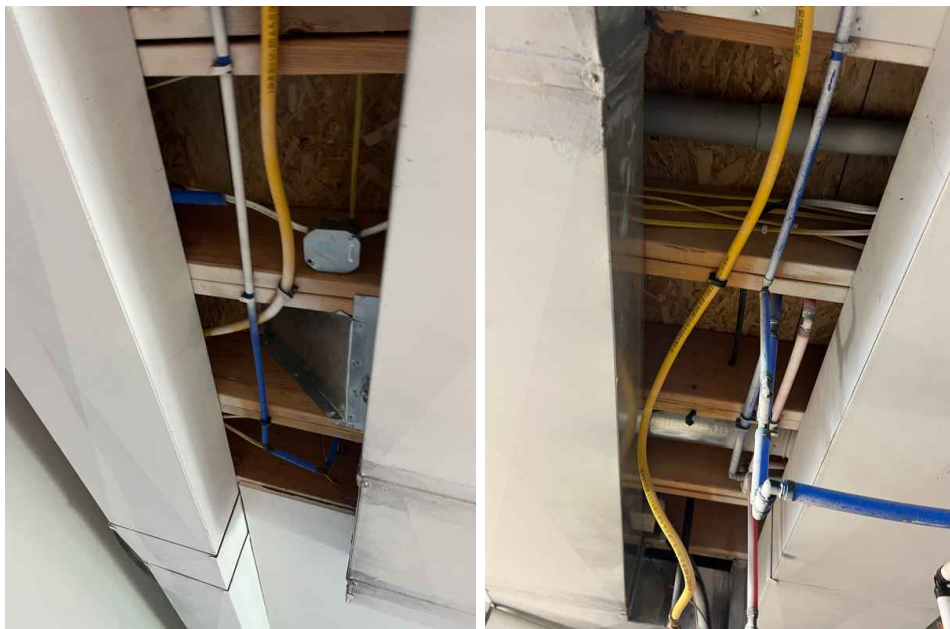
9.2.2 Ceilings

FIRE BARRIER

Exposed HVAC ductwork and missing drywall in the garage are a fire breach. Recommend properly enclosing the ductwork and installing missing drywall for safety purposes.

Contact a qualified professional.

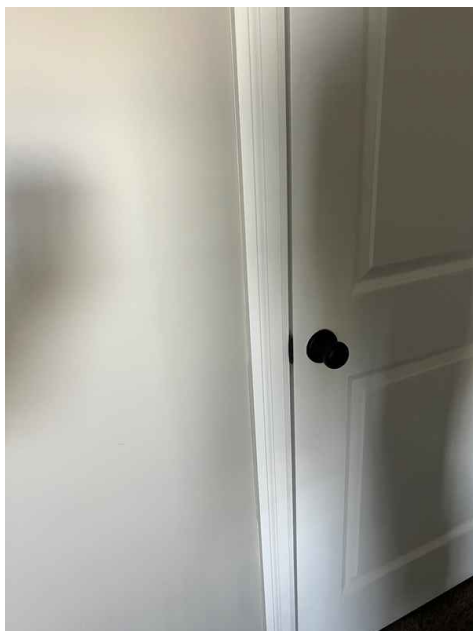
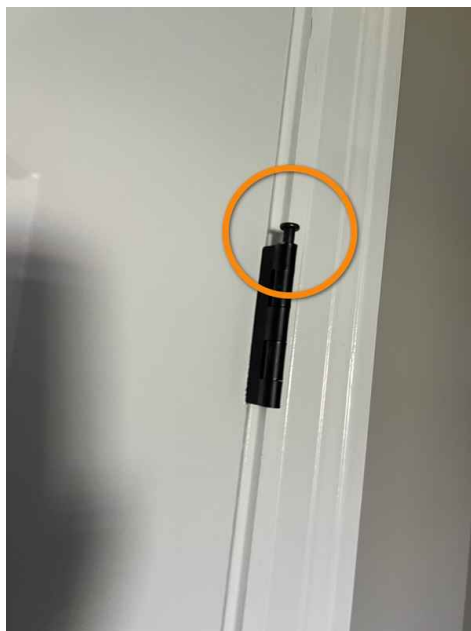
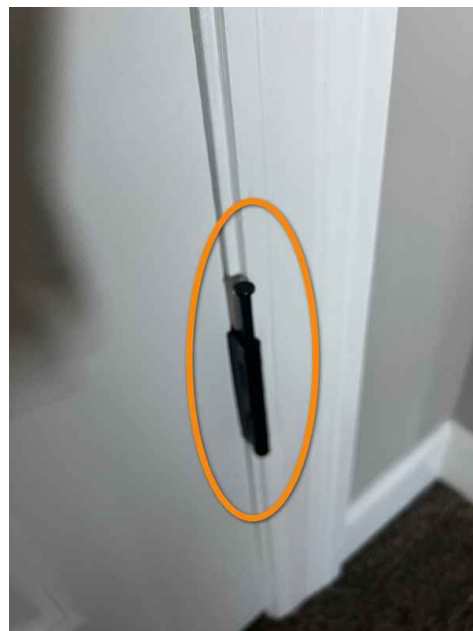
9.6.1 Doors

DOOR DOESN'T LATCH

Doors do not properly close and latch.

Contact a handyman or DIY project

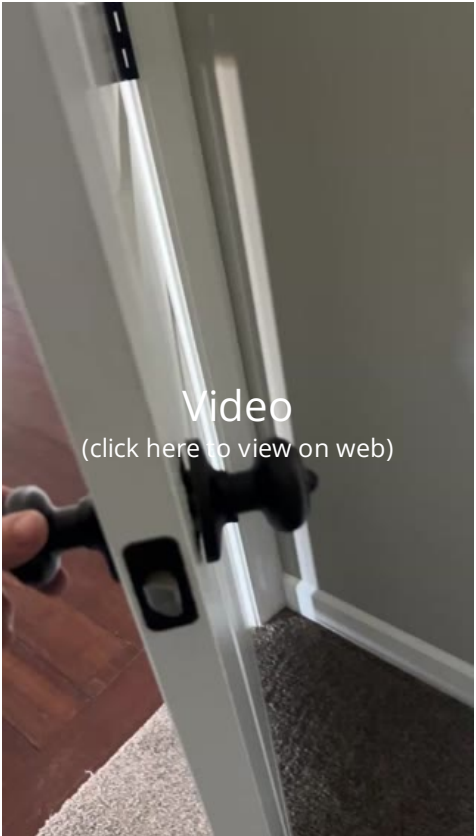
9.6.2 Doors

LOOSE DOOR KNOB

Maintenance required to loose door knobs.

Recommendation
Contact a handyman or DIY project

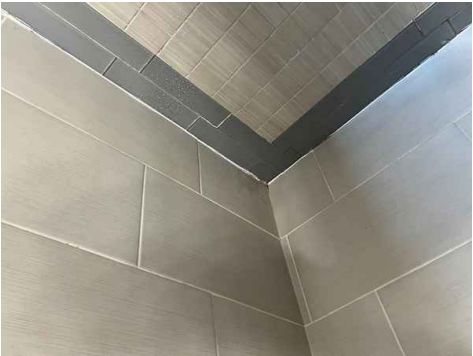
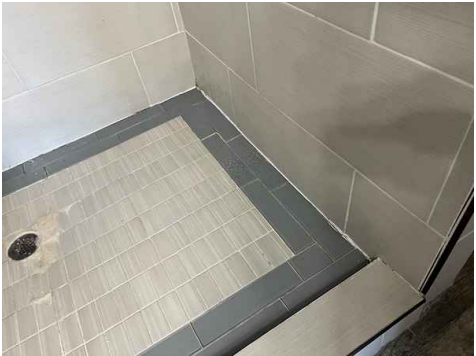
9.8.1 Shower Enclosures

PREVIOUS REPAIRS

Damaged, deterioration, previous repairs and evidence of leaking are present at the tile shower enclosure. Recommend further evaluation and repairs by qualified contractor.

Recommendation
Contact a qualified professional.

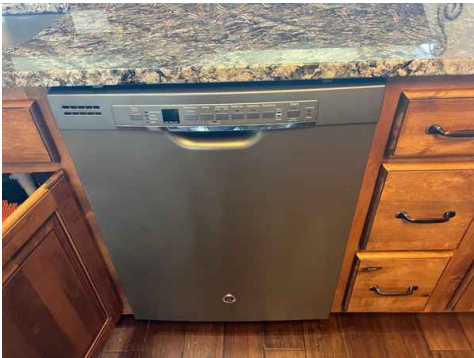
10.1.1 Dishwasher

INOPERABLE

Dishwasher is beyond design and did not cycle at inspection. Recommend further evaluation and repair or replacement.

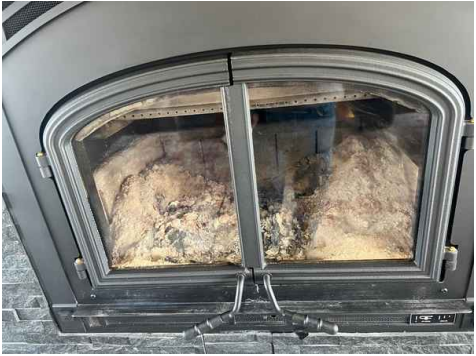
Recommend fireplace, flue, and chimney be cleaned and inspected before use.
