## PROPERTY INSPECTION REPORT FORM

**Name of Client:** Larry & Shirley Truitt

**6/17/24 Date of Inspection**

**564 Gypsum Mine Rd., Fredericksburg, TX (Pre-List)**

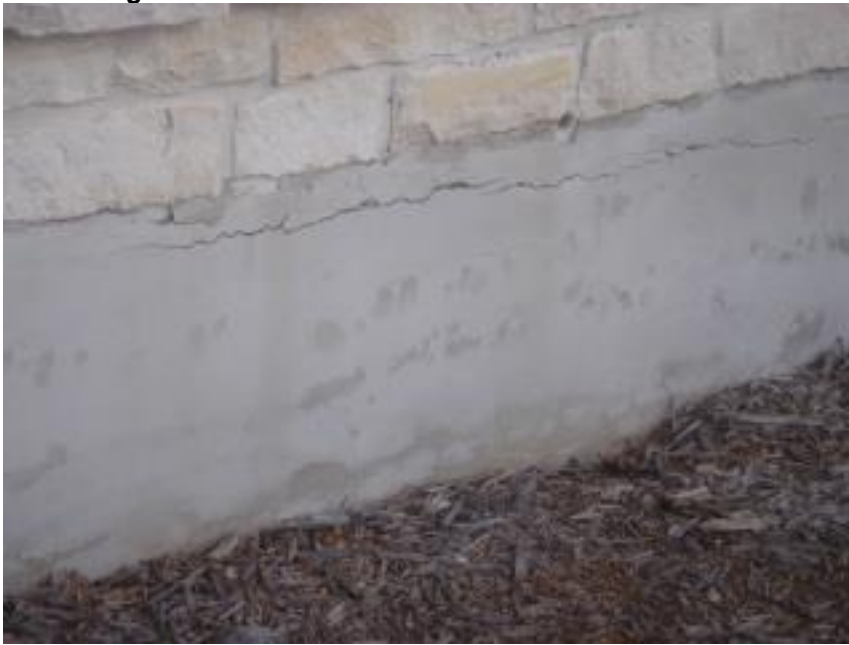
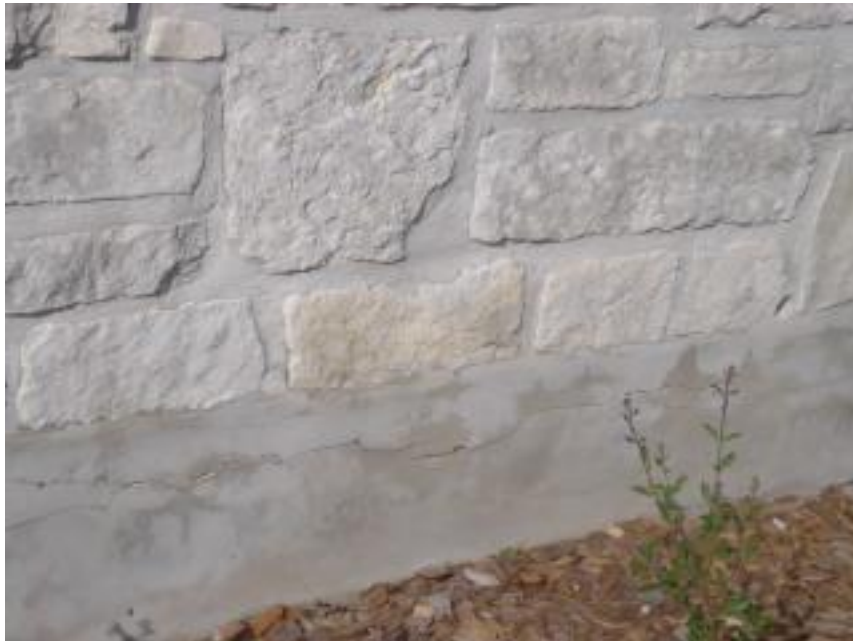
**Comments:** Signs of prior movement/settlement observed in the form of hairline type fracture cracks to walls and ceiling surfaces.

**In my opinion (as required by TREC) your foundation appears to be performing as designed and intended. I do however always recommend that if additional details about foundation performance is preferred or required to help you make this purchase decision that a licensed professional engineer with foundation experience be consulted.**

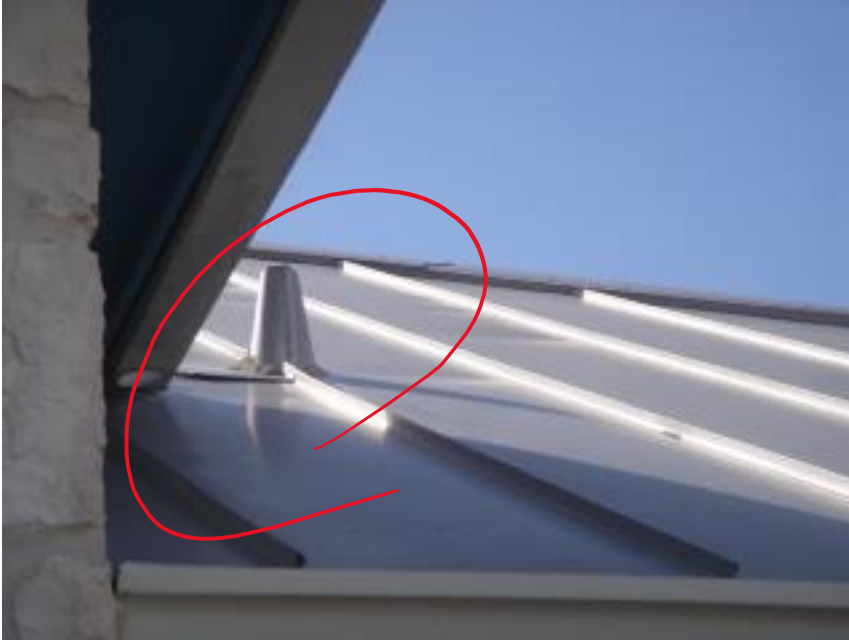
*Comments:* **Flashing is no longer secured/sealed in place. (see where pulling up)**

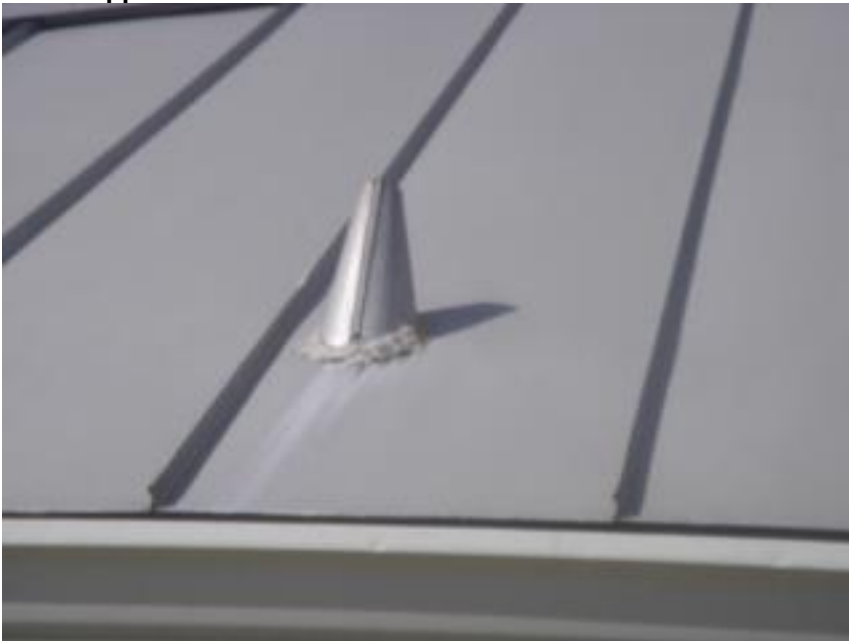
**Locations where caulking, roof tar and/or other sealant have been applied would indicate locations of prior moisture migration and a repair. These products become dry and cracked over time due to exposure and need to be reapplied.**

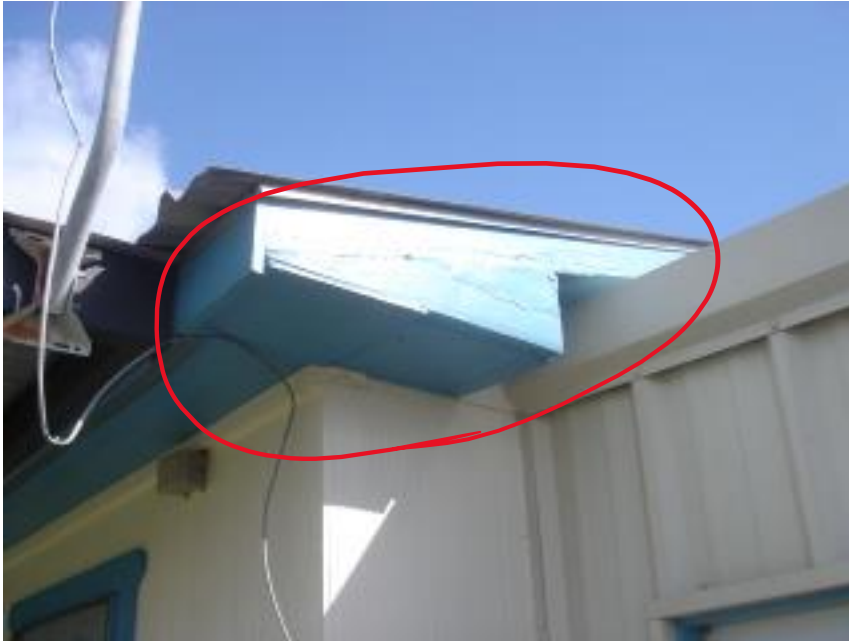
Noted wood rot due to exposure to moisture. Note where repaired. See mostly minor amounts at garage/guest house building.

Wood fill.

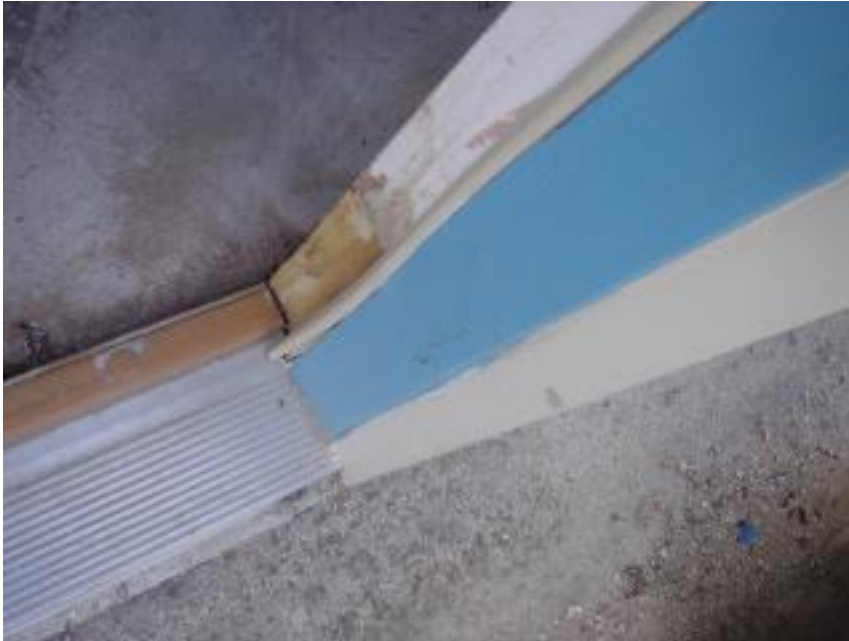
Noted signs of moisture and minor rot to trim of door at metal shop building with no overhand.

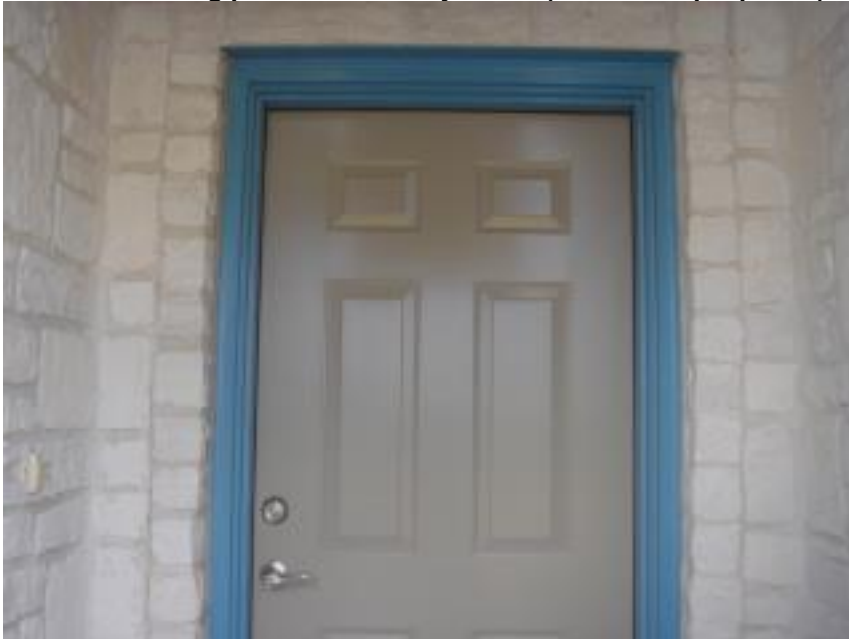
**Noted no viewing port at main entry door. (window or peep hole)**

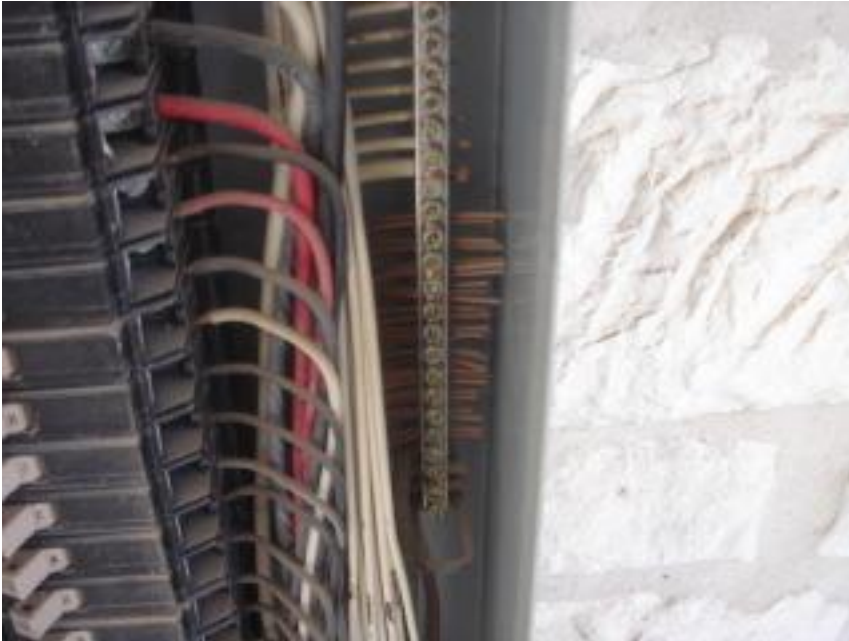
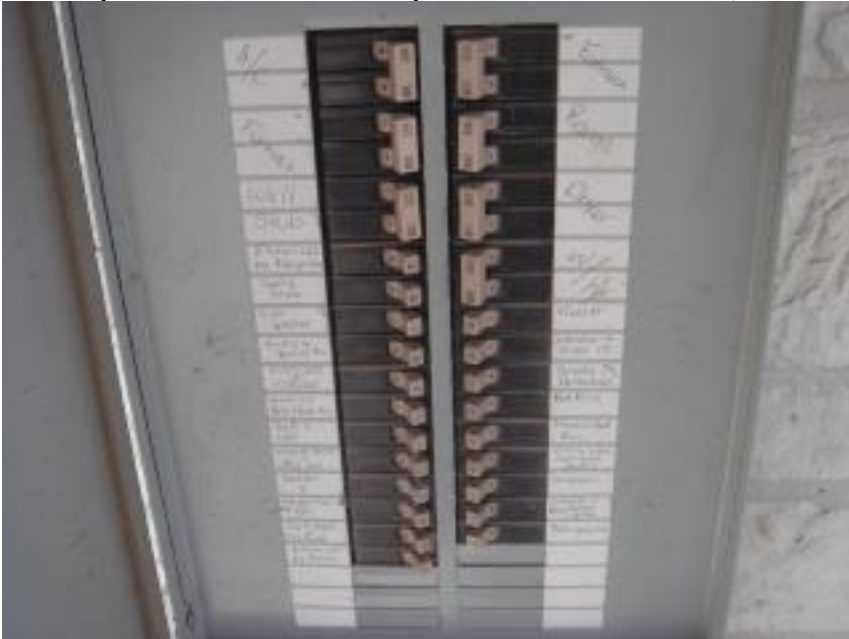
**Arc-Fault outlets/breakers/circuit protection not observed at one or more required locations (bedrooms, kitchen, laundries & garages) as required by current safety codes (2014 National Electrical Code - NEC210.12-a) These are normally AFCI breakers located in houses service panel. They can sense presence of loose wire among other faults that can create an arc. If an arc is present the breaker will trip. These circuits are now required to protect most all circuits in the house EXCEPT where already protected by GFCI outlets. These devices provide an extra level of protection from arc/short, related hazards and should be included.**

required repair item. Current National Electrical code (NEC) Section 210.12 requires that AFCI "Arc Fault" protection be provided on branch circuits that supply outlets, lighting, smoke alarms, etc. TREC Standard of practice require that lack of these devices be identified. These were not available until recently and most existing homes will not have them. If your house was constructed prior to 1996 it is likely your clothes dryer and range outlets were wired with just 3 wires connected to a 3 prong outlet. Modern 220 volt dryers and ranges require 4 wire circuits and outlets (dedicated ground). If your home was constructed after 2009 with recessed can light fixtures they are required to be "IC - contact allowed" type fixtures. This allows that insulation material can be in direct contact with the fixture. This is difficult to determine so therefore may not have been confirmed. Older type fixtures may blink off and on if in contact with insulation materials due to heat.

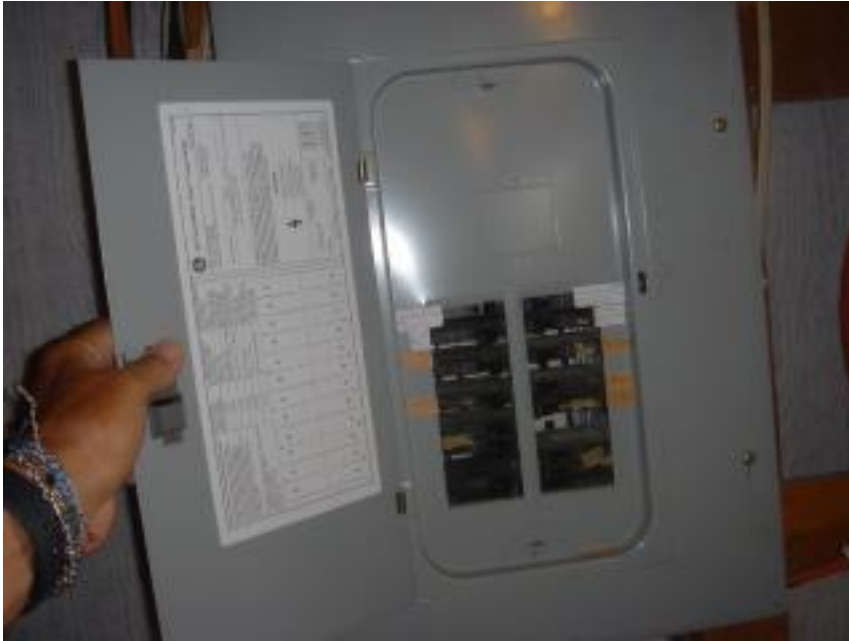
**Switches/outlets observed are not rated for use with aluminum branch circuits wires.**

**Noted outlets mounted below 66 inches from floor level. Most all electrical safety codes require that any outlet installed/mounted below 66 inches be rated and marked as “tamper resistant” – with clear marking “TR”. The Texas Real Estate Commission “Standards of Practice” requires documentation as a deficiency regardless of age of property.**

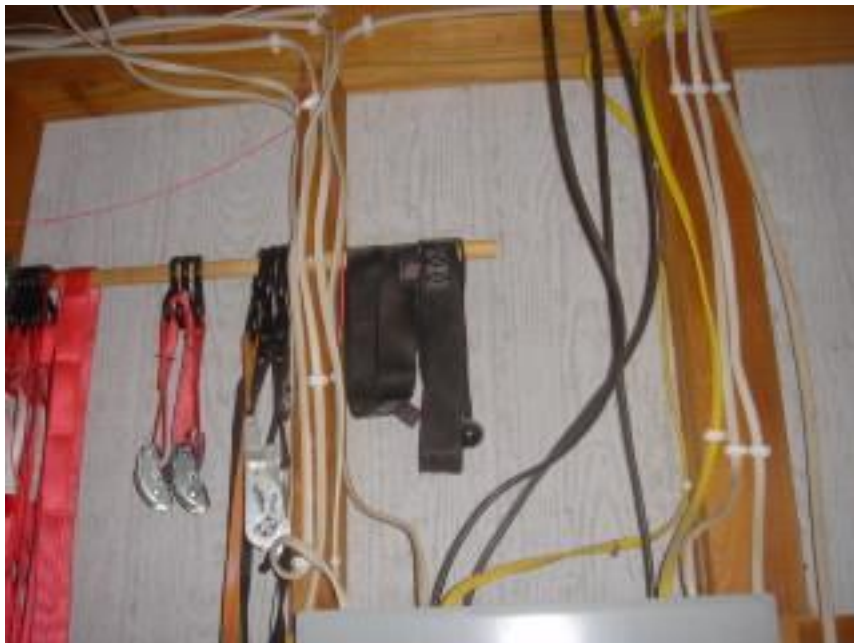
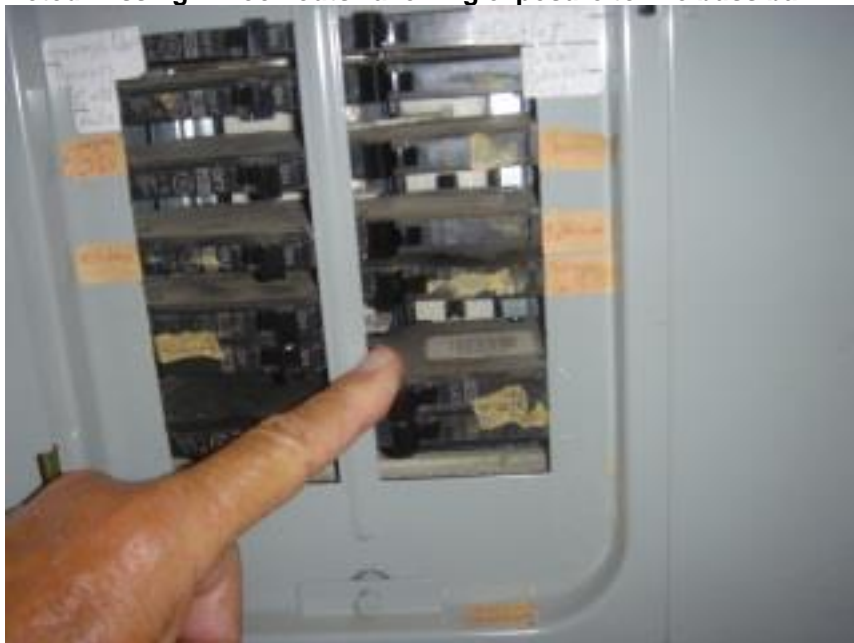
**Noted missing “knock-outs” allowing exposure to live buss bar.**

**A licensed electrician should be consulted prior to end of option period and/or prior to closing to observe conditions present and make repair or replacement recommendations.**

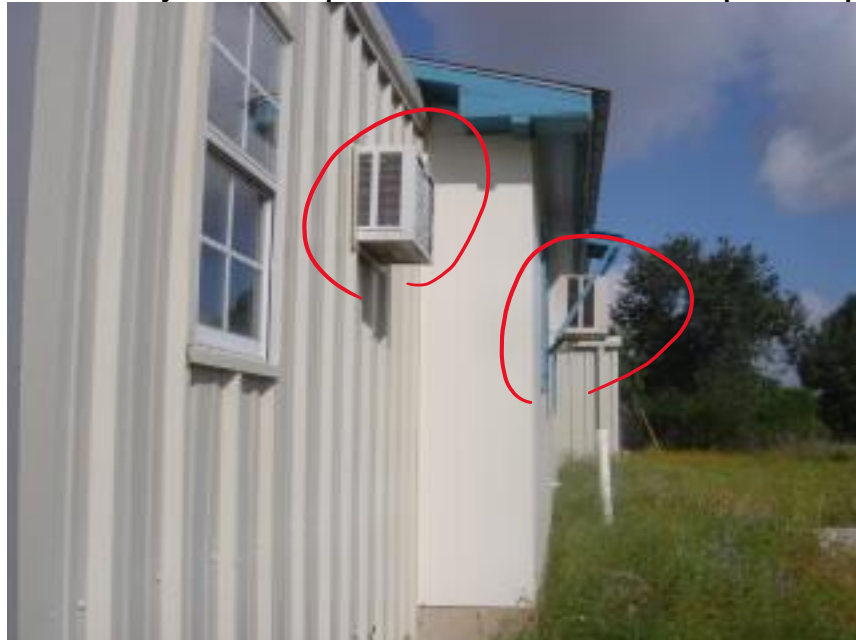
**Noted small room size window a/c units in place. These may or may not provide adequate capacity to fully and economically condition space. These units are not test operate or part of this inspection.**

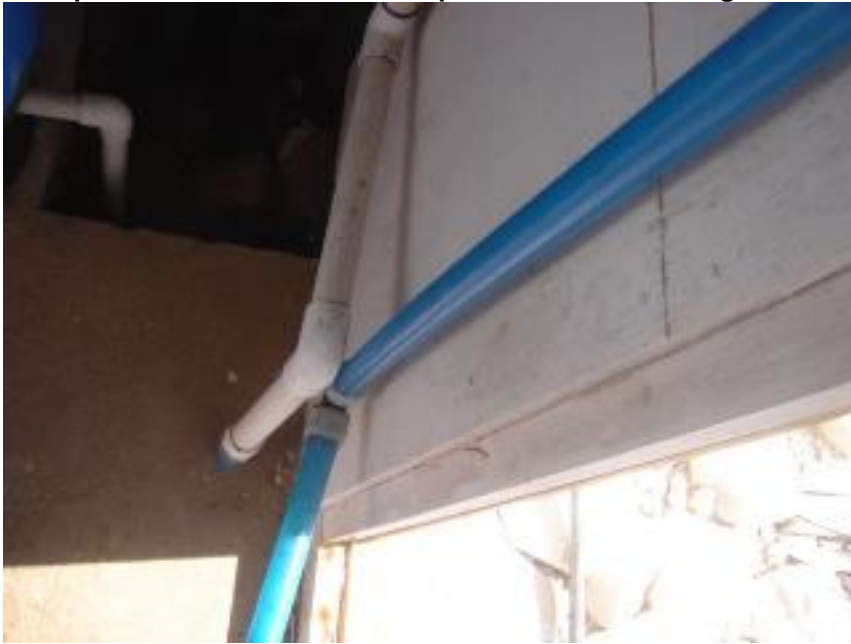
**All exposed water lines should be protected from freezing.**

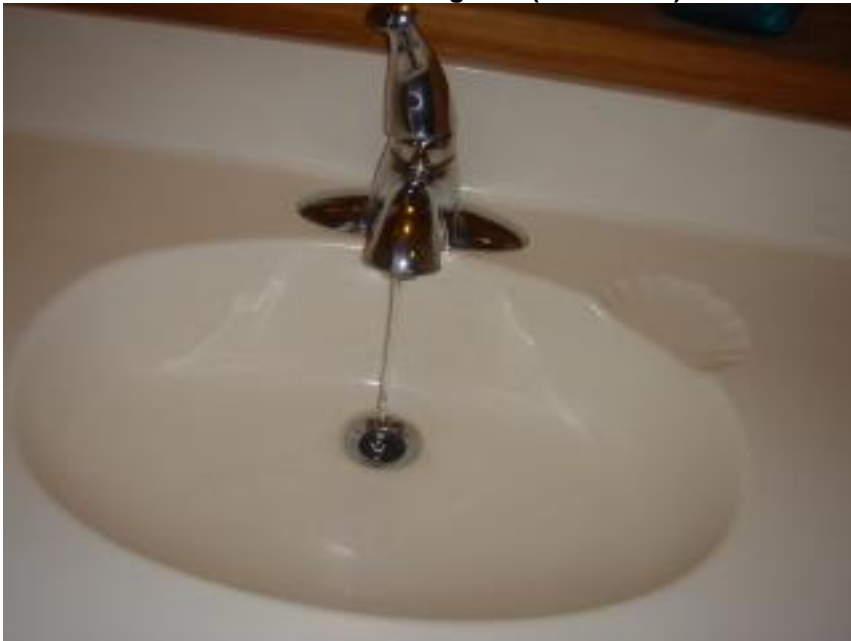
**At guest house vanity.**

**Faucet screens are restricted throughout (hard water).**

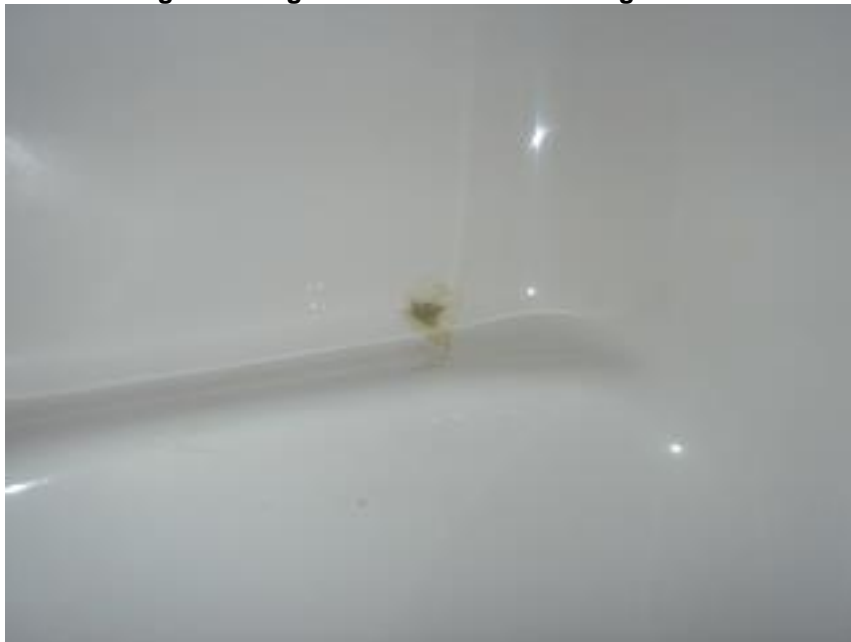
**Noted damage to fiberglass shower enclosure – guest.**

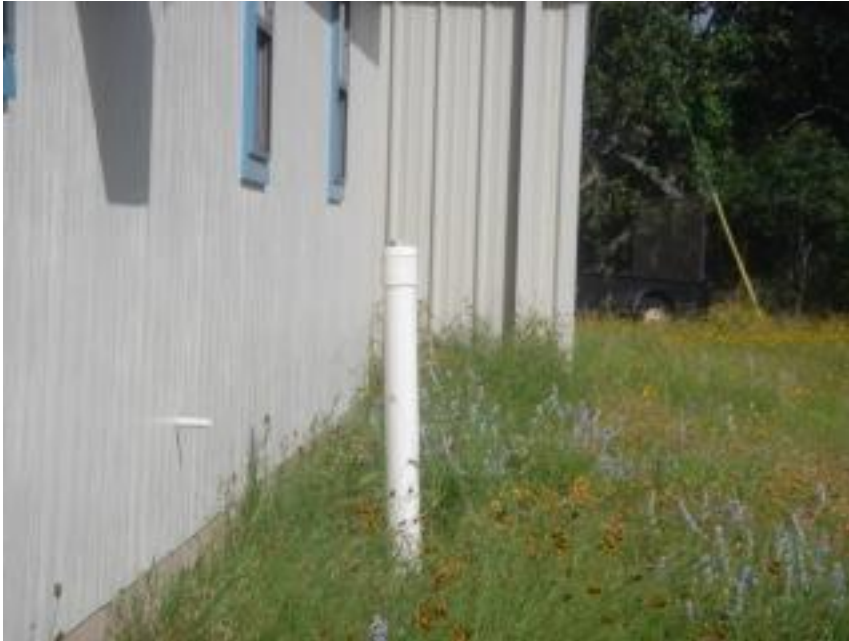
**Noted sections of PVC piping that is exposed. This allows it to be subject to both freeze and UV exposure damage. PVC is not intended for direct exposure.**

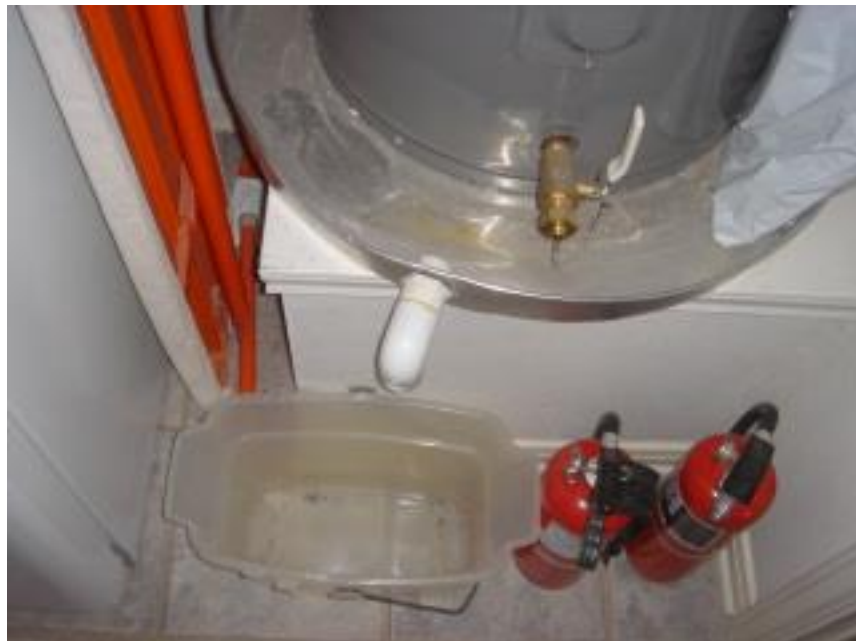
**Drain should extend to outside.**

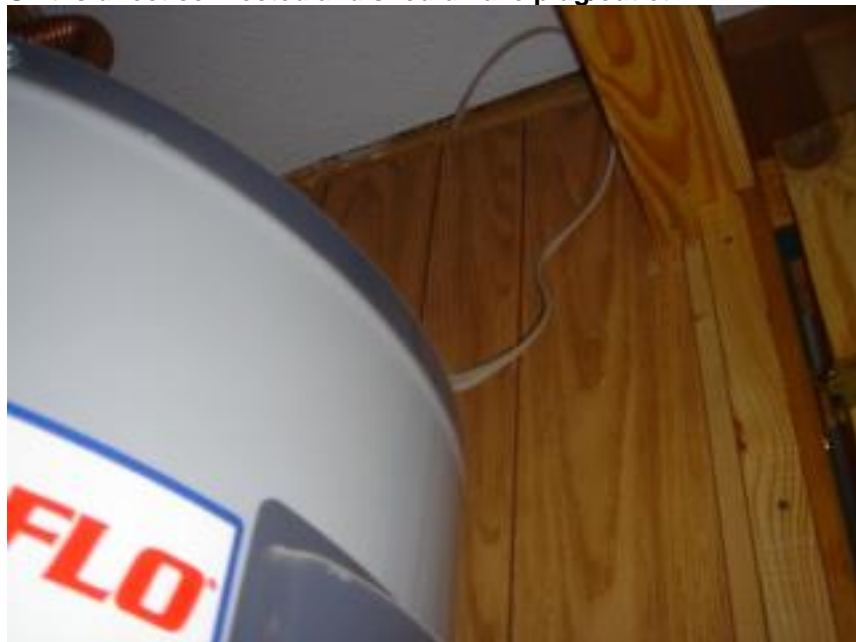
**Guest house.**

**Unit is direct connected and should have plug/outlet.**

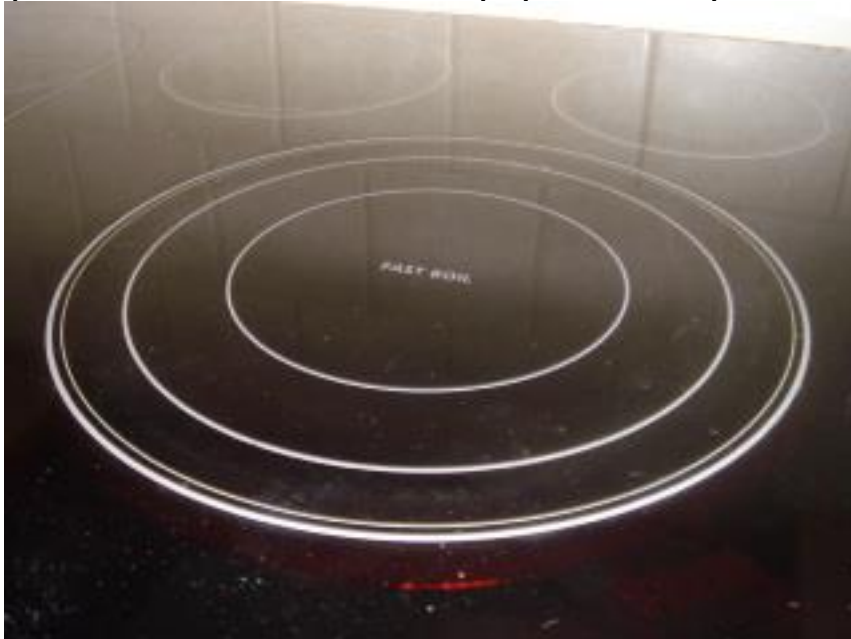
**Noted surface blemishes and scratches. Unable to determine possible effects to operation. Manufacturers specifications should be reviewed for proper uses and operation.**
