## RESIDENTIAL INSPECTION

20149 US-63

Queen City, MO 63561

08/11/2026

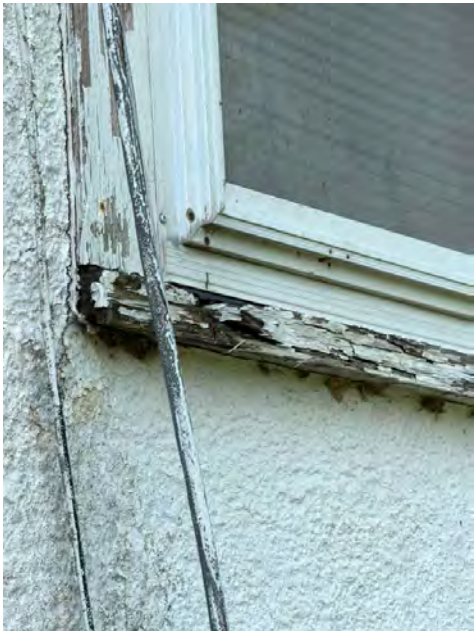
### 3.2.1 Siding, Flashing & Trim

#### **ROTTING WOOD SIDING/TRIM**

EAST

Rotting wood siding/trim should be replaced and all surfaces should be repainted to ensure that the material blow is sealed and protected.

Recommendation  
Contact a qualified siding specialist.

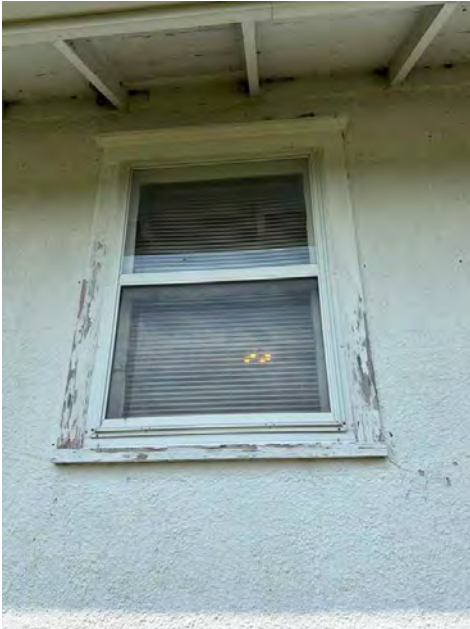
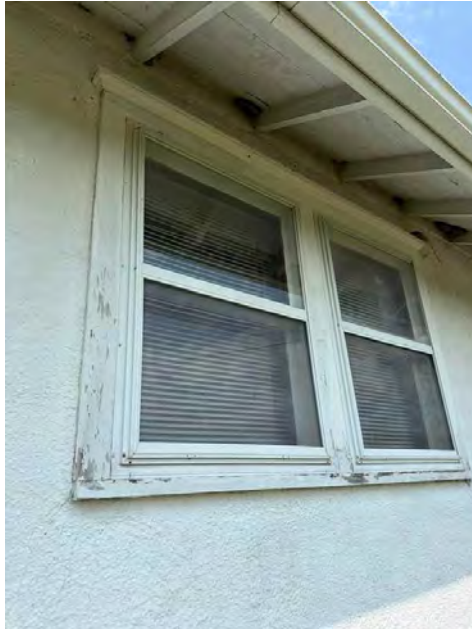
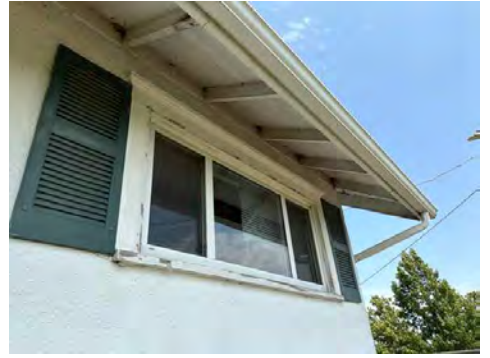
3.2.2 Siding, Flashing & Trim  
**PAINT REFRESH**

MULTIPLE

Ensuring damaged or deteriorating paint is refreshed will help to ensure the longest possible lifespan of a material covering.

Recommendation  
Contact a qualified painting contractor.

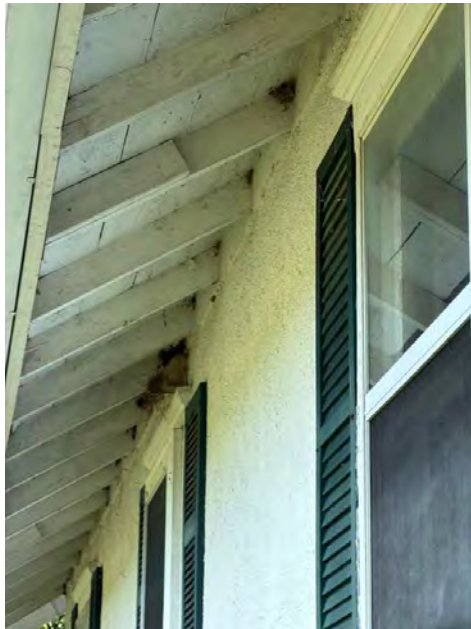
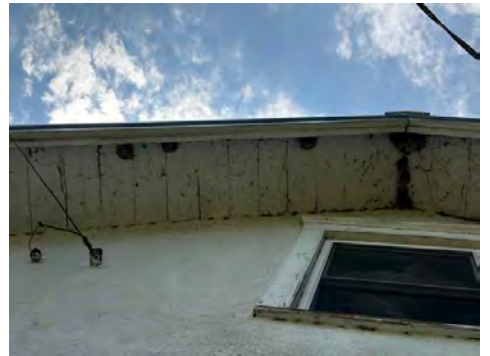
### 3.3.2 Eaves, Soffits & Fascia

#### **NEST**

#### MULTIPLE

A nest was visible in the soffit/fascia material. Recommend removal by a pest control pro.

Contact a qualified pest control specialist.

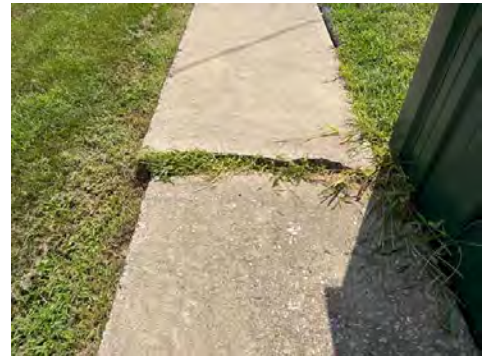
## 3.4.1 Walkways, Patios &amp; Driveways

**DRIVEWAY/WALKWAY TRIP HAZARD**

## DRIVEWAY/WALKWAY EAST

Trip hazards observed in the driveway or walkway. Patch or repair recommended.

Contact a qualified concrete contractor.

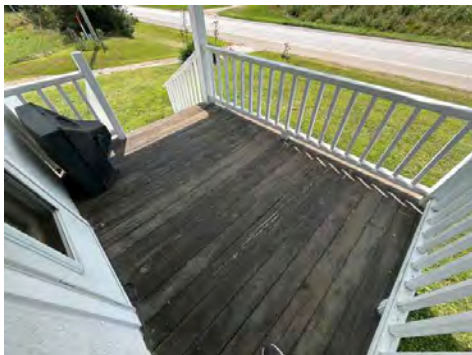
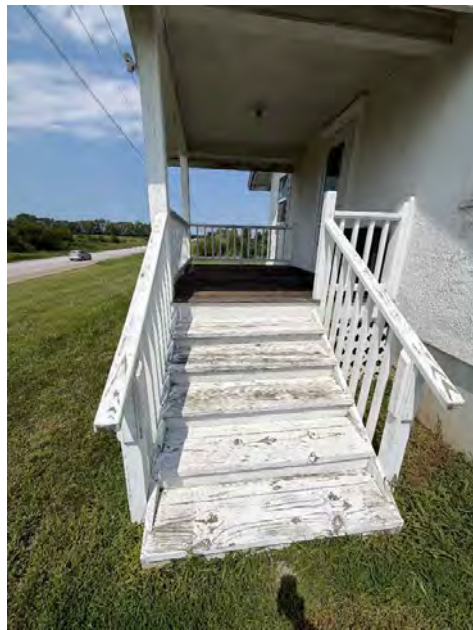
## 3.5.1 Decks, Balconies, Porches &amp; Steps

**DECK - WEATHER SEALANT**

## WEST

Deck is showing signs of weathering and/or water damage. Recommend water sealant/weatherproofing be applied.

Contact a handyman or DIY project

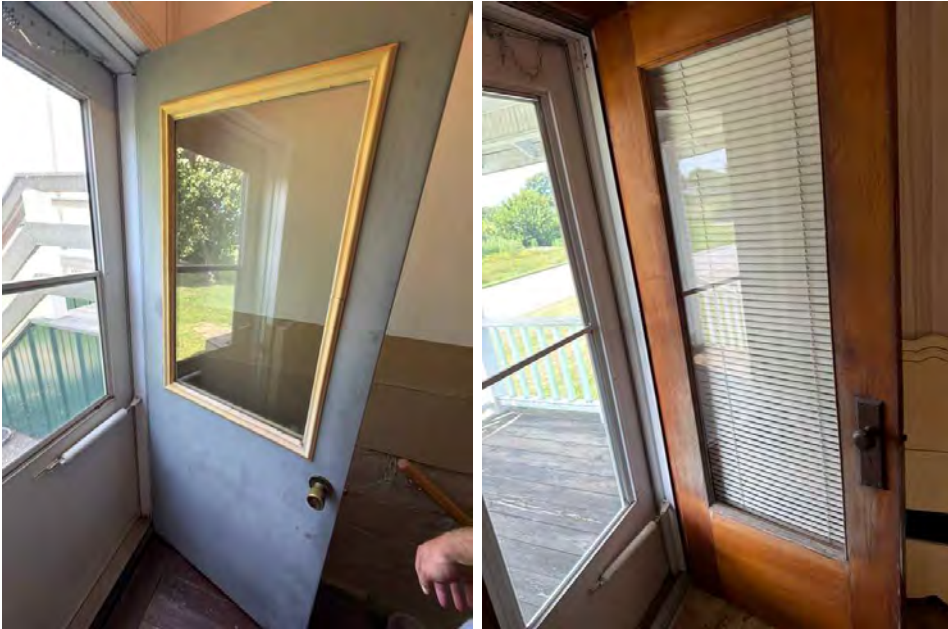
## 3.7.1 Exterior Doors

**PAINT/REFINISH RECOMMENDED**

## EAST, WEST

Door finish is worn. Recommend refinish and/or paint to maximize service life.

Contact a handyman or DIY project

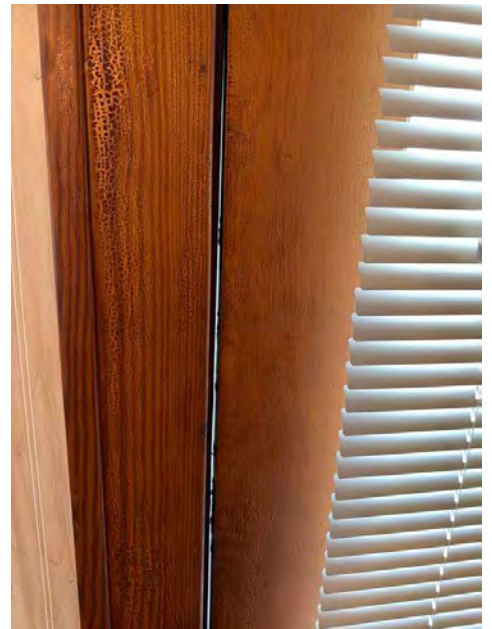
### 3.7.2 Exterior Doors

#### **WEATHERSTRIPPING MISSING/GAP**

##### LIVING ROOM

Door is missing standard weatherstripping. This can result in significant energy loss and moisture intrusion. Recommend installation of standard weatherstripping.

Contact a qualified handyman.

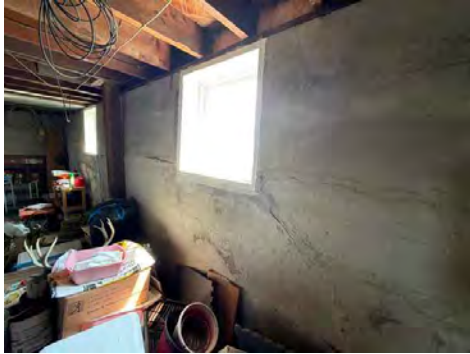
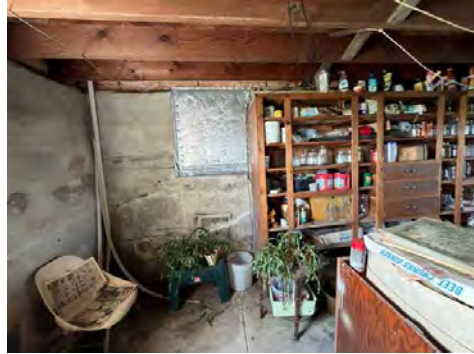
## 4.2.1 Foundation

**WALL(S) BOWING/LEANING**

WEST, SOUTH

Foundation wall is bowing and/or leaning this is evidence of structural damage. Repair of wall is recommended to reduce future continued movement.

Contact a foundation contractor.

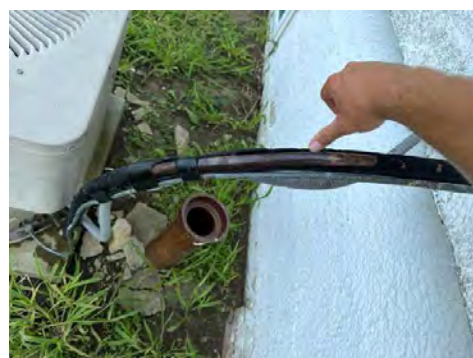
### 6.2.1 Cooling Equipment

#### **INSULATION MISSING OR DAMAGED**

NORTH

Missing or damaged insulation on refrigerant line can cause energy loss and condensation. Recommend replacing the degrading or damaged insulation material with new.

Contact a handyman or DIY project

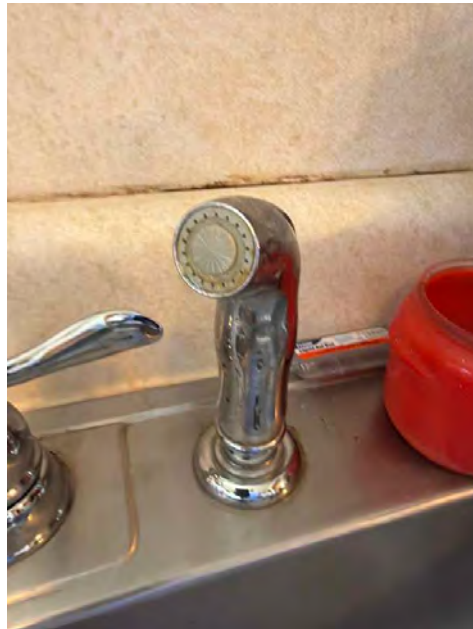
### 7.3.1 Water Supply, Distribution Systems & Fixtures

#### **FIXTURE LOOSE/LEAKING OR DAMAGED**

##### KITCHEN

Fixture is loose, leaking or damaged. Recommend a qualified plumber evaluate and repair to prevent water damage.

Contact a qualified plumbing contractor.

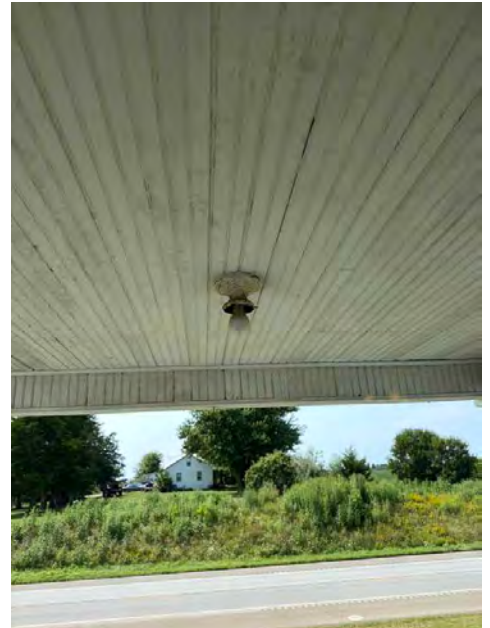
### 8.2.3 Lighting Fixtures, Switches & Receptacles

One or more lights or fans were not operating. New light bulb possibly needed or replacement of the fixture by a qualified professional.

Contact a handyman or DIY project

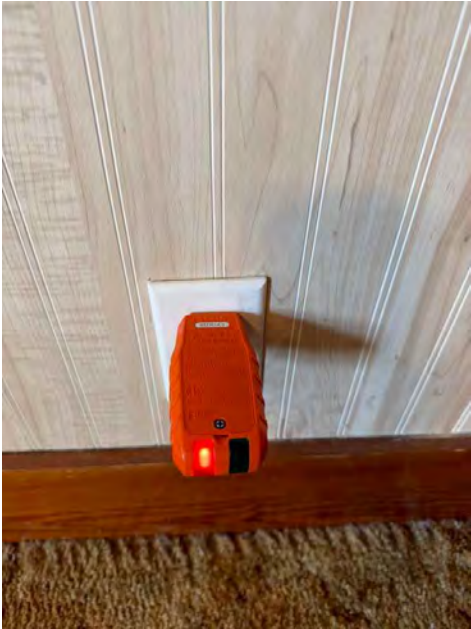
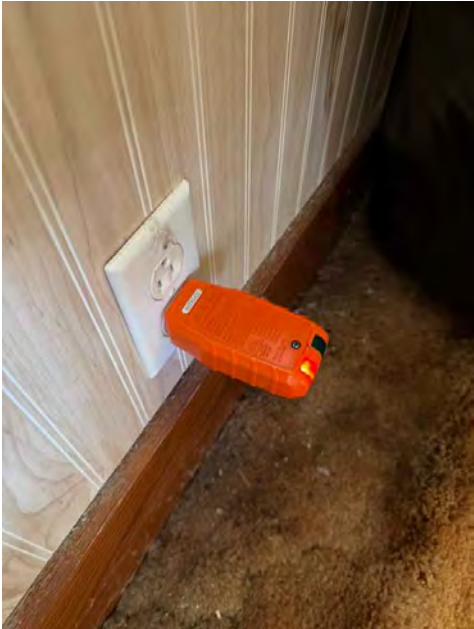
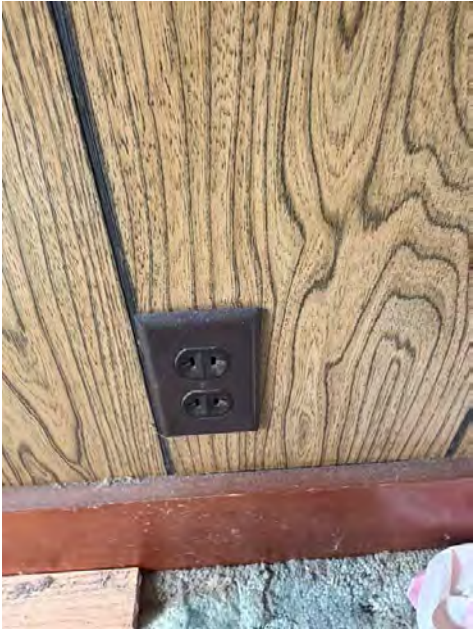
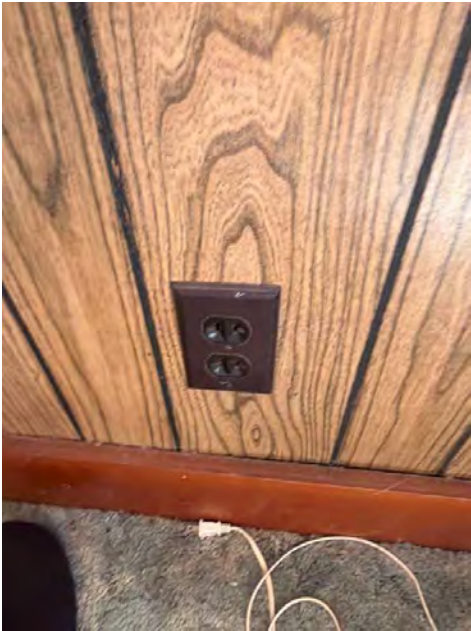
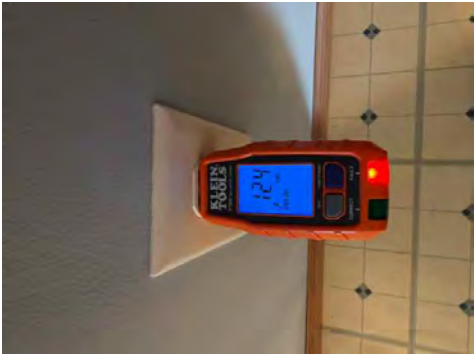
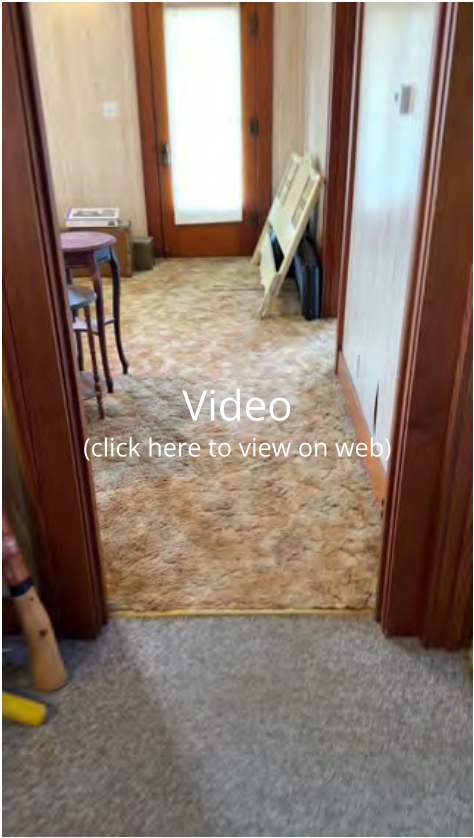
### 8.2.4 Lighting Fixtures, Switches & Receptacles

One or more receptacles are ungrounded. To eliminate safety hazards, all receptacles in kitchen, bathrooms, garage & exterior should be grounded. This is something that that is common to see in this age of home. You may repair if desired.

Contact a qualified electrical contractor.

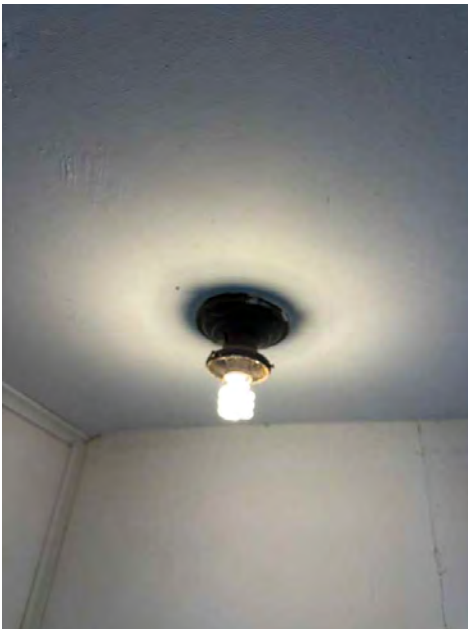
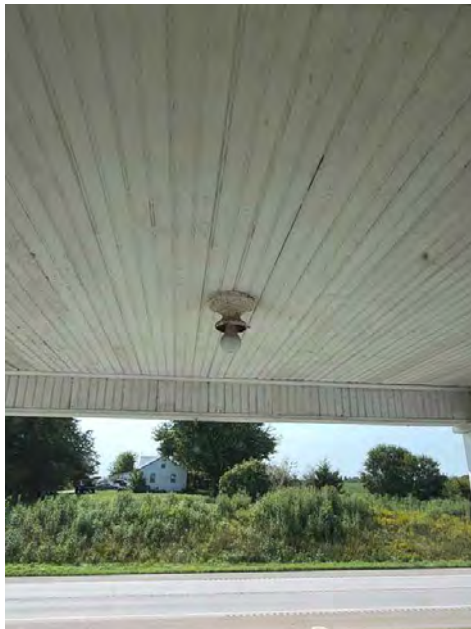
#### 8.2.5 Lighting Fixtures, Switches & Receptacles

### **MISSING/DAMAGED SCNCE(S)/FAN BALDE(S)**

One or more light fixtures were missing scone(s). The scone is the decorative cover of the light. Some light fixtures have replacement sconces. Others are more difficult to obtain.

Contact a handyman or DIY project

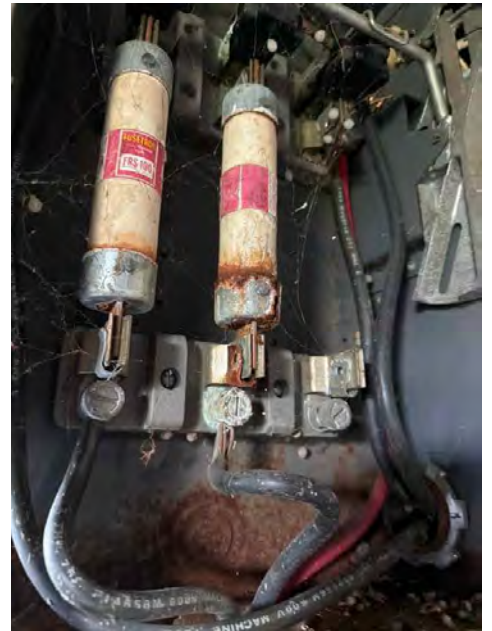
#### 8.6.3 Main & Subpanels, Service & Grounding, Main Overcurrent Device

### **CORROSION**

Electric panel was observed to have a fairly high level of corrosion. This could indicate that high levels of moisture are in areas surrounding the panel. I recommend trying to reduce all moisture in the area of the electrical panel.

Contact a qualified electrical contractor.

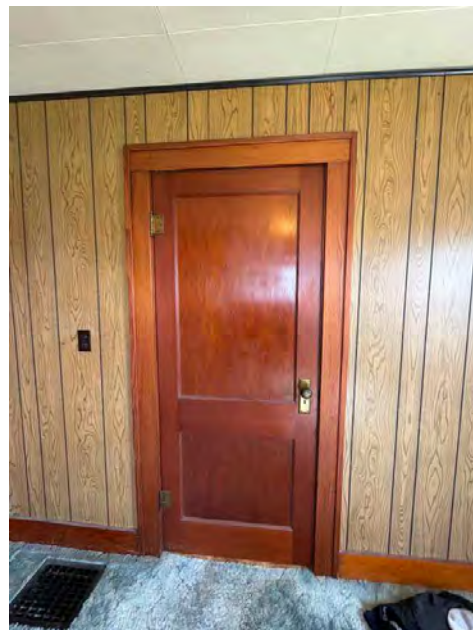
Door sticks and is tough to open or close. Recommend sanding down or cutting back offending sides.

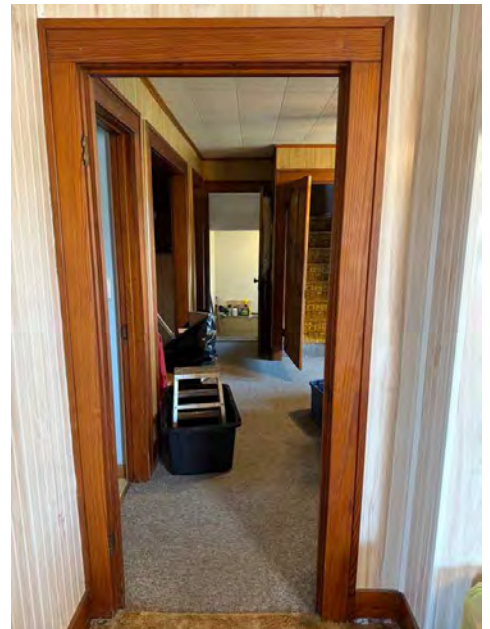
### 10.1.3 Doors

#### **DOOR MISSING**

Door was observed to be missing at time of inspection. Recommend installation of door if desired.

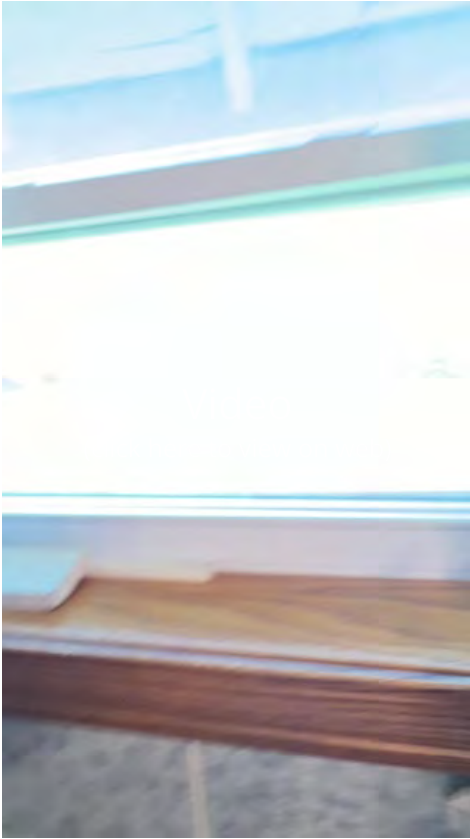
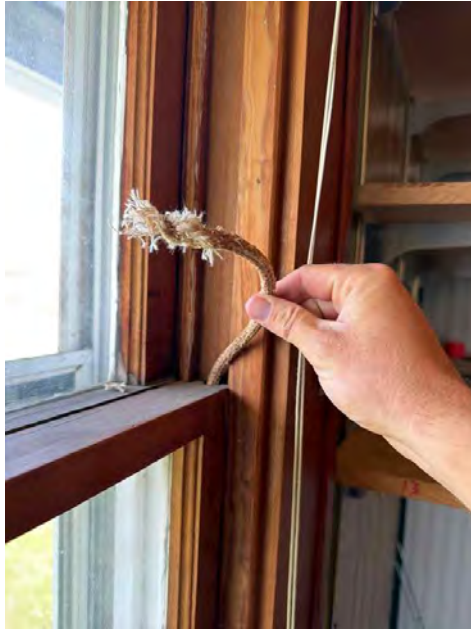
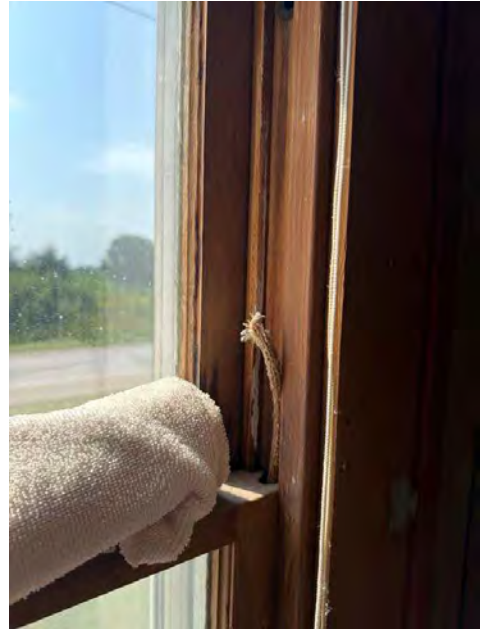
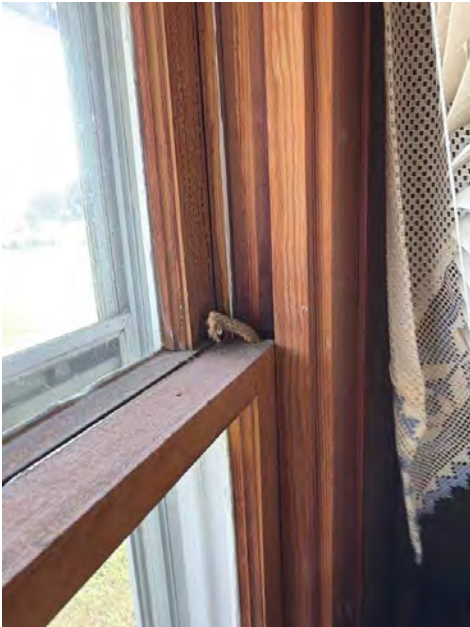
### 10.2.1 Windows

#### **DAMAGED**

One or more windows appears to have general damage to the pane, but are operational. Recommend a window professional clean, lubricate & adjust as necessary.

Contact a qualified window repair/installation contractor.

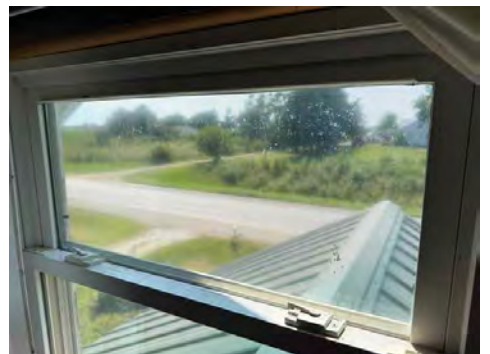
### 10.2.2 Windows

#### **FAILED SEAL/DAMAGED PANE**

Observed condensation between the window panes which indicates a failed seal. Recommend qualified window contractor evaluate & replace.

Contact a qualified window repair/installation contractor.

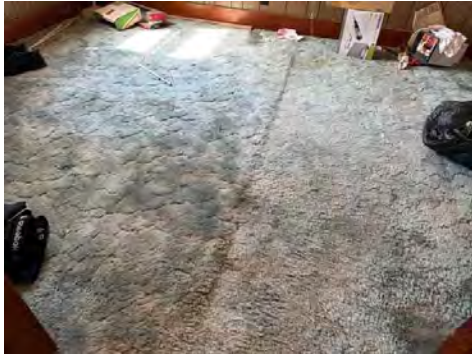
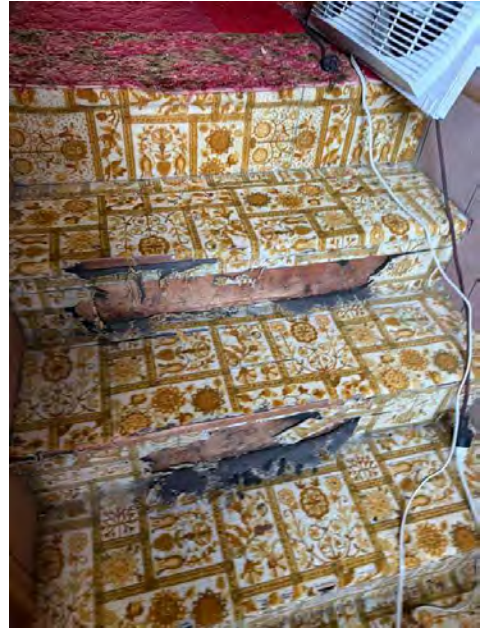
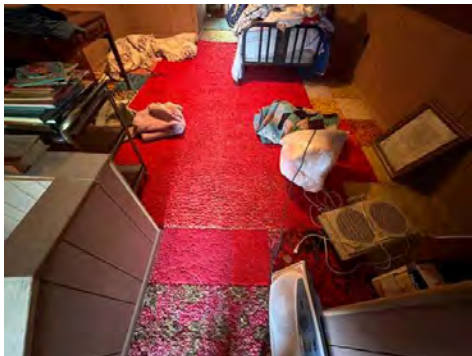
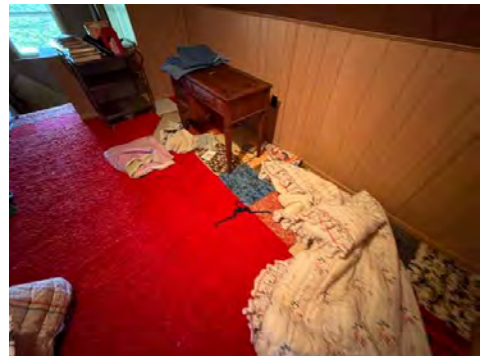
## 10.3.1 Floors

**DAMAGED (GENERAL)**

The flooring had general moderate damage or wear visible at the time of the inspection. Recommend service by a qualified contractor.

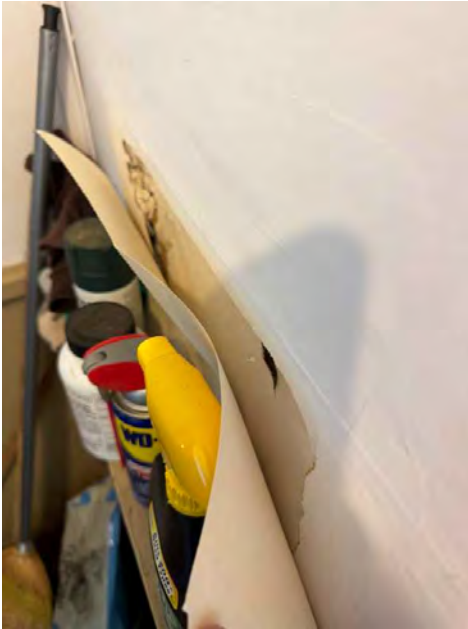
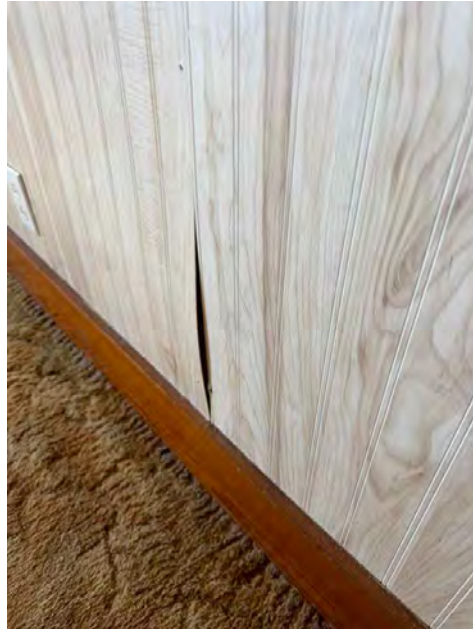
## 10.4.1 Walls

**POOR PATCHING/POOR PAINTING**

Sub-standard drywall patching or painting observed at time of inspection. Recommend re-patching or paint touch up.

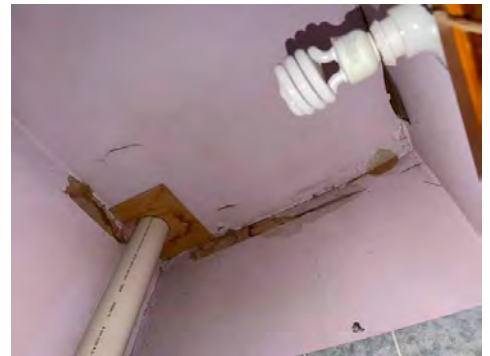
## 10.4.2 Walls

**MOISTURE DAMAGE**

Stains on the walls visible at the time of the inspection appeared to be the result of possible moisture intrusion. The source of moisture may have been corrected. Recommend further examination by a qualified contractor to provide confirmation.

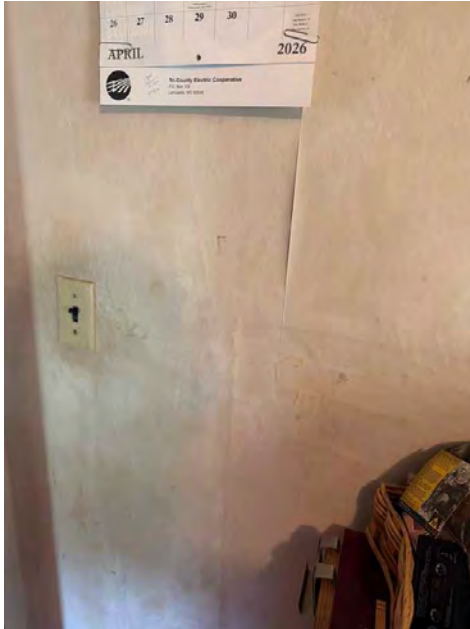
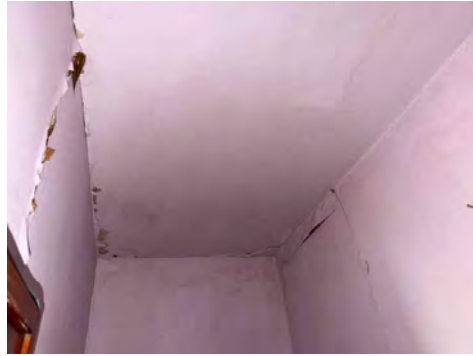
Peeling or cracking wallpaper was identified in one or more locations.

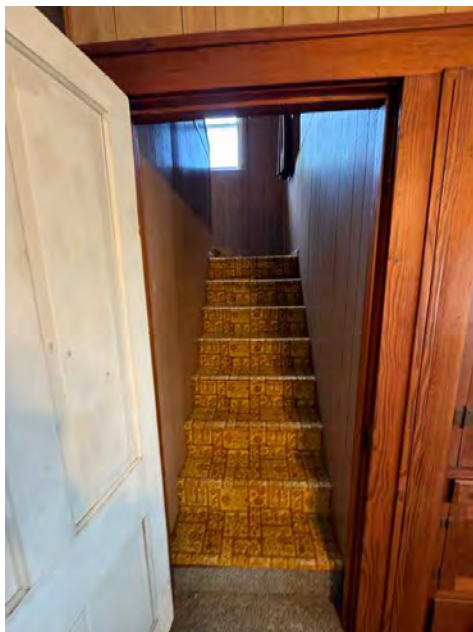
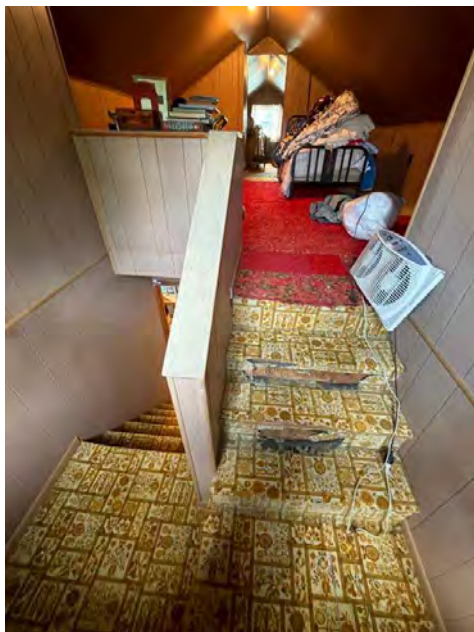
#### 10.6.1 Steps, Stairways & Railings

Staircase had no handrails. This is a safety hazard. Recommend a qualified carpenter install a handrail.

Contact a qualified carpenter.

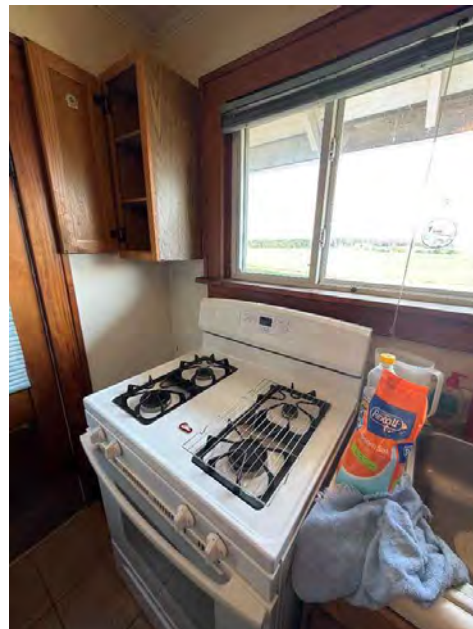
**EXHAUST SYSTEM MISSING**  
KITCHEN

No exhaust system present to prevent moisture and grease in kitchen area. Recommend qualified contractor install range hood or exhaust system.

Contact a qualified electrical contractor.

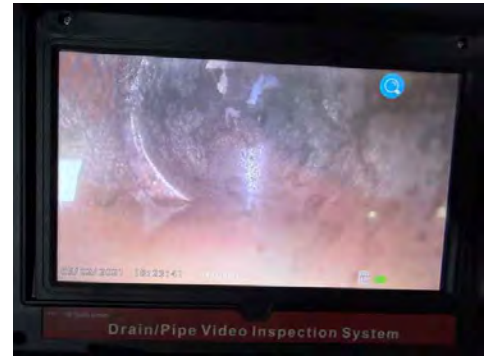
At one or more location(s) at a pipe union the pipe and fitting are offset. This can result in blockages and backups if not addressed. Recommend repair by a qualified contractor.
