## RESIDENTIAL REPORT

3851 Audrain Road 581  
Vandalia, MO 63382

07/15/2026

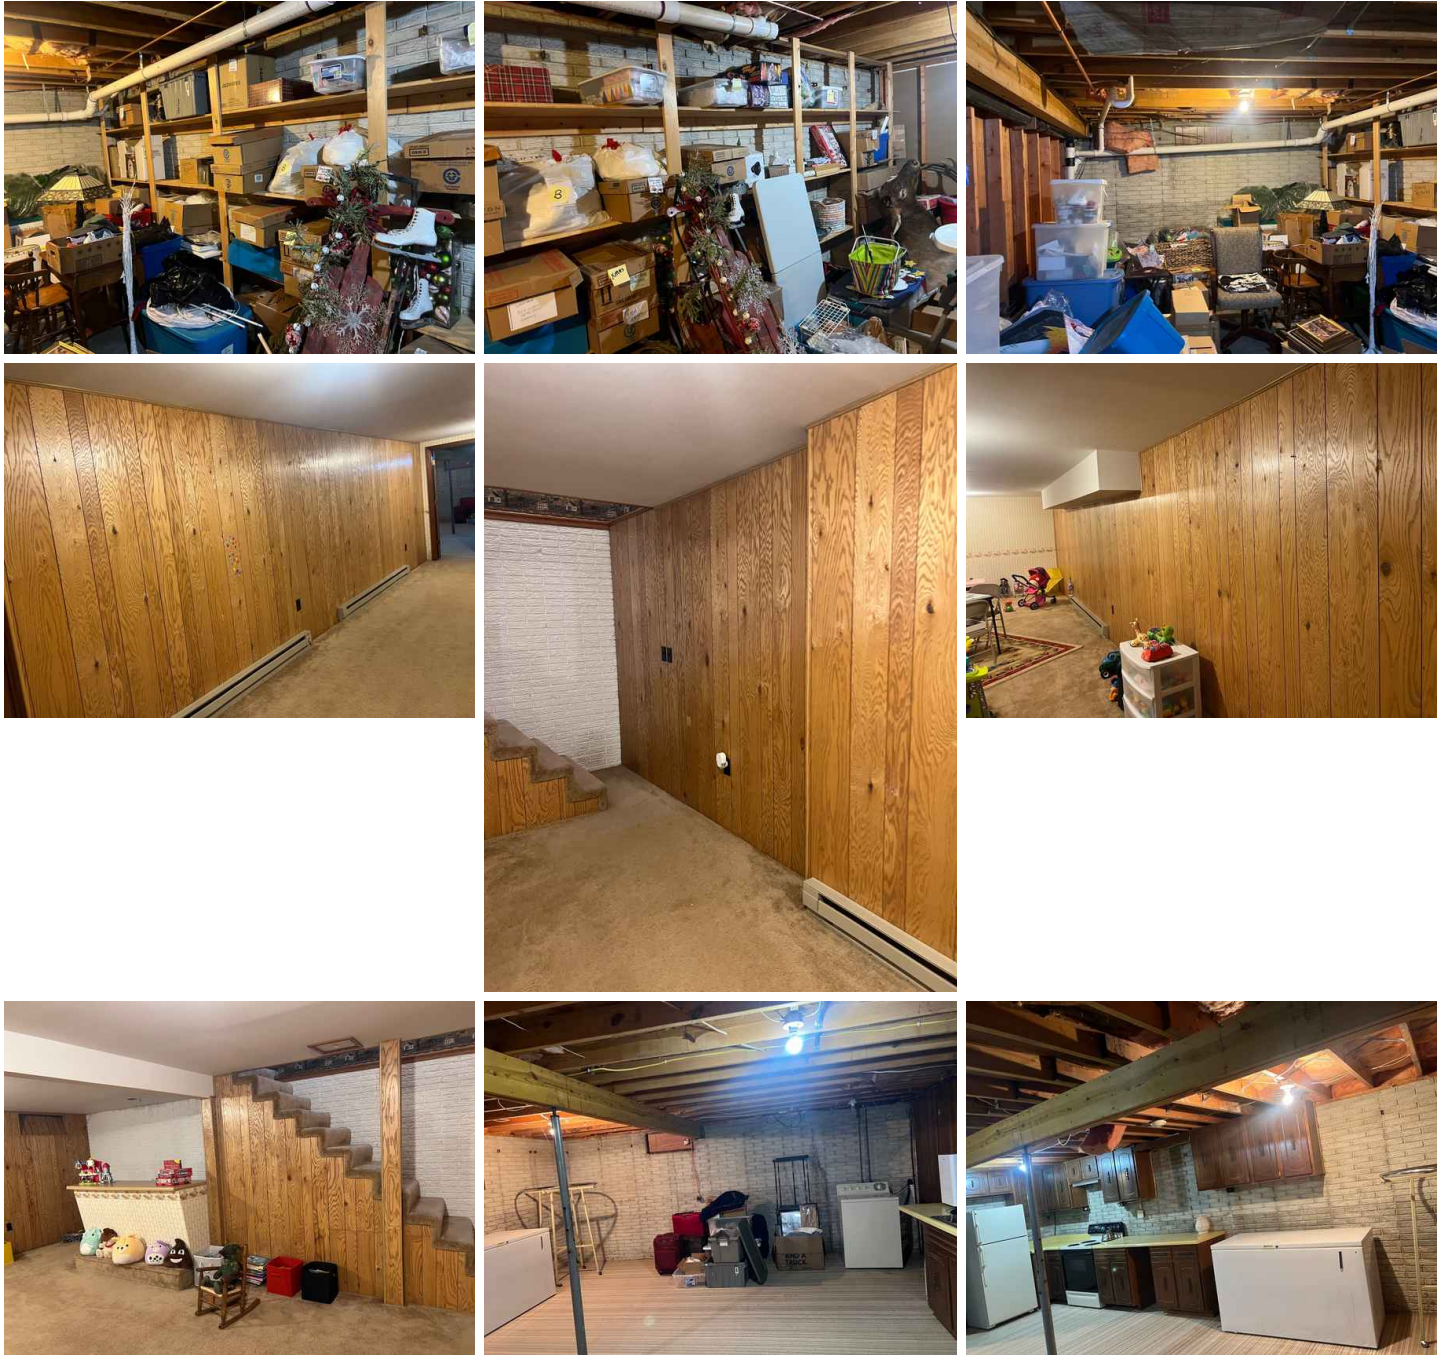
2.1.1 Foundation, Basement & Crawlspaces  
**LIMITED VISIBILITY**  
BASEMENT

View of the foundation was limited due to finish materials and stored items.

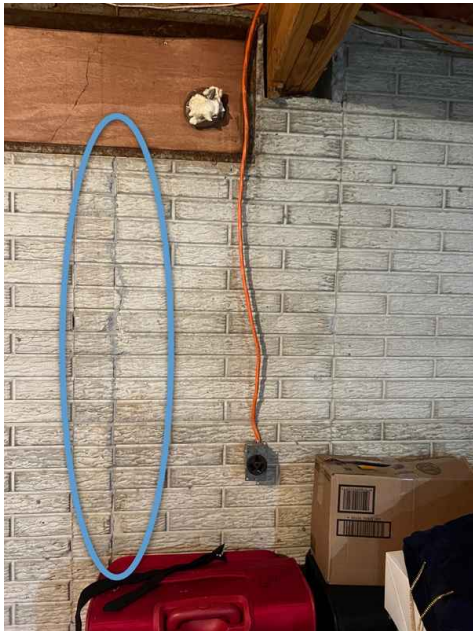
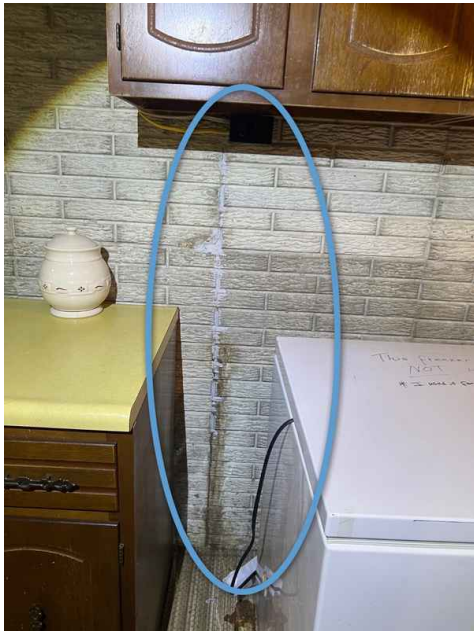
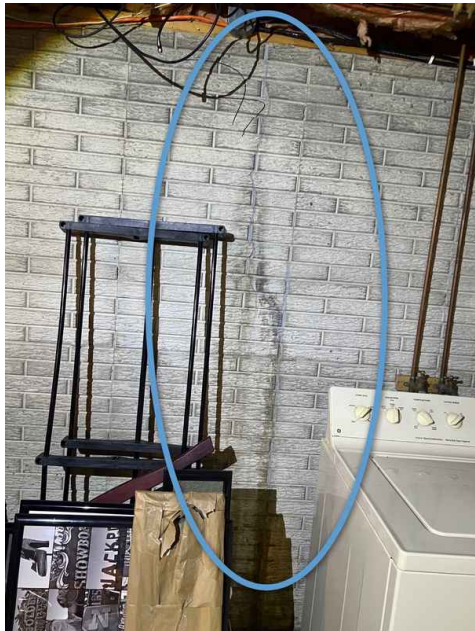
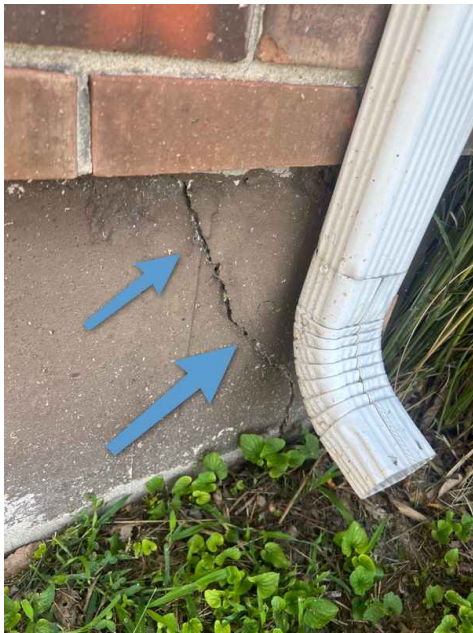
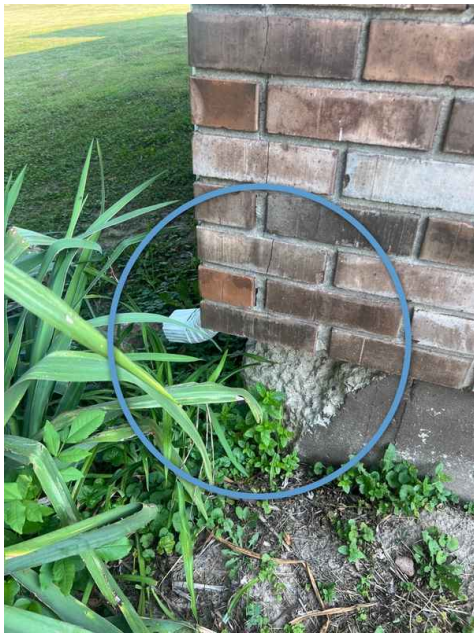
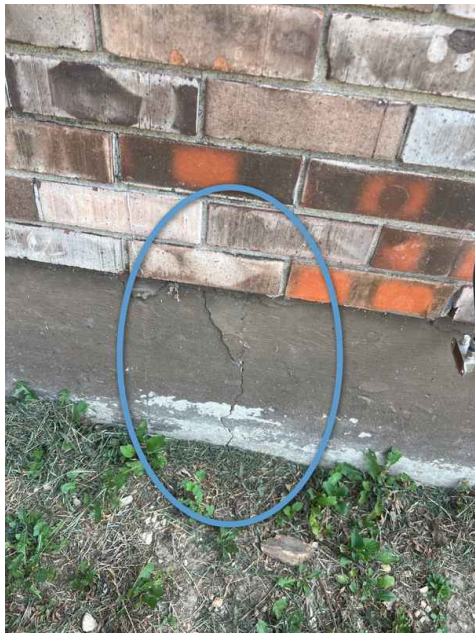
## 2.1.2 Foundation, Basement & Crawlspaces

### **TYPICAL CRACKING**

Cracking is present in the foundation walls. Cracks are typical with no evidence of structural issues.

Contact a qualified waterproofing contractor

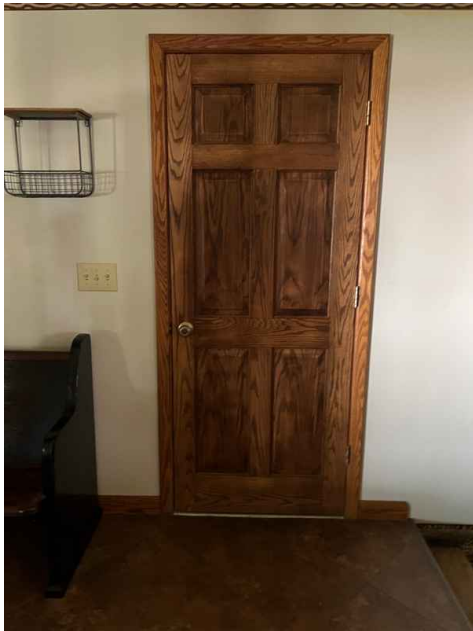
### 3.4.1 Exterior Doors

#### **NON FIRE RATED**

Recommend upgrading garage pedestrian door to a fire-rated door.

Contact a qualified professional.

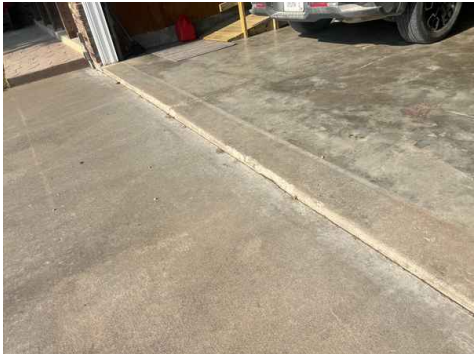
3.7.1 Walkways, Patios & Driveways

**TRIP HAZARDS**

DRIVEWAY/GARAGE FLOOR SEAM

Settlement/heaving has led to trip hazard(s).

Contact a qualified concrete contractor.

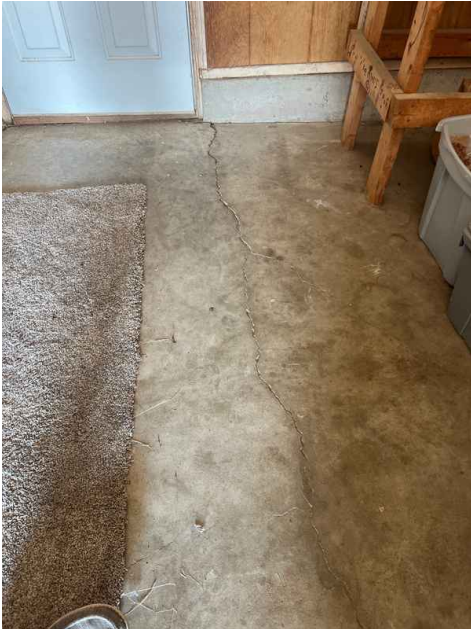
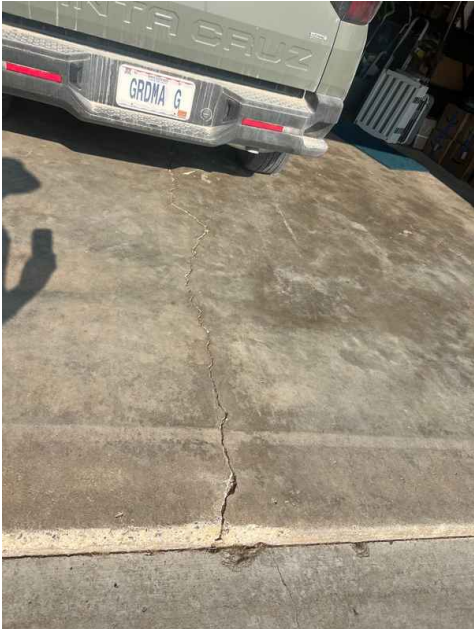
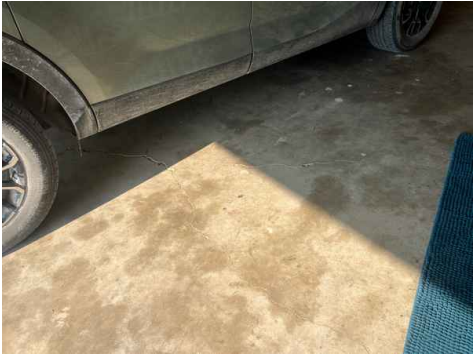
3.7.2 Walkways, Patios & Driveways

**CRACKING (TYPICAL)**

DRIVEWAY, GARAGE FLOOR

Typical cracking is present in the concrete flatwork.

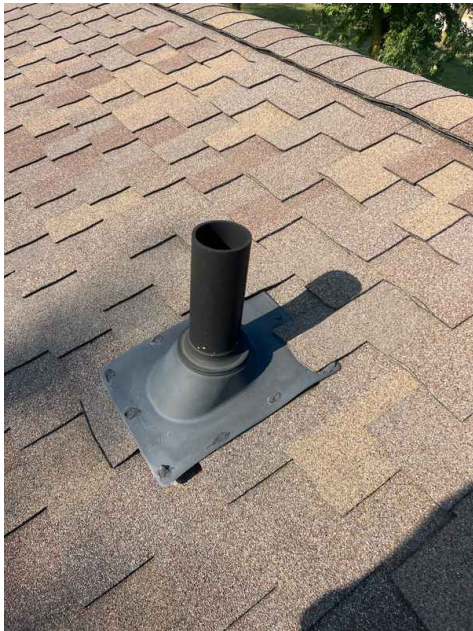
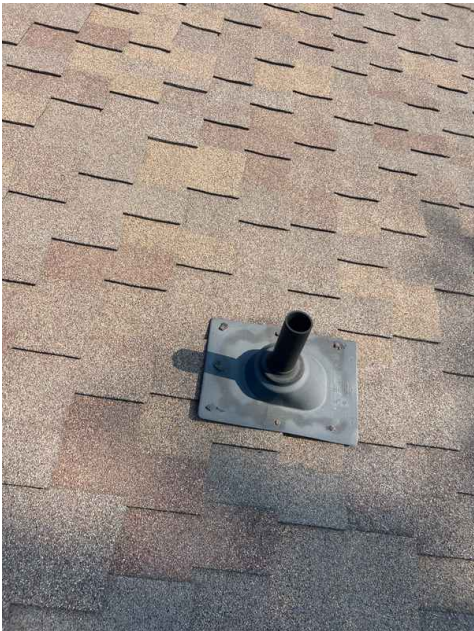
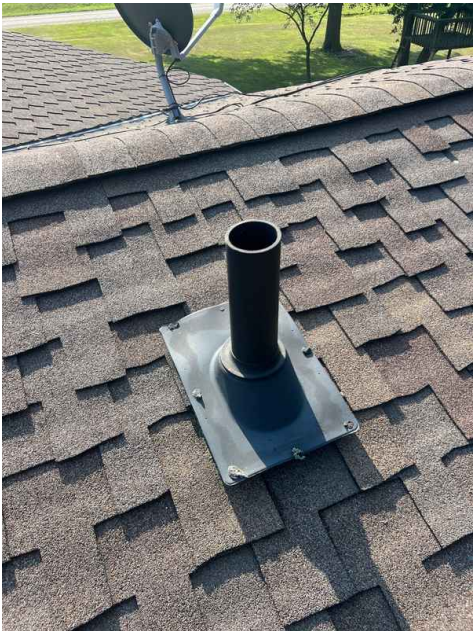
4.3.1 Flashings  
**IMPROPER INSTALLATION**  
ROOF

Plumbing vent flashing is improperly installed. Recommend replacement by a qualified roofing contractor.

Contact a handyman or DIY project

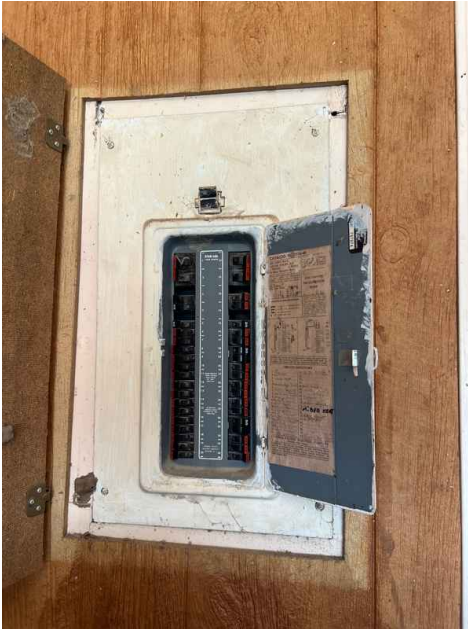
5.2.1 Service and Grounding Equipment, Main Overcurrent Device, Main and Distribution Panels

OBSOLETE AND DEFECTIVE PANELS

Replacement required to the Federal Pacific Stab-lok electric panel for due to several documented failures and fires associated with the panels.

Contact a qualified electrical contractor.

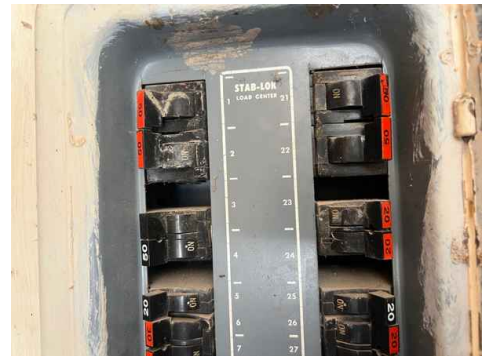
### 5.2.2 Service and Grounding Equipment, Main Overcurrent Device, Main and Distribution Panels

#### **OPEN KNOCKOUT**

Replacement required to the open knockout(s) present in the panel covers for safety purposes.

Contact a handyman or DIY project

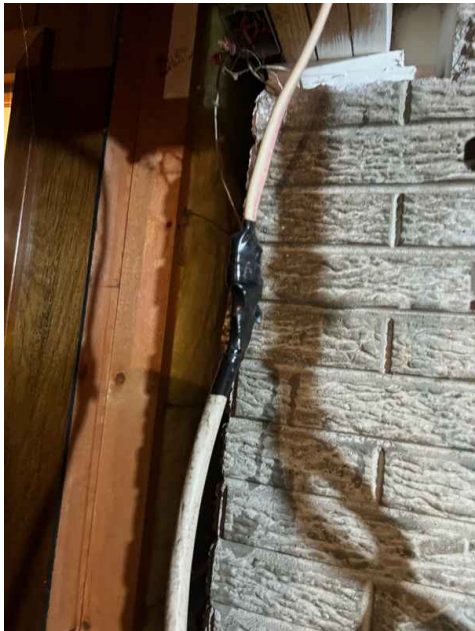
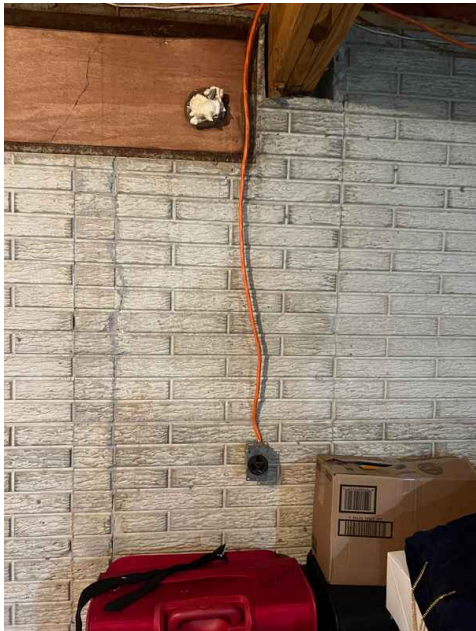
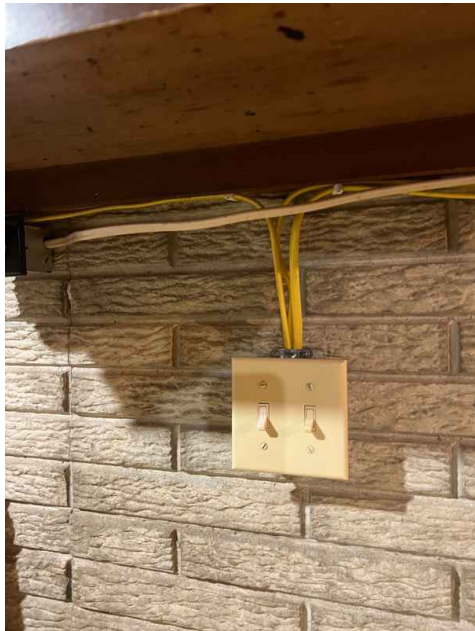
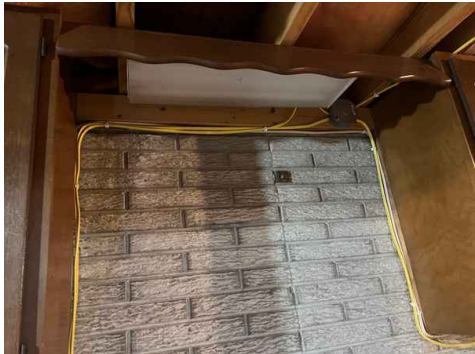
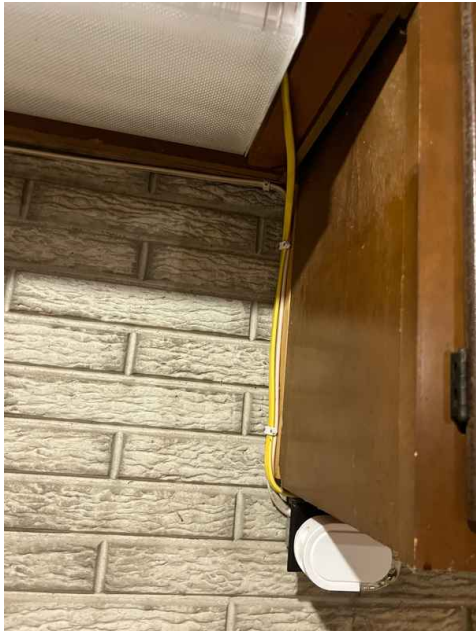
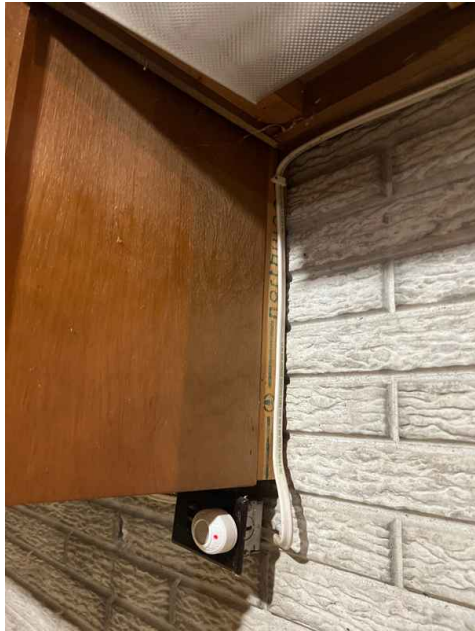
### 5.3.1 Branch Circuit Conductors, Overcurrent Devices and Compatibility of Their Amperage & Voltage

#### **IMPROPER WIRING**

Improperly run and unsecured wiring is present in the unfinished basement. Recommend repairs by a qualified electrical contractor for safety purposes.

Contact a qualified electrical contractor.

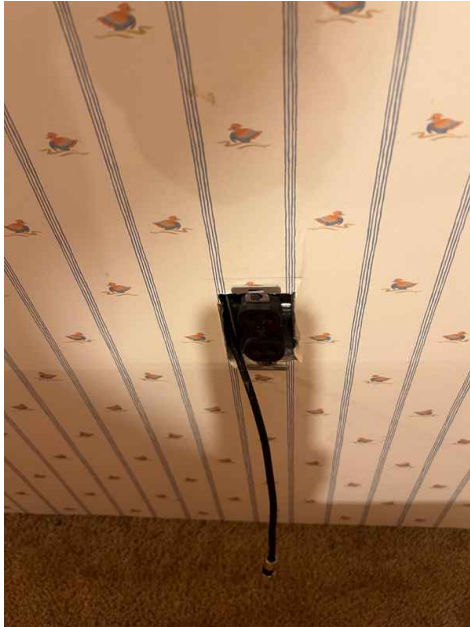
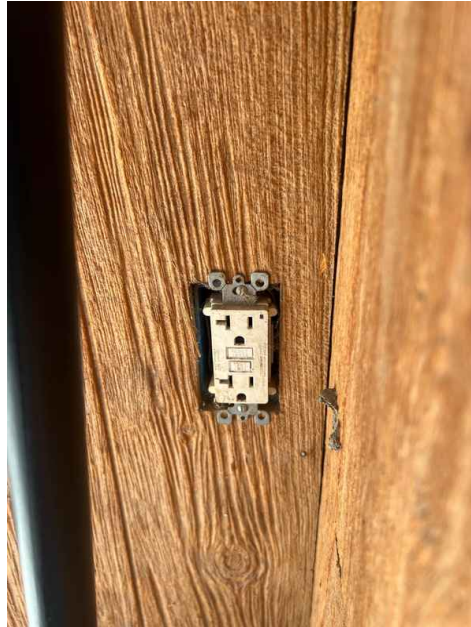
## 5.4.1 Connected Devices and Fixtures

**COVER PLATES MISSING**

Receptacles(s)/Switch(s) are missing a cover plate(s). Open wiring is a shock risk. Recommend installation of cover plates for safety purposes.

Contact a handyman or DIY project

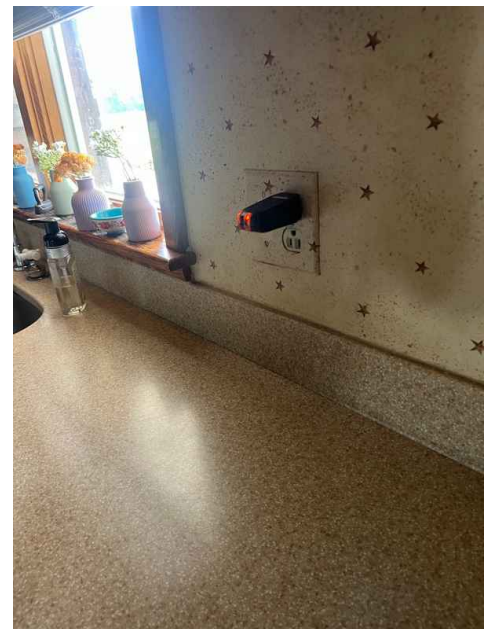
## 5.6.1 GFCI &amp; AFCI

**NO GFCI PROTECTION INSTALLED**

KITCHEN

GFI protection is not present at all required locations. Recommend qualified electrical contractor install GFI protection for safety purposes

Contact a qualified electrical contractor.

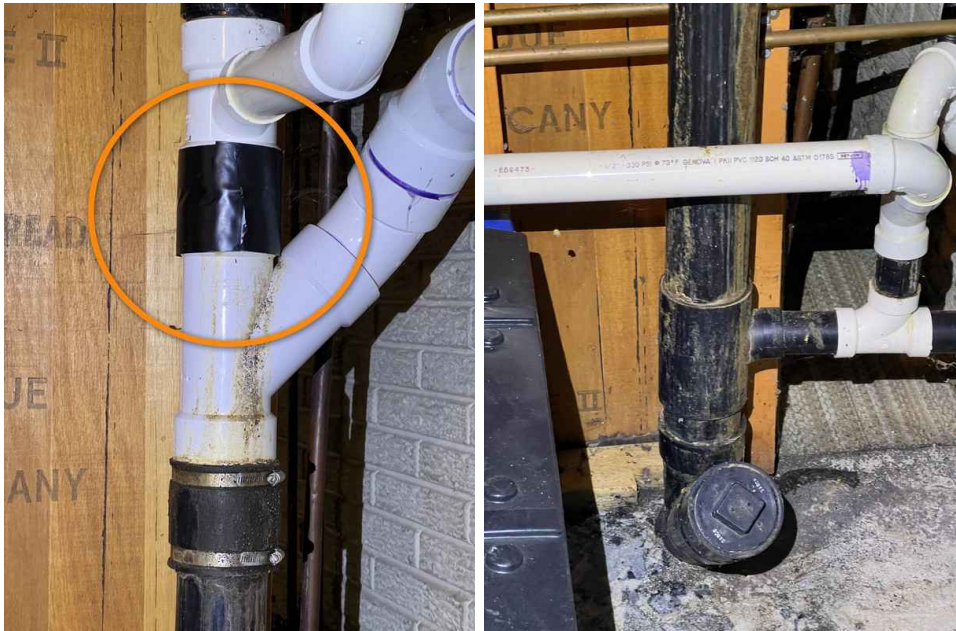
### 6.2.1 Drain, Waste, & Vent Systems

#### **IMPROPER DRAIN REPAIRS**

##### WASTE STACK

Improper repairs and evidence of leaking are present on the main waste stack. Recommend proper repairs.

Contact a qualified professional.

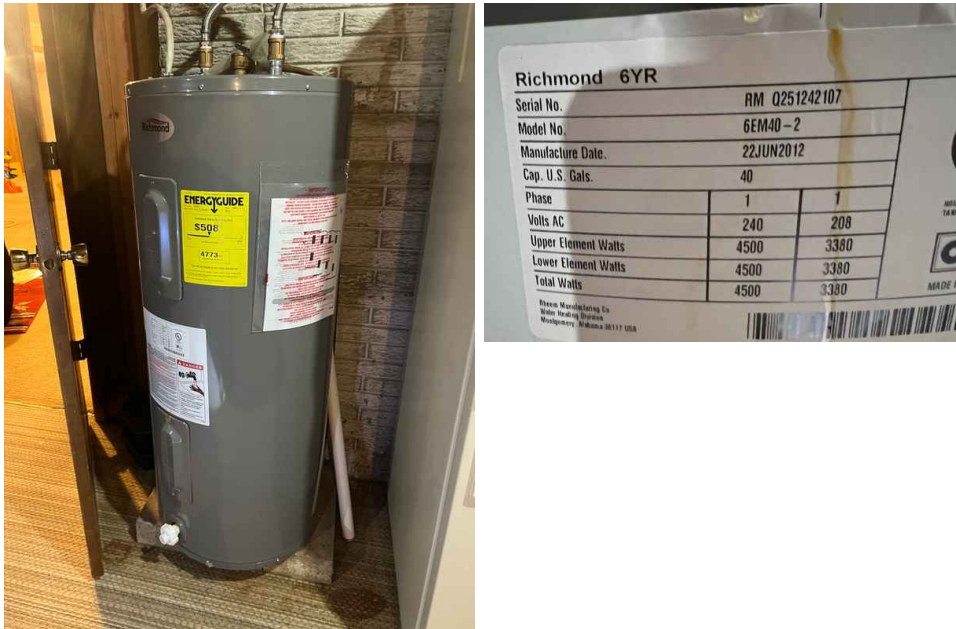
6.4.1 Water Heater

**BEYOND DESIGN LIFE**

Unit is in working order but beyond design life. Recommend upgrading for efficiency purposes.

Recommendation  
Contact a qualified plumbing contractor.

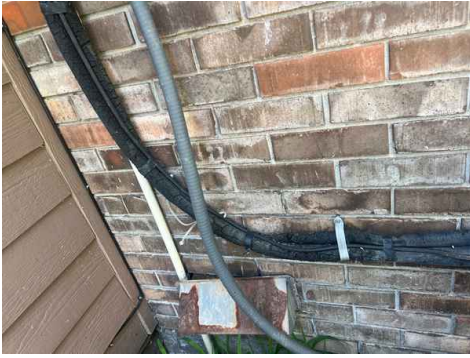
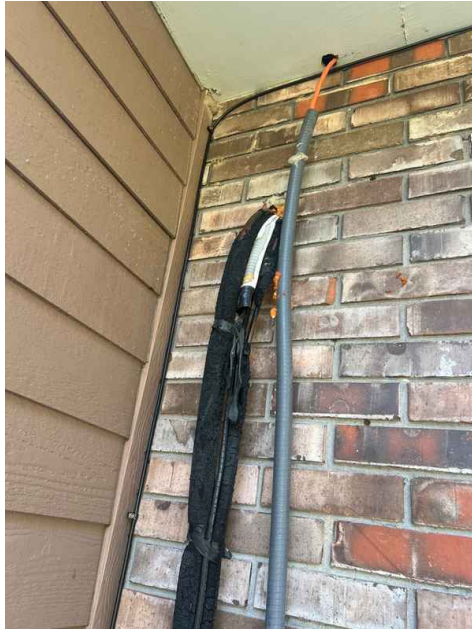
8.1.1 Cooling Equipment

INSULATION MISSING OR DAMAGED

Recommend replacing the deteriorated/missing line insulation and sealing the entry area for efficiency purposes.

Contact a handyman or DIY project

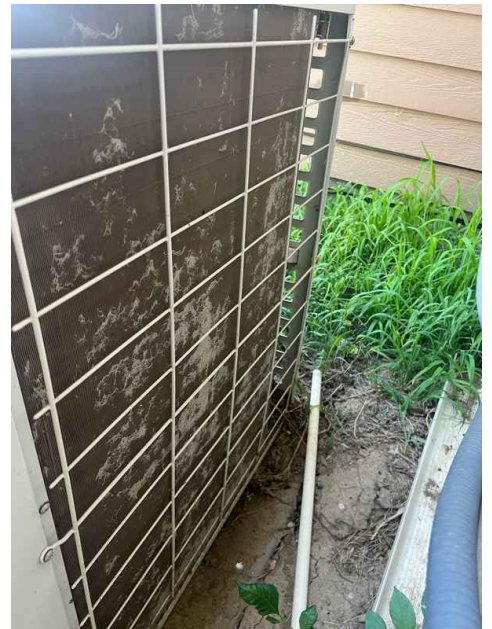
#### 8.1.2 Cooling Equipment

### MAINTENANCE AND CLEANING

System(s) are in need of maintenance and cleaning. Exterior coils are dirty.

Contact a qualified HVAC professional.

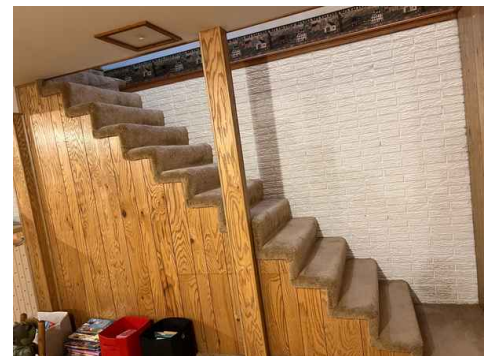
#### 9.4.1 Steps, Stairways & Railings

##### UNSAFE OPENINGS

Rail openings are not up to safety standards. Openings should not exceed 4".

Contact a handyman or DIY project

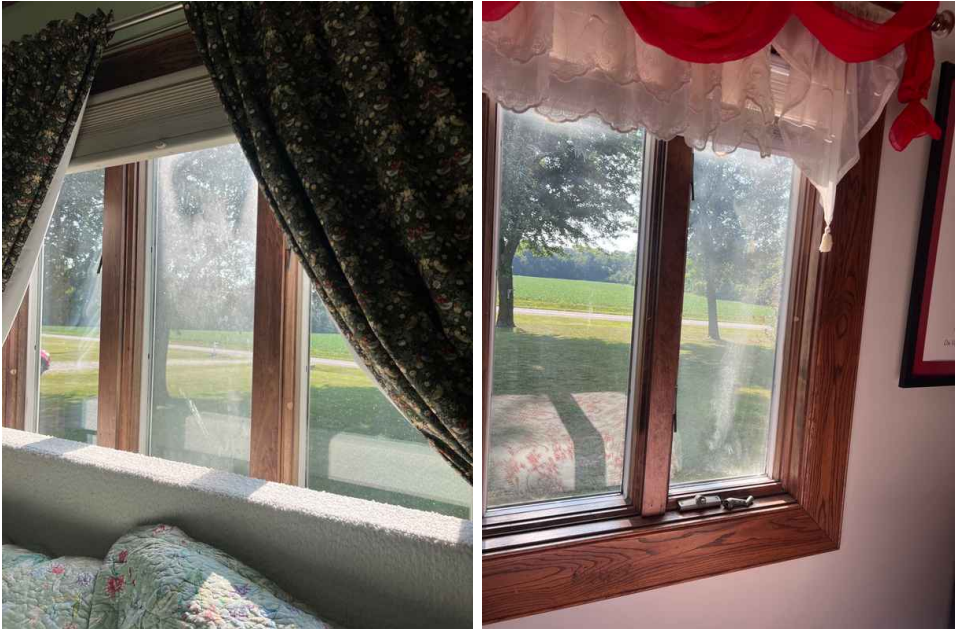
#### 9.7.1 Windows

##### FAILED SEAL(S)

BEDROOMS

Window pane(s) appear fogged due to failed seals. Recommend further evaluation and an estimate of replacement by a qualified contractor. Due to interior and exterior conditions failed seals may not be detectable at the time of the inspection.

Contact a qualified professional.

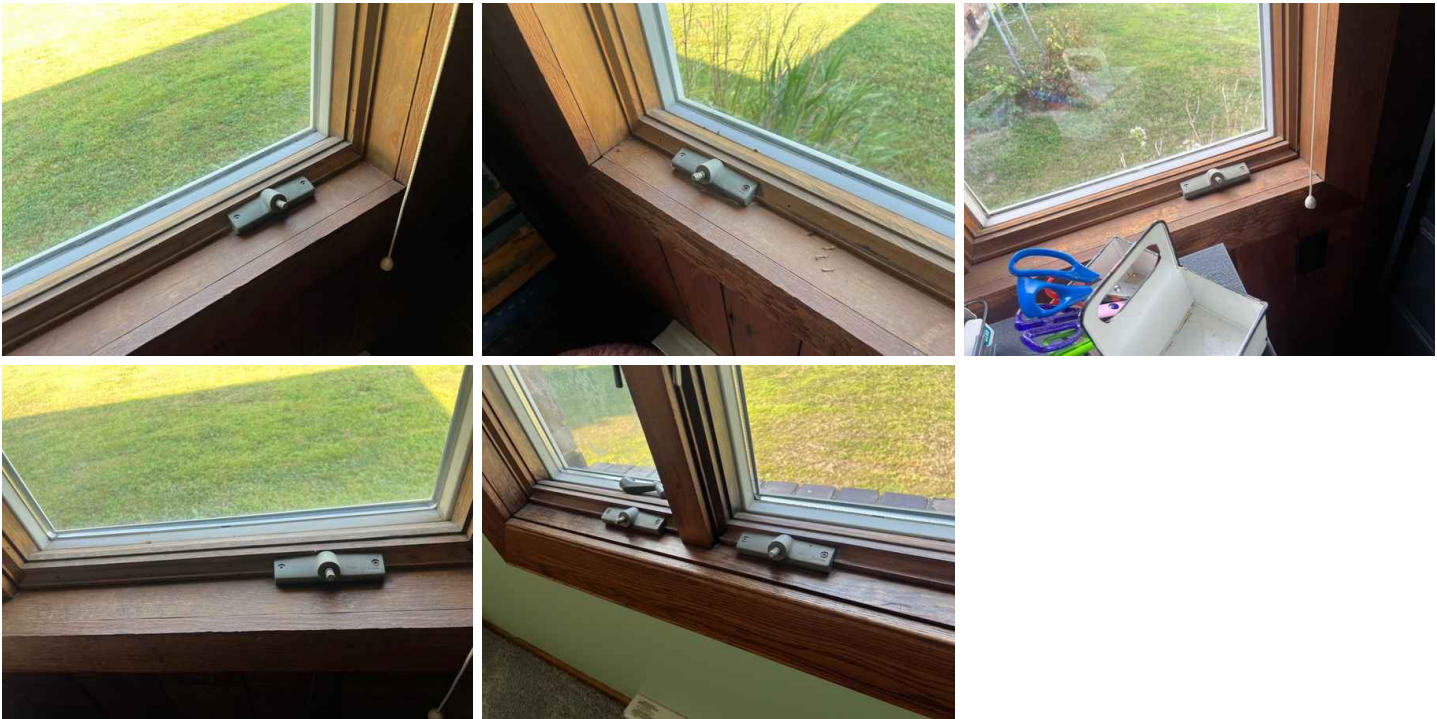
9.7.2 Windows

**MISSING/DAMAGED HARDWARE**

WINDOW CRANK HANDLES

Repairs or replacement to missing/damaged hardware.

Contact a qualified professional.
