## Property Inspection Report

LOCATED AT:  
16508 Hailey Ct  
Tyler, TX 75703

INSPECTED ON:  
Wednesday, February 11, 2026

Inspector, Dominic Cacciapaglia 22932  
B2K Inspections

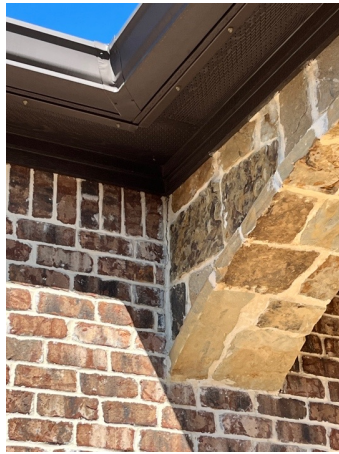
24: Minor cracks noted in areas. Grout could use repointing in these areas

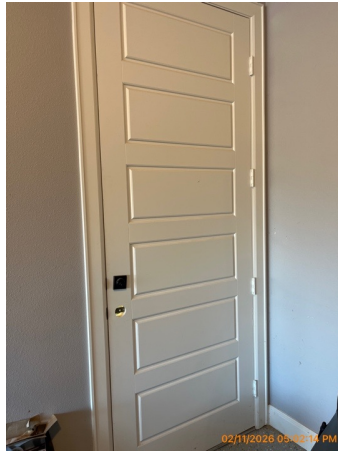
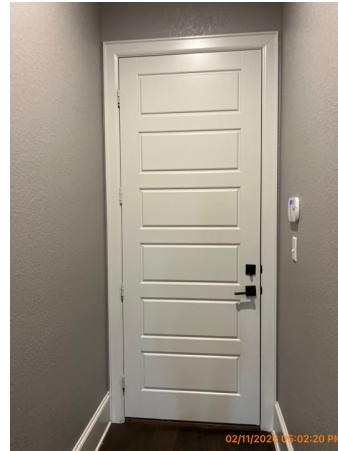
29: The both of the exterior doors between the house and the attached garage (garage man-doors) are not equipped with self-closing hinges. The purpose of these is to slow the spread of a fire from the garage to the house and to prevent gases such as car fumes and/or carbon monoxide from having a passage into the house by ensuring the door is closed while not in use.

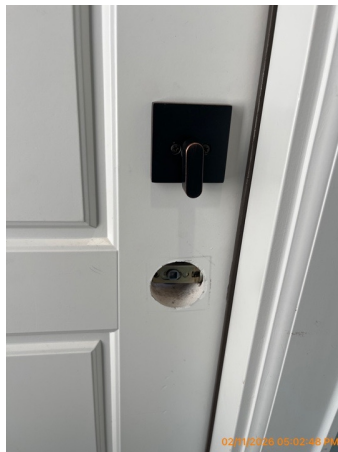
30: Door between laundry/bathroom and garage lacks a doorknob

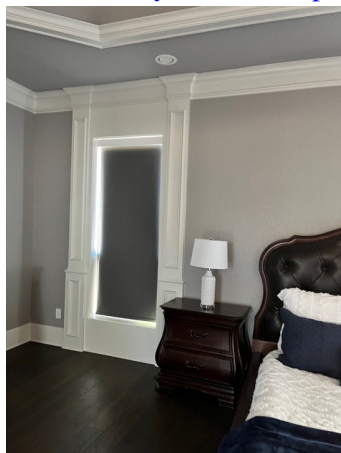
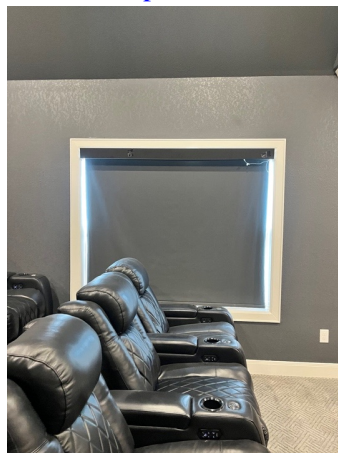
37: Unable to operate automatic blinds in theatre room and left side window of master bedroom.

Batteries may be dead, or proper remotes to operate were unable to be located

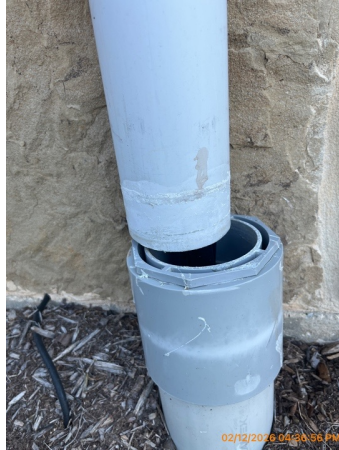
**49: Conduit separated**

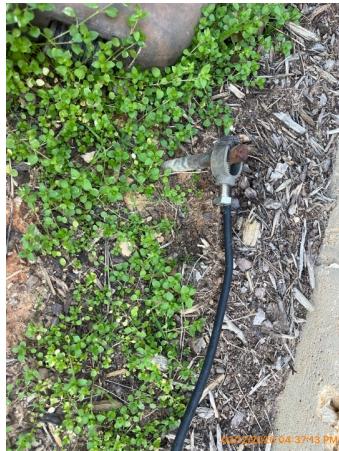
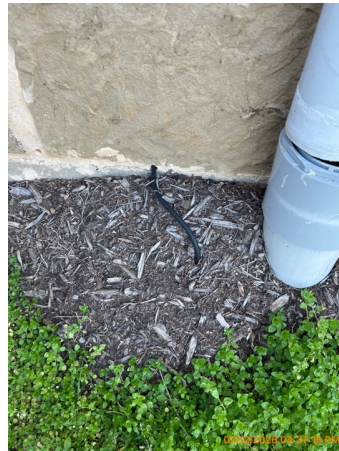
**50:** The earth ground is connected to a copper rod driven into the ground. A second appears to be buried nearby

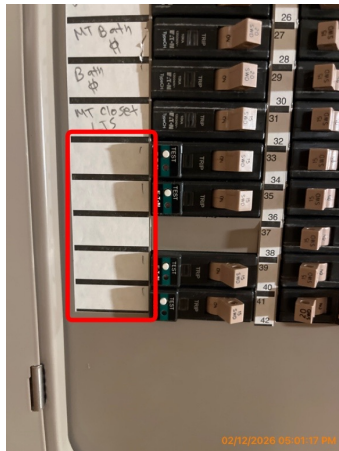
54: GENERAL: The service panel is not fully labeled.

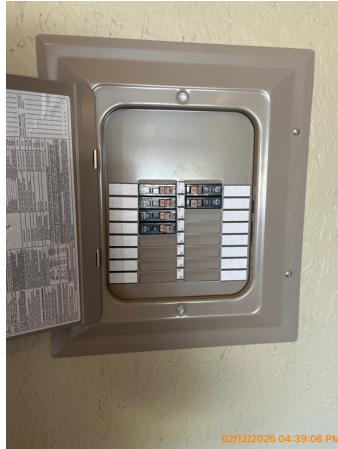
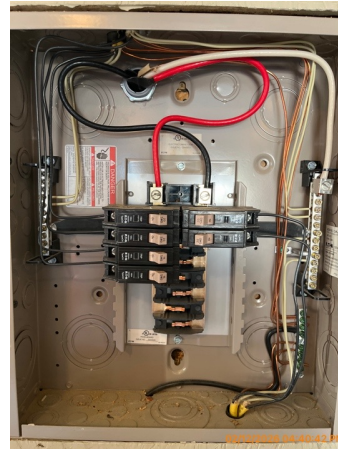
75: General images:

74: There is a subpanel present in the detached garage. All comments made below will be on this panel.

76: GENERAL: The sub panel is in good condition with circuitry installed and fused correctly.

77: GENERAL: There is room for additional breakers.

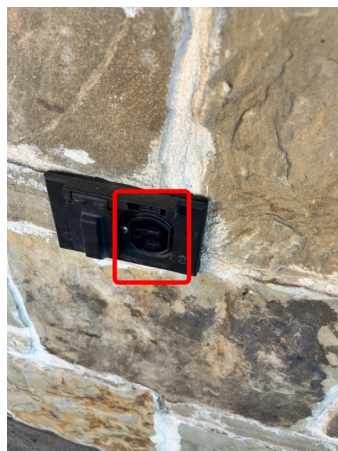
**92: GFCI receptacles near pool lack outdoor covers**

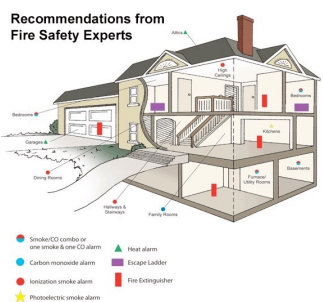
**94: Smoke detectors not present in all areas required. (Mounts present, but detectors missing in two upstairs bedrooms)**

One is required in each bedroom. One in each hallway adjacent to each sleeping area and at least one on each floor if more than one story. Alarm system connected detectors and heat detectors do not count toward the minimum.

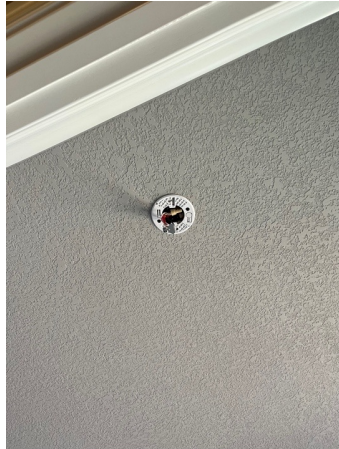
**95:** Carbon monoxide detectors present in all required locations

**96:** Recommend owner change batteries in the smoke detectors (and carbon monoxide detectors if present) and verify proper operation after the installation of new batteries, as part of move in procedure.

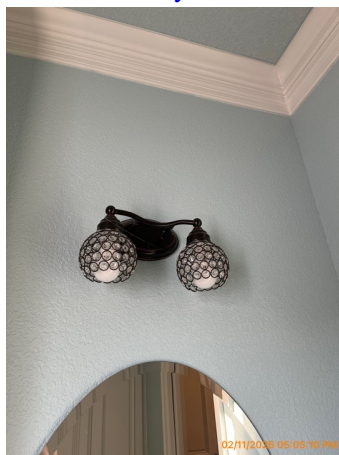
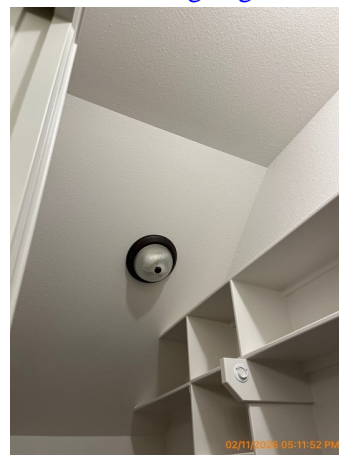
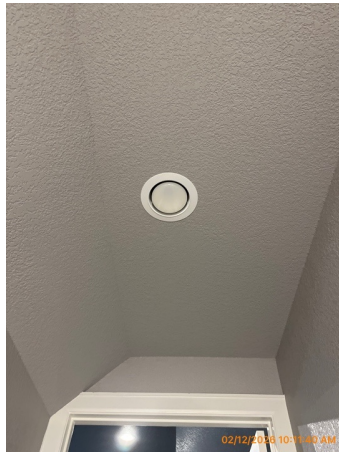
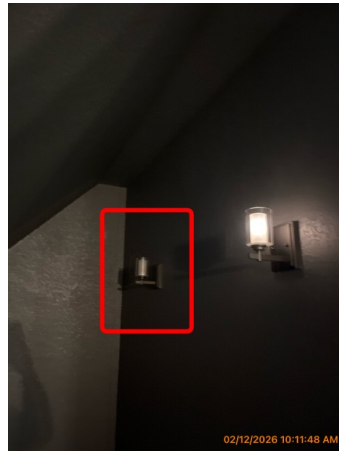
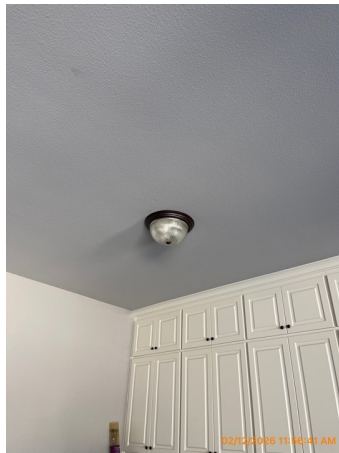
**98:** Some lights where inoperative at time of inspection.

Locations: bathroom between laundry room and garage, downstairs back right bedroom closet, stairway near theater, theater room, main garage

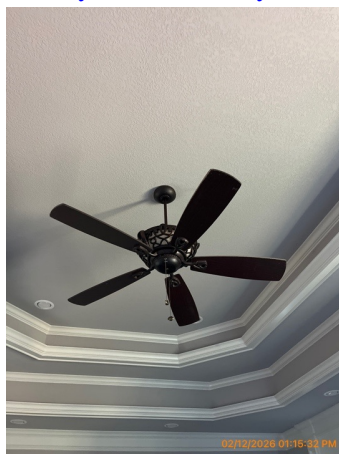
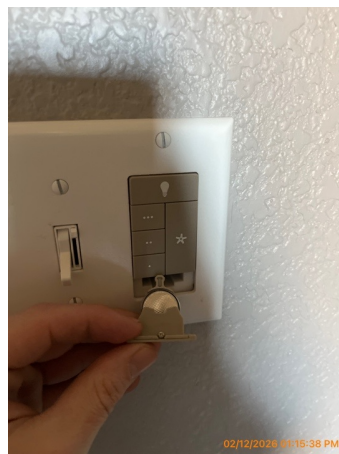
99: Ceiling fan/light in master bedroom were inoperative.  
Battery in control may be dead.

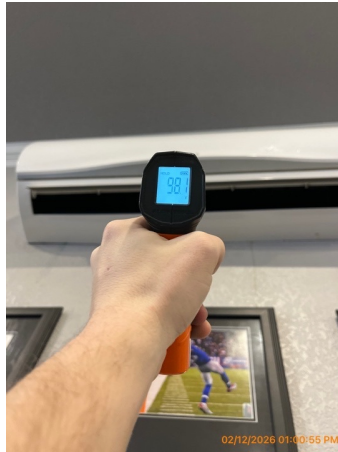
164: Heated air supply temperature:

160: Unit failed to function when set to heat.  
Recommend evaluation by specialist and repair as necessary

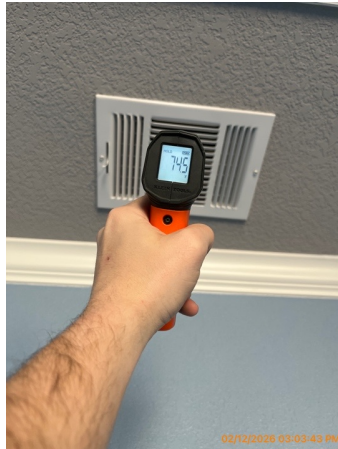
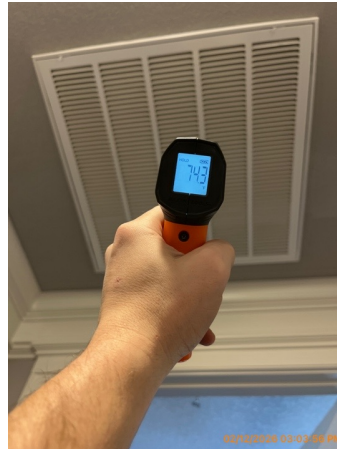
**196:** Failed to respond to user controls. Blower operated, but condensing unit did not turn on when thermostat was set to cool.

Recommend evaluation by specialist and repair as necessary.

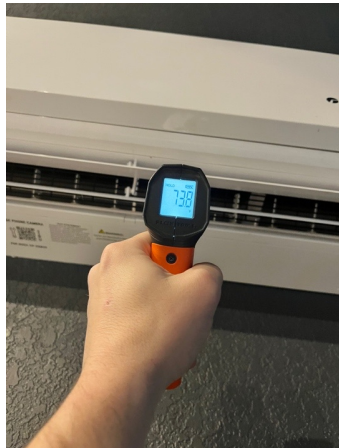
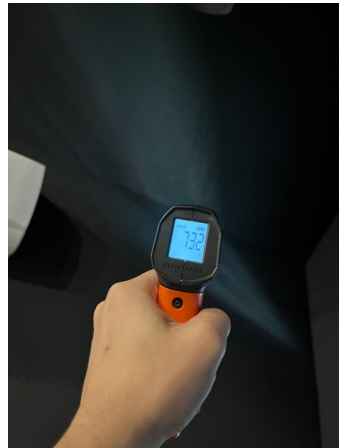
**204:** When set to cool, air blew from mini split but was not cooling  
Recommend evaluation by specialist

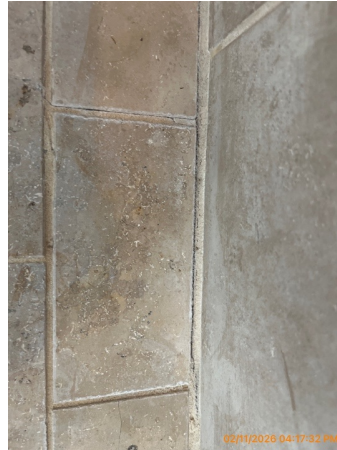
**234:** Minor cracks in grout and some cracked tiles noted in master shower

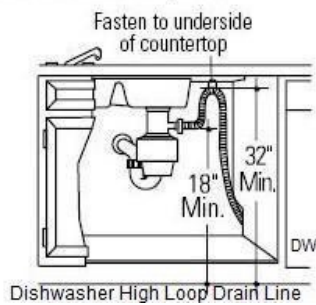
**281:** Dishwasher lacks air gap or backflow loop or the loop is not elevated high enough. This is considered a deficiency.

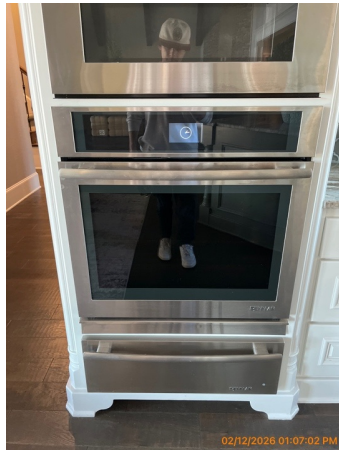
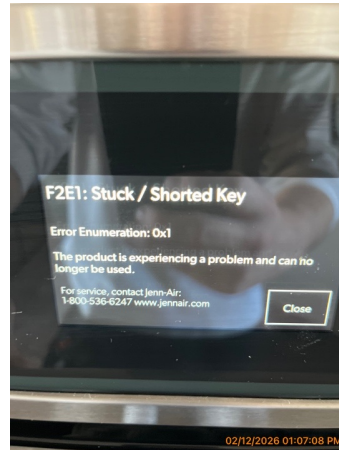
**287:** Left side oven was inoperative and had error code

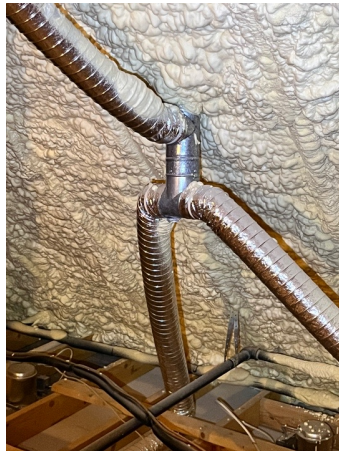
**291:** Three bathroom vent fan ducts share the same penetration through the roof. Some jurisdictions forbid this sort of installation due to the possibility of backdrafting, unless each has a back-draft damper. Unable to determine if present

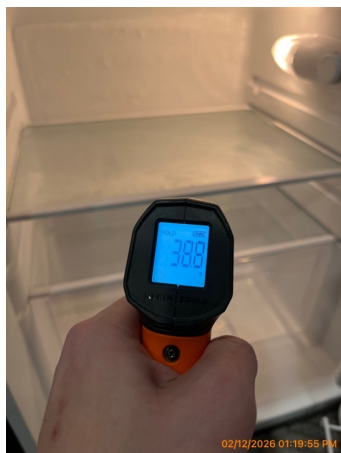
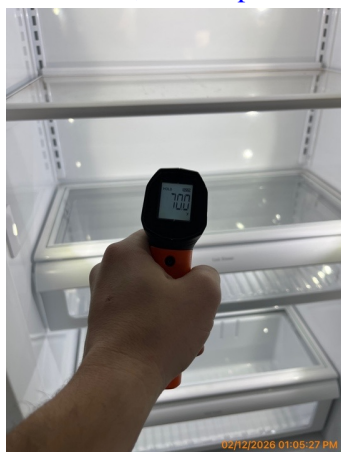
**301:** Refrigerator side of kitchen refrigerator was not cooling properly at the time of inspection.

Set to 33 F, but temp at 71 F

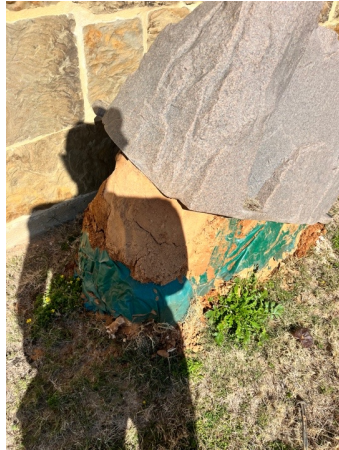
305: Cover for backflow preventer was completely filled with dirt (maybe from ants).  
Dirt should be cleared so valves are made accessible

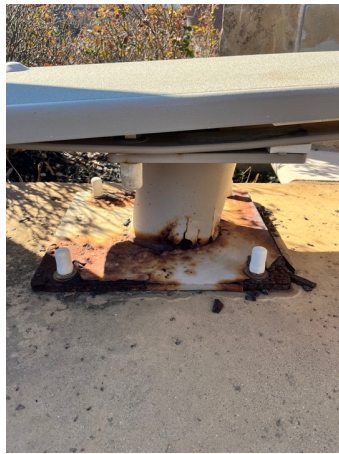
**311:** Diving board is rusted at the base.

Note that water slides and diving boards have a history of safety issues.

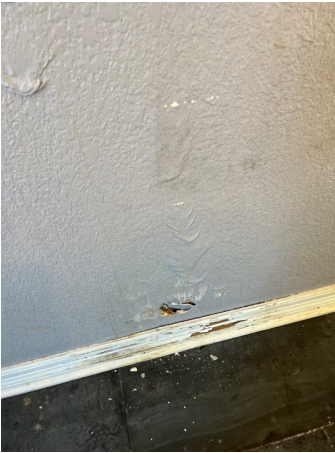
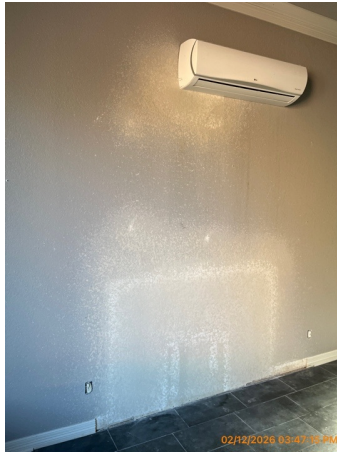
s-21: Wall in man cave showed signs of previous moisture damage on first day of inspection (subsequent to previous leakage of the mini split on this wall).

The wall was repaired during the second day of inspection (not subcontractors of B2K). Repair work appears to be satisfactory.

No evidence of active leak at time of inspection.

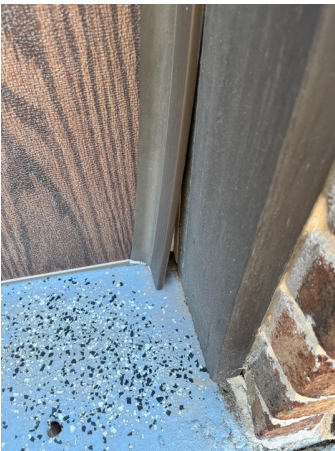
s-23: Lower ends of some weather strips coming loose near the overhead garage doors

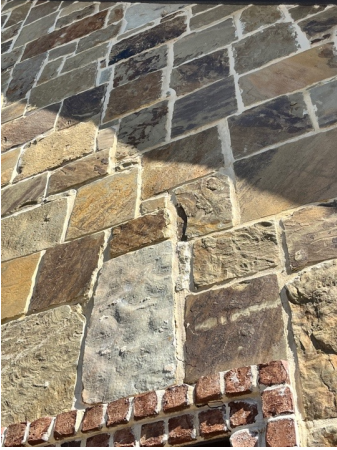
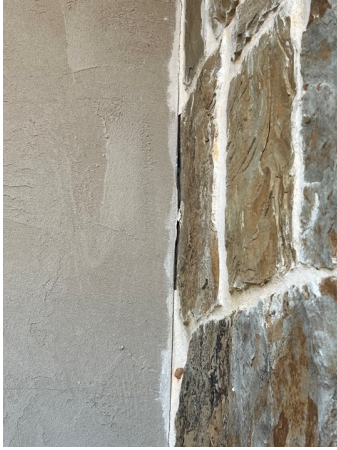
s-24: Minor cracks noted in areas. Grout could use repointing in these areas

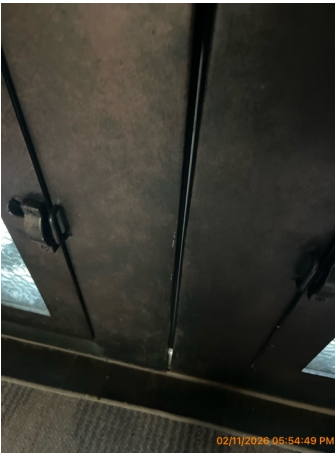
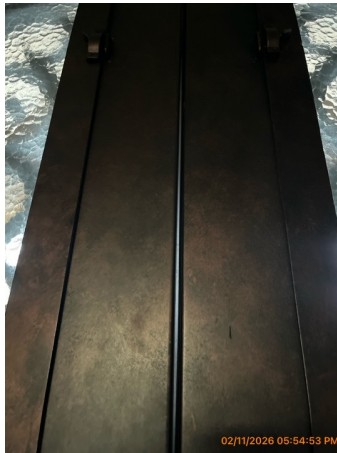
s-28: Front door doesn't seal tightly against weatherstripping when closed. Light seen through gap.

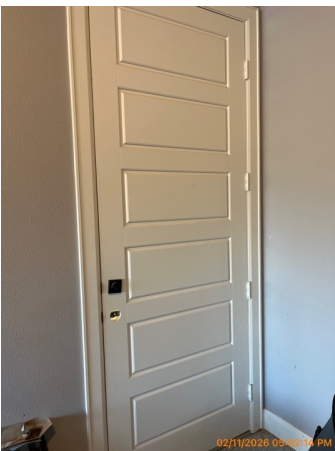
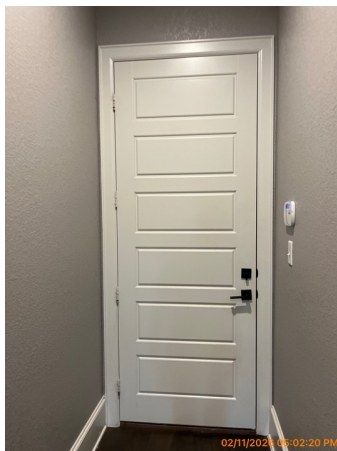
s-29: The both of the exterior doors between the house and the attached garage (garage man-doors) are not equipped with self-closing hinges. The purpose of these is to slow the spread of a fire from the garage to the house and to prevent gases such as car fumes and/or carbon monoxide from having a passage into the house by ensuring the door is closed while not in use.

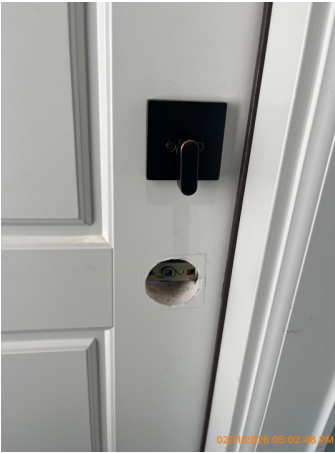
s-30: Door between laundry/bathroom and garage lacks a doorknob

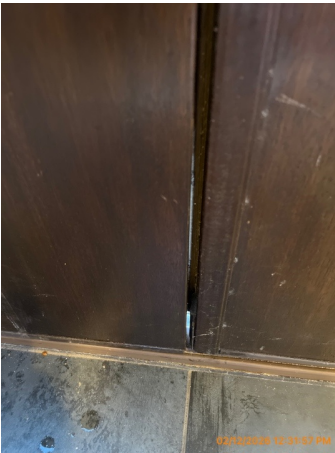
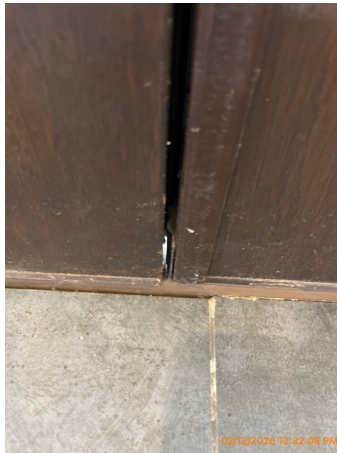
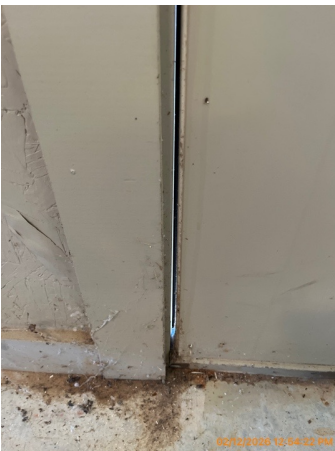
s-31: Multiple exterior doors have minor gaps where light can be seen through weather stripping (Man cave, upstairs bedroom, detached garage etc).

We recommend all doors seal tightly to keep outside moisture/air out

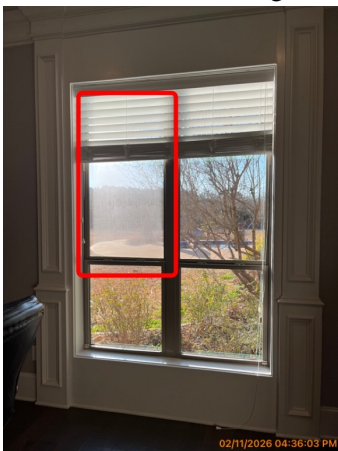
Master bedroom

**s-35:** Some windows show a speckled, iridescent effect. This is not a seal failure allowing condensation but rather the low-e (uv blocking) coating failure.

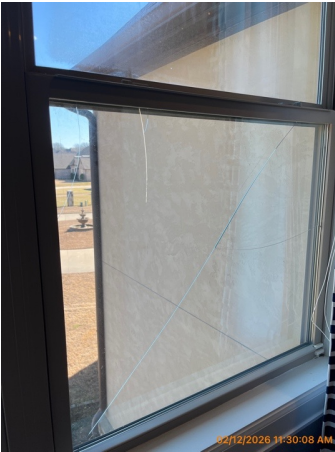
**s-36:** Window in upstairs right side bedroom has broken glazing

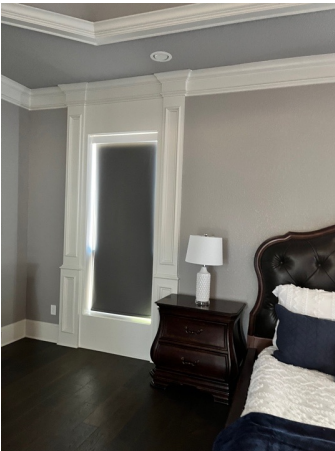
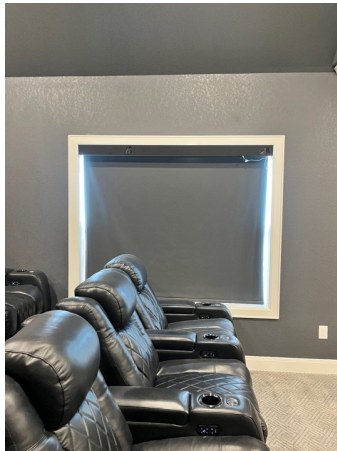
**s-37:** Unable to operate automatic blinds in theatre room and left side window of master bedroom. Batteries may be dead, or proper remotes to operate were unable to be located

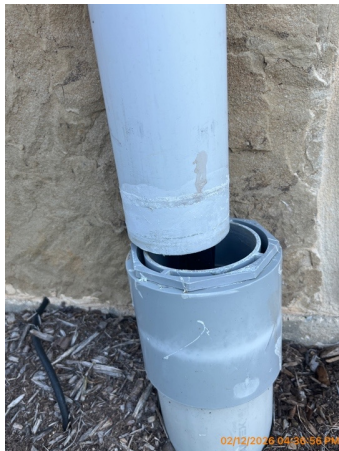
s-49: Conduit separated

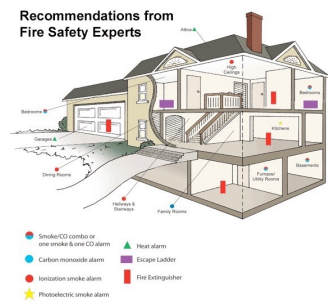
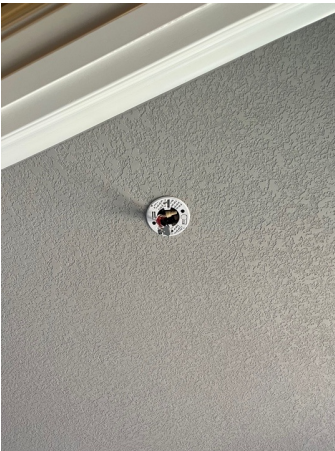
s-94: Smoke detectors not present in all areas required. (Mounts present, but detectors missing in two upstairs bedrooms)

One is required in each bedroom. One in each hallway adjacent to each sleeping area and at least one on each floor if more than one story. Alarm system connected detectors and heat detectors do not count toward the minimum.

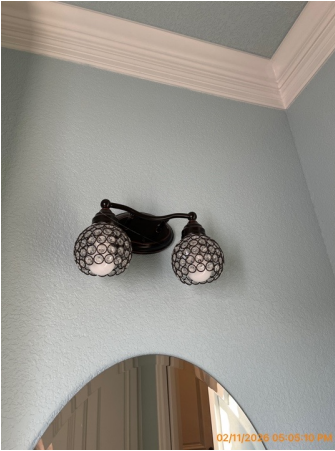
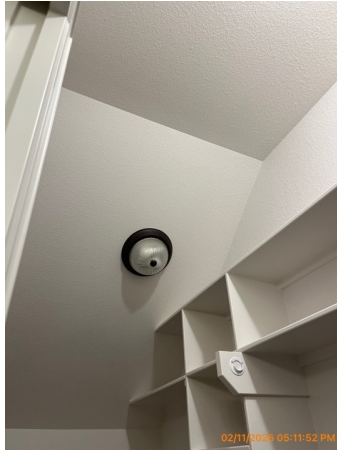
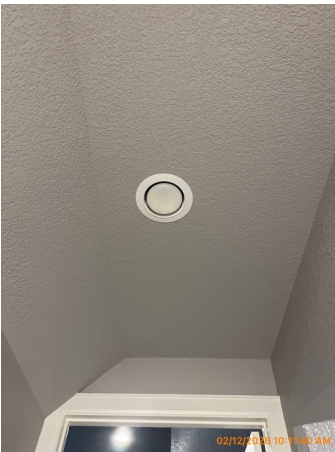
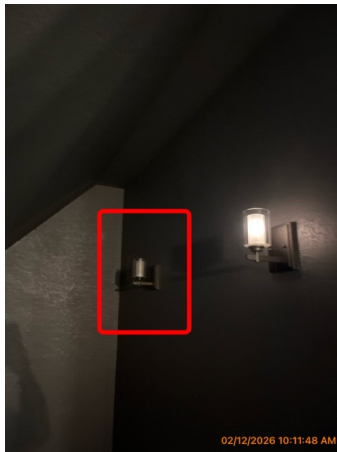
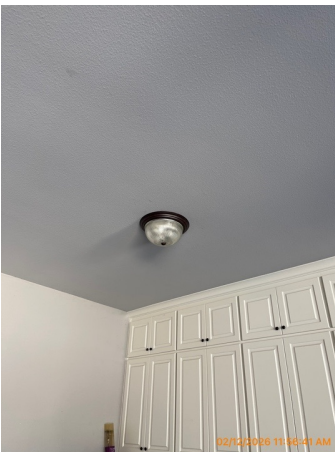
s-98: Some lights where inoperative at time of inspection.

Locations: bathroom between laundry room and garage, downstairs back right bedroom closet, stairway near theater, theater room, main garage

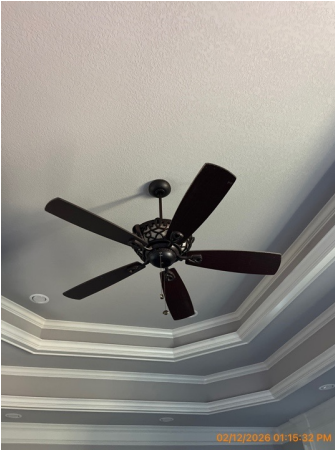
s-99: Ceiling fan/light in master bedroom were inoperative.  
Battery in control may be dead.

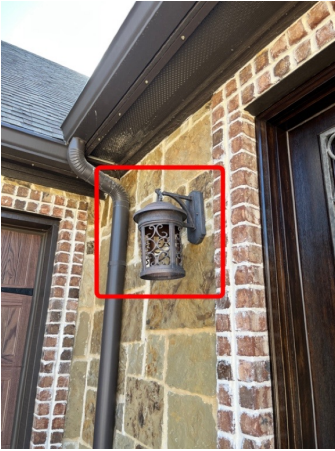
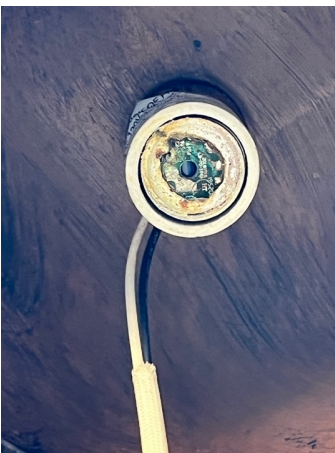
s-100: Some exterior lights were inoperative. Likely need new bulbs.  
Fixture at front porch appears it has the base of a broken bulb stuck in the socket

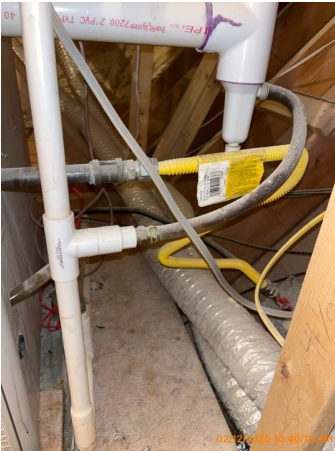
**s-124:** The fuel piping does not include a 'T' extension to collect condensation and debris, as is considered good practice. In the course of future upgrading or repair, a 'drip leg' should be added to the gas piping just ahead of the connector.

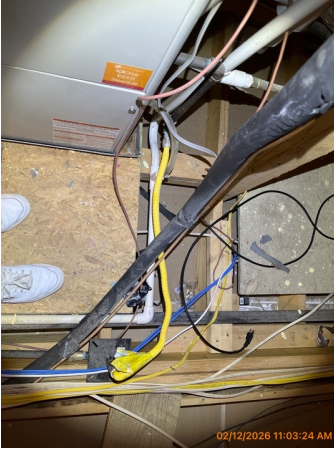
**s-142:** The fuel piping does not include a 'T' extension to collect condensation and debris, as is considered good practice. In the course of future upgrading or repair, a 'drip leg' should be added to the gas piping just ahead of the connector.

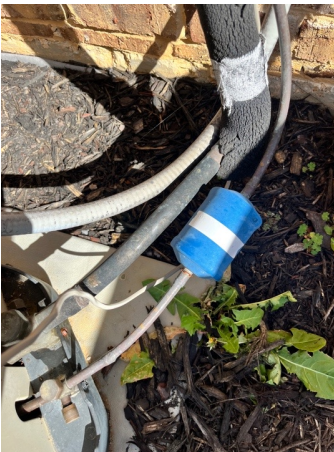
**s-176:** Insulation is deteriorated and missing from portions of the refrigerant lines in areas. We recommend that all missing insulation be replaced to increase energy efficiency.

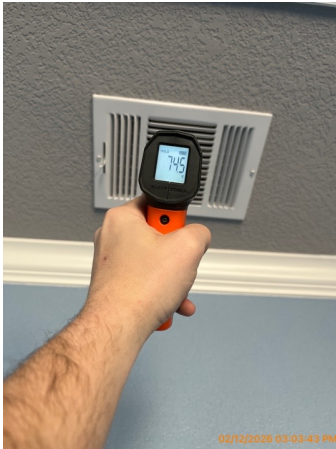
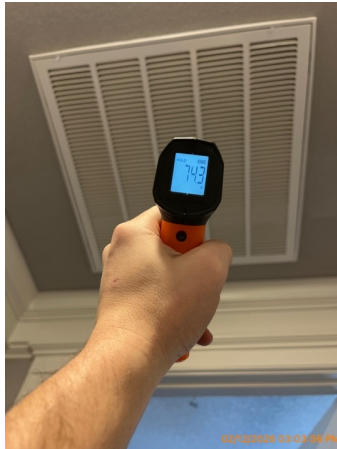
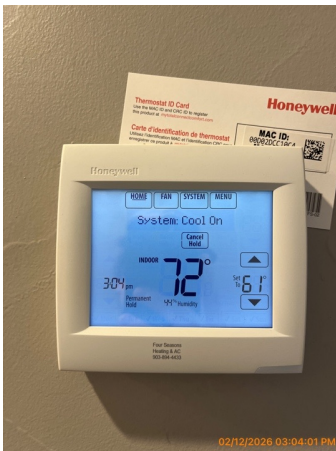
s-196: Failed to respond to user controls. Blower operated, but condensing unit did not turn on when thermostat was set to cool.

Recommend evaluation by specialist and repair as necessary.

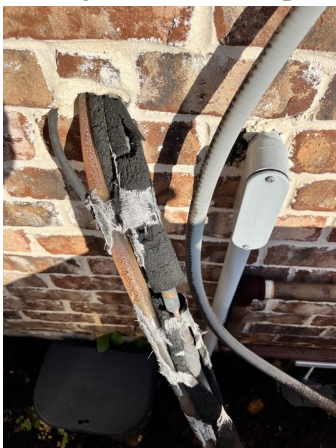
s-203: Insulation is deteriorated and missing from portions of the refrigerant lines in areas. We recommend that all missing insulation be replaced to increase energy efficiency.

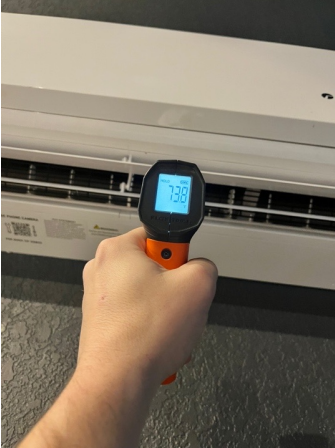
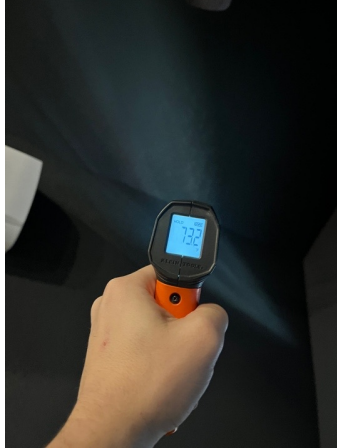
s-204: When set to cool, air blew from mini split but was not cooling  
Recommend evaluation by specialist

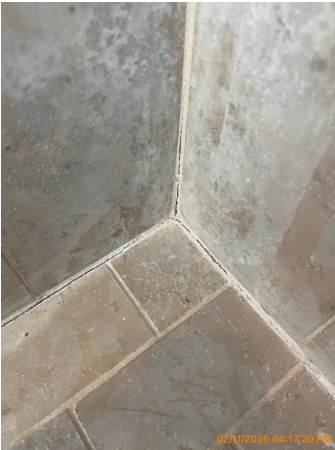
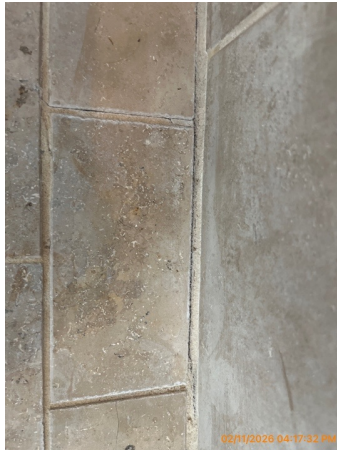
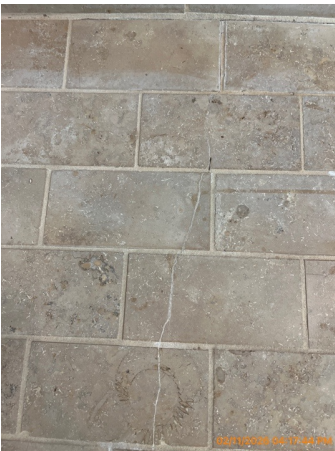
s-234: Minor cracks in grout and some cracked tiles noted in master shower

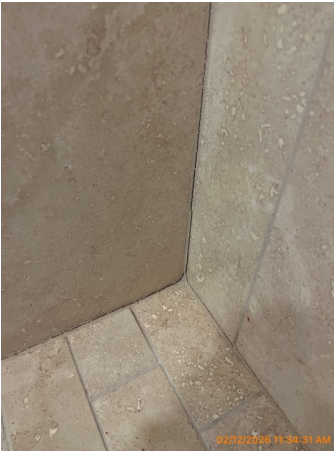
s-235: Minor cracks in grout of upstairs middle bedroom shower

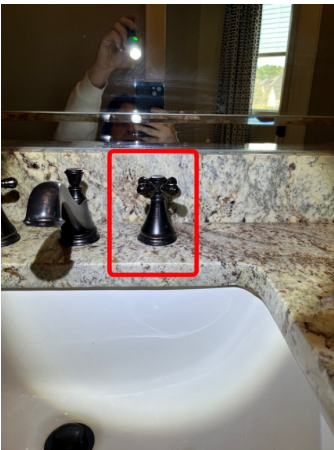
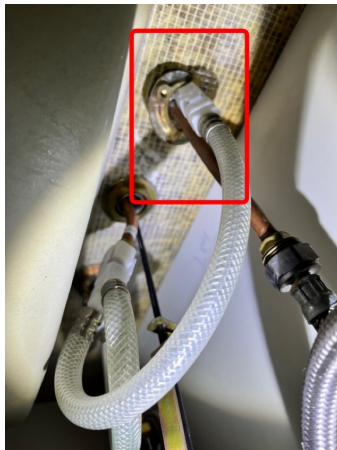
s-236: Cold water valve handle is loose where it should be secured to the countertop. (Upstairs right side bedroom en-suite bathroom)

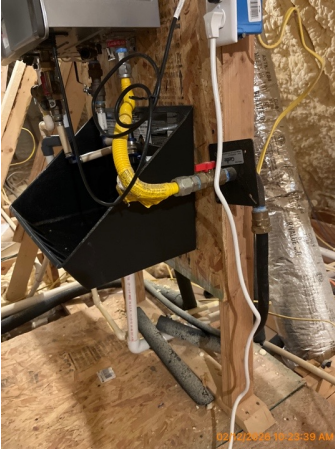
s-247: GAS SHUT-OFF VALVE: The gas piping does not include a sediment trap/drip leg installed downstream of the shutoff valve to collect condensation and debris. In the course of future upgrading or repair, a 'drip leg' should be added to the gas piping just ahead of the connector.

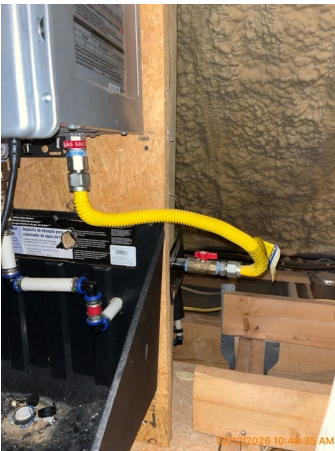
Left

s-264: GAS SHUT-OFF VALVE: The gas piping does not include a sediment trap/drip leg installed downstream of the shutoff valve to collect condensation and debris. In the course of future upgrading or repair, a 'drip leg' should be added to the gas piping just ahead of the connector.

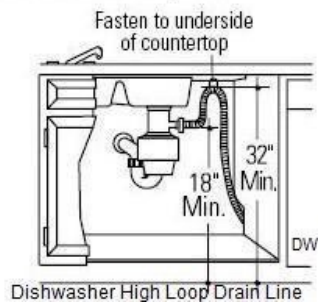
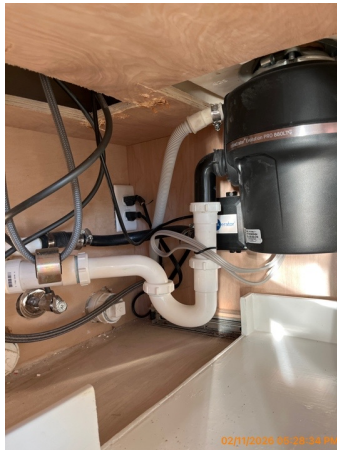
s-281: Dishwasher lacks air gap or backflow loop or the loop is not elevated high enough. This is considered a deficiency.

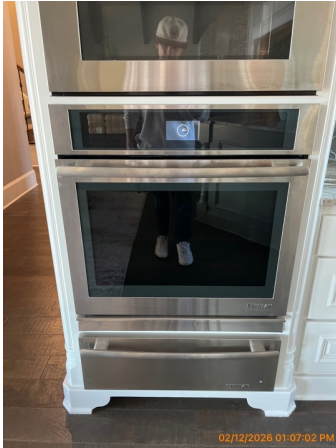
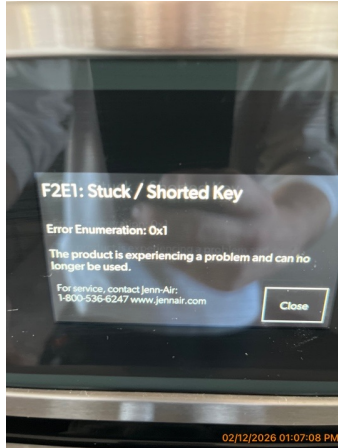
s-287: Left side oven was inoperative and had error code

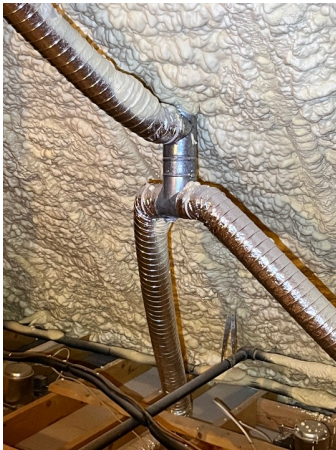
s-291: Three bathroom vent fan ducts share the same penetration through the roof.

Some jurisdictions forbid this sort of installation due to the possibility of backdrafting, unless each has a back-draft damper. Unable to determine if present

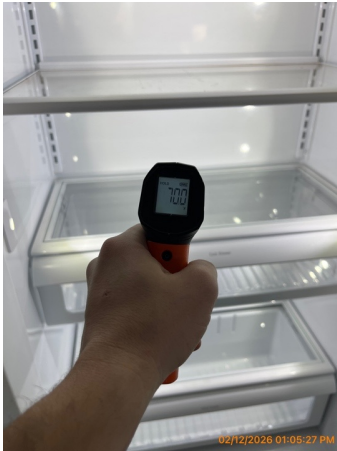
s-301: Refrigerator side of kitchen refrigerator was not cooling properly at the time of inspection.  
Set to 33 F, but temp at 71 F

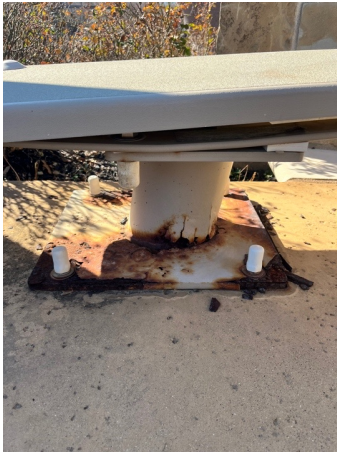
s-311: Diving board is rusted at the base.

Note that water slides and diving boards have a history of safety issues.
