# MERIT INSPECTION SERVICE INC.

## PROPERTY INSPECTION REPORT FORM

**Name of Client:** Kermit & Minnie Feuge **7/30/2024** **Date of Inspection**

**4402 Cherry Mountain Loop, Fredericksburg, TX**

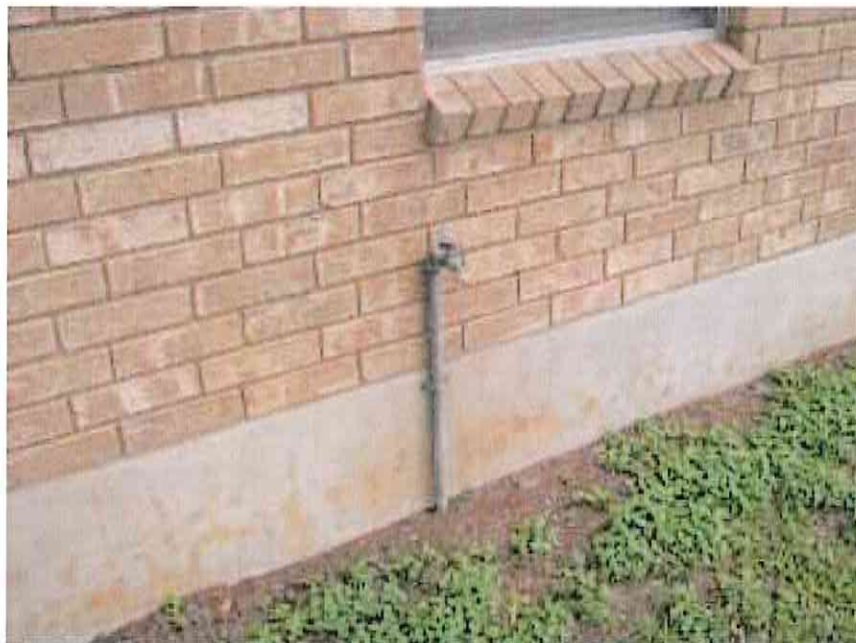
Static water pressure was observed to be between acceptable range (45-80 psi).

As is common with homes of this age and/or visibly observed during the inspection process this home appears to have had copper water service lines run through the concrete foundation. New PVC piping noted in storage, in attic and inside cabinets (+ sellers statements) indicate that copper water lines have been abandoned and rerouted.

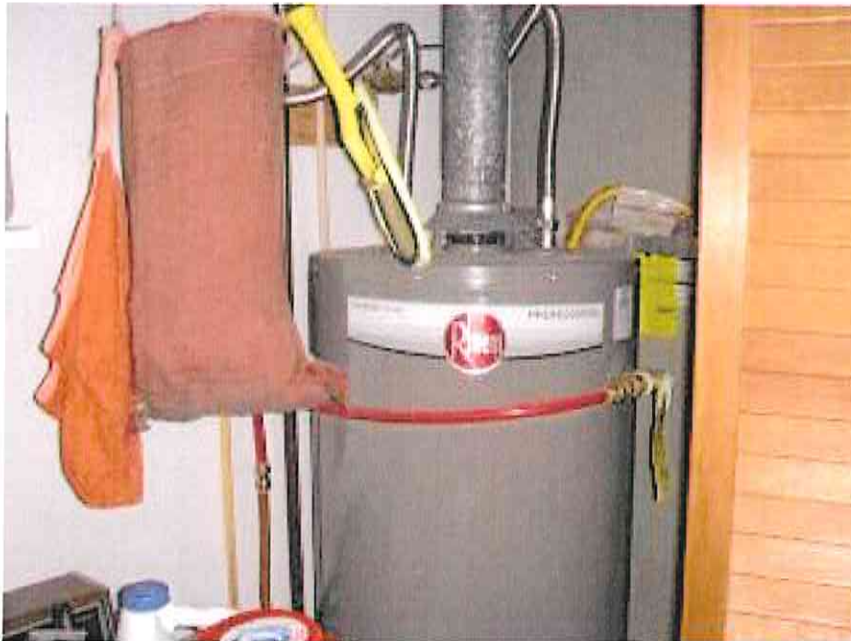
**IMPORTANT NOTE:** Life expectancy is between 8-10 years depending on water condition, use and service frequency. If unit in place is older - budget for replacement. (\$575 - 875) WATER HEATERS LOCATED IN GARAGE AREAS NEED TO BE ELEVATED NO LESS THAN 18" INCHES ABOVE THE GRADE LEVEL. (AND PROTECTED FROM IMPACT TYPE DAMAGE) T&P valves are not tested operated on old water heaters. Installed expansion relief devices/tanks should be in place at water heaters in any incidence where your water supply system has a "PRV" (pressure reducing valve) installed - most times at water meter - very common in Kerrville. These were not common in the past but plumbers are now requiring them be installed with new water heaters. ( additional cost at water heater replacement time)

**A licensed plumber should be consulted prior to end of option period and/or prior to closing to observe conditions present and make repair or replacement recommendations.**
